D. Clark Arboriculture 2741 The Rise Victoria B.C. V8T-3T4 (250)208-1568 clarkarbor@gmail.com www.dclarkarboriculture.com

Re: 135 Menzies Street, Victoria BC V8Z 3G4

The following memorandum is an outline of D. Clark Arboriculture's attendance in tree management activities relating to the demolition phase at 131-139 Menzies Street. I attended 135 Menzies St. on December 20th, 2024, January 15, 2025, and January 21, 2025, to oversee exploratory excavation requirements established in the Arborist Tree Management Plan (submitted June 11th, 2024). This memorandum is supplementary to the Arborist Report and Arborist Tree Management Plan (submitted June 11th, 2024) and summarizes the following arboricultural management activities:

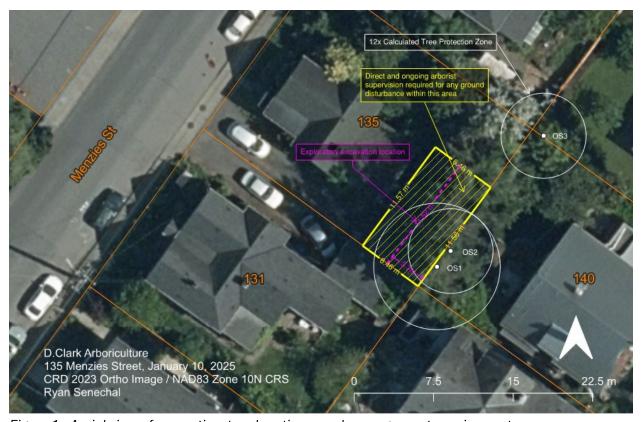
Hydrovac exploratory excavation took place on January 20th, 2025, at the rear of 135 Menzies Street (*Figure 1*). Bedrock was encountered at the southwest side of the property beside the remaining garage (40 cm depth) and increased in height to just below the existing grade at the mid point of the exploratory trench. The bedrock reached its lowest point at the northeast end of the trench approximately 11 m from the garage (90 cm depth). No roots were encountered from trees identified for protection. Roots were pruned (3 x 2.5 cm) on the on-property western redcedar #2 identified to be removed.

Figure 1 - Aerial view of properties, tree locations, and management requirements.

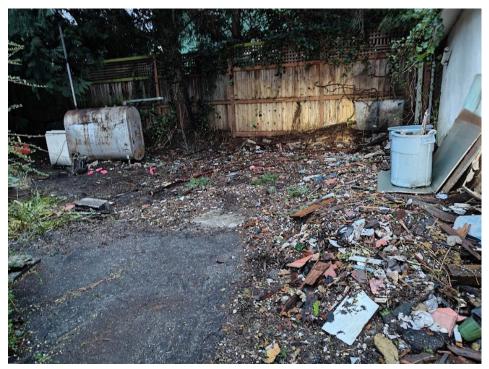
On my initial site visit for exploratory excavation behind 135 Menzies Street (December 20th, 2024) there were several constraints restricting hydrovac trenching (*Figures 2*) which required the postponement of supervised excavation. A shed had been removed prior to our arrival, and all other structures including property fences, landscaping, and hardscaping remained undisturbed. These constraints to exploratory excavation included a large concrete slab, a brick walkway, and hazardous building debris. A heating oil tank remained on a section of the concrete slab and was required for servicing the occupied home.

Figure 2 - View of oil tank, driveway, shed, slab, and debris (December 10, 2024).

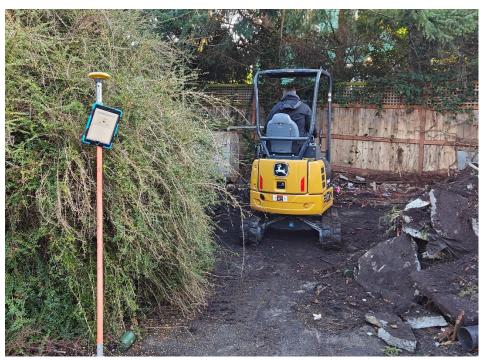
A follow up visit was coordinated for arborist supervision to remove the concrete slab and site debris (that would enable a hydrovac to complete exploratory excavation) on January 15th, 2025. A finishing bucket on a JD17 mini excavator was used to lift and break up the concrete, and to grub the surface of building debris along the trench location. All grubbed materials were staged to the southwest of the trench (outside the Tree Protection Zone). An 8 cm ø root (belonging to Douglas fir #OS1) at the surface had previously been damaged and was pruned 2 m from the trunk. Low branches were pruned on

Figure 3 – Slab and building debris removal (January 15th, 2025)

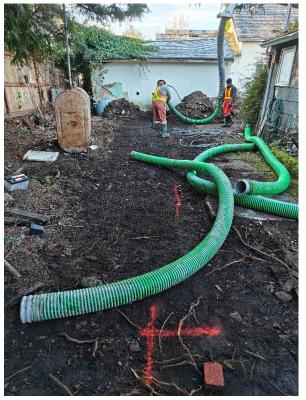
Figure 4 - Exploratory trench layout.

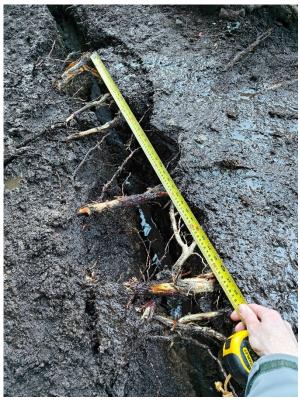
Figure 5 - View of roots to be pruned on redcedar #2 (tree to be removed).

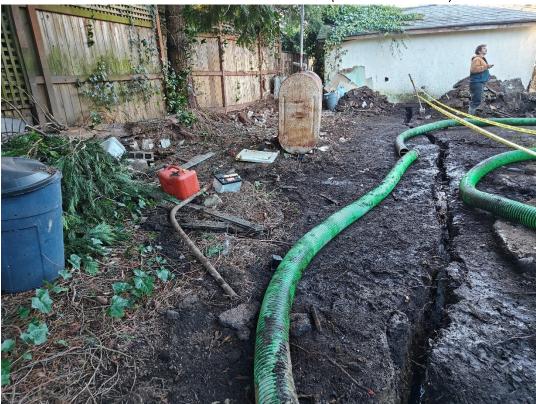
Figure 6 – Completed trench viewed from the northeast side of the property.
