Home Inspection Report

PROPERTY INSPECTED:
1012 Oliphant Avenue
Victoria, BC V8V 2V1

Date of Inspection: 08/07/2024

Inspection No. 1013-2-3237

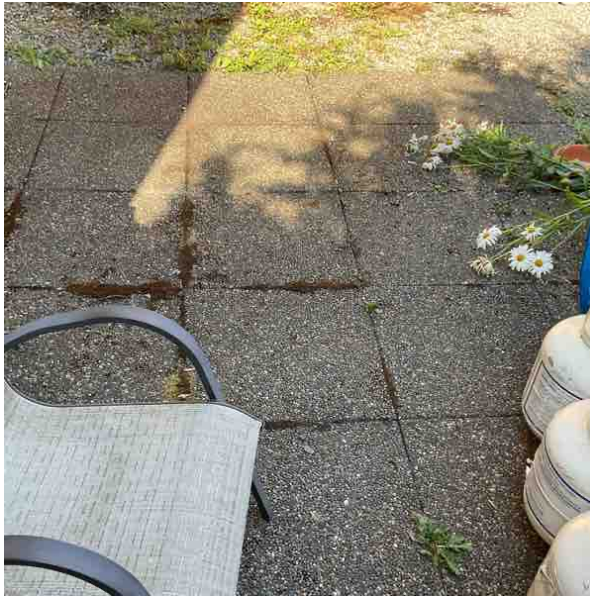
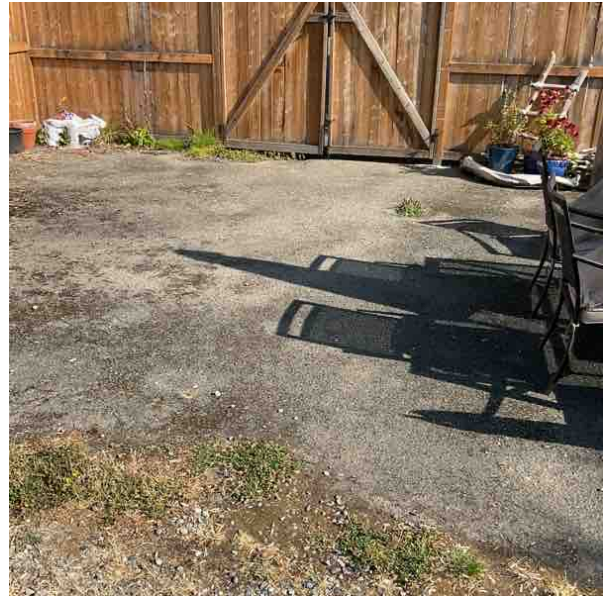
2.3.1 Patio surfaces show typical wear and tear. **(Exterior Back)**

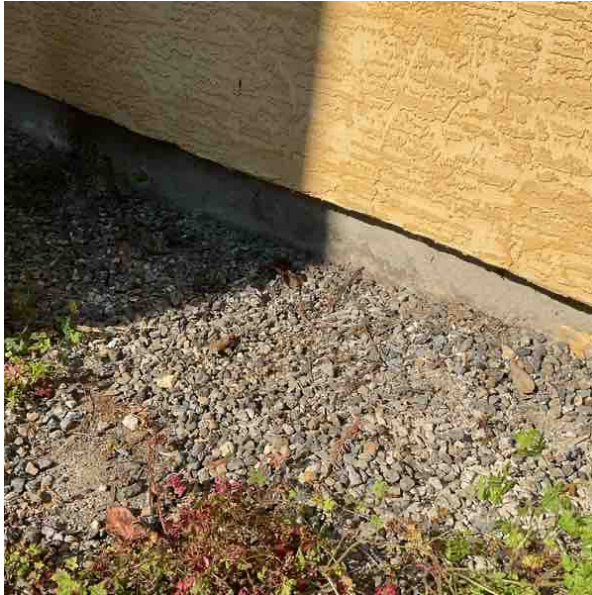
3.3.1 Inspected minor concrete cracks. This is normal for concrete. Minor movement can occur at these cracks. We recommend a good quality sealant be applied to prevent seepage.

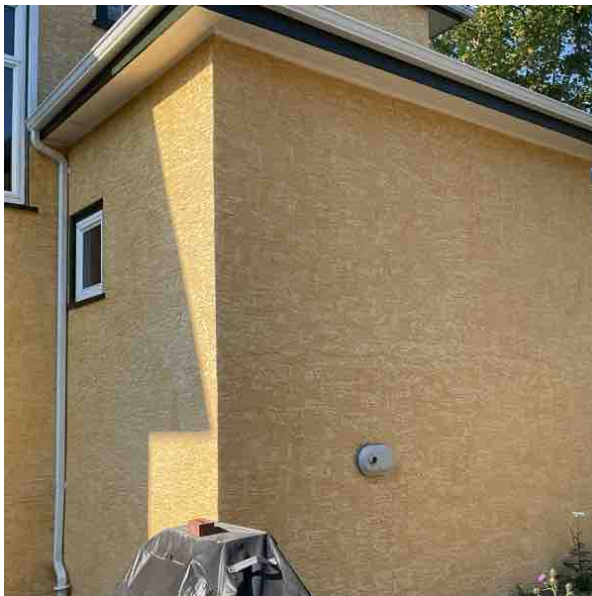
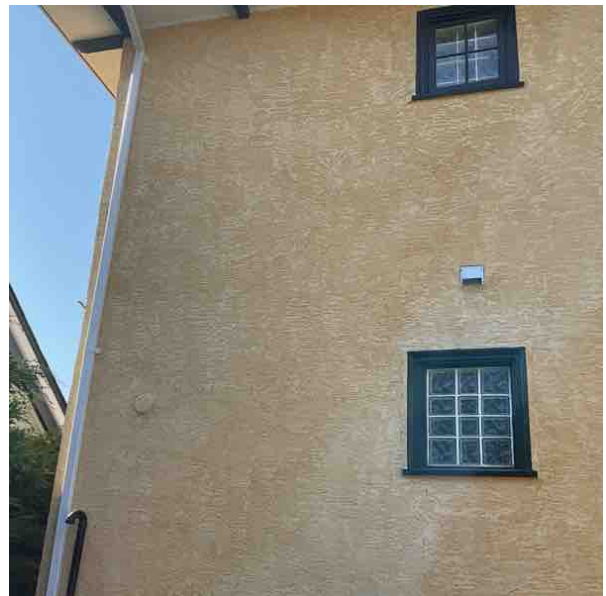
3.4.1 Stucco is in good condition. Minor cosmetic shrinkage cracks are inherently common and normally do not pose a concern.

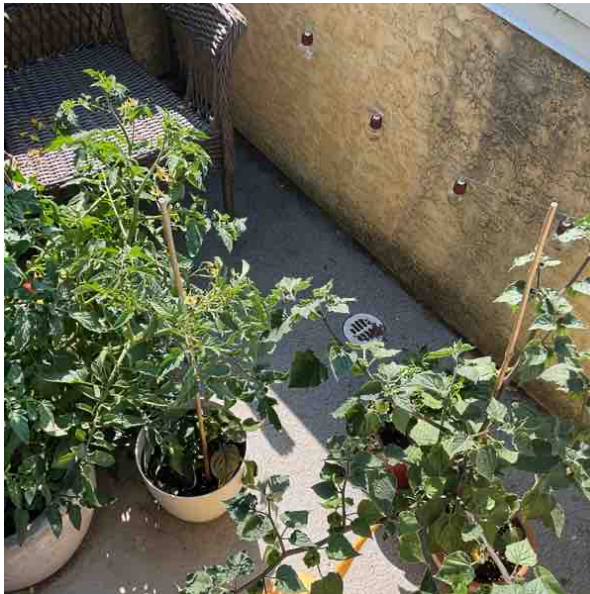
3.10.1 The vinyl deck covering is in fair condition and showing signs of typical wear and tear relative to age. Minor touch up repairs may be required. Budget accordingly.

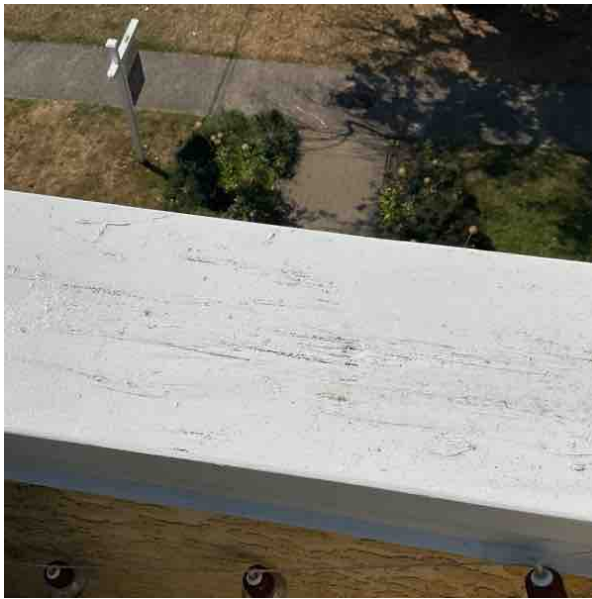
3.10.2 The railing cap shows deterioration, budget for repairs or replacement for safety.

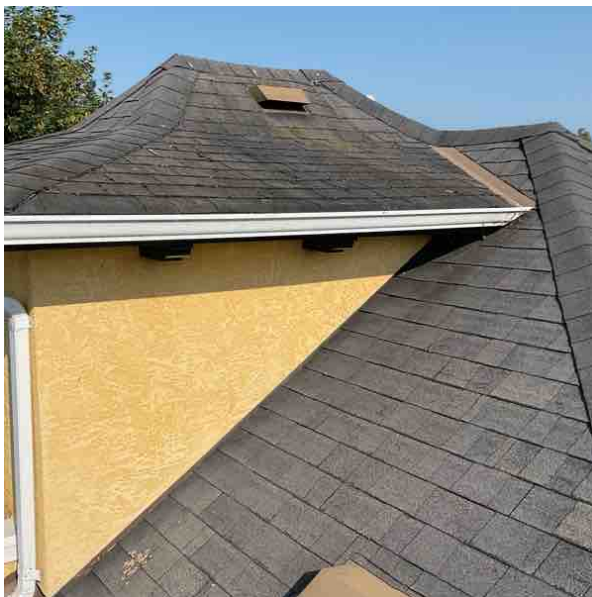
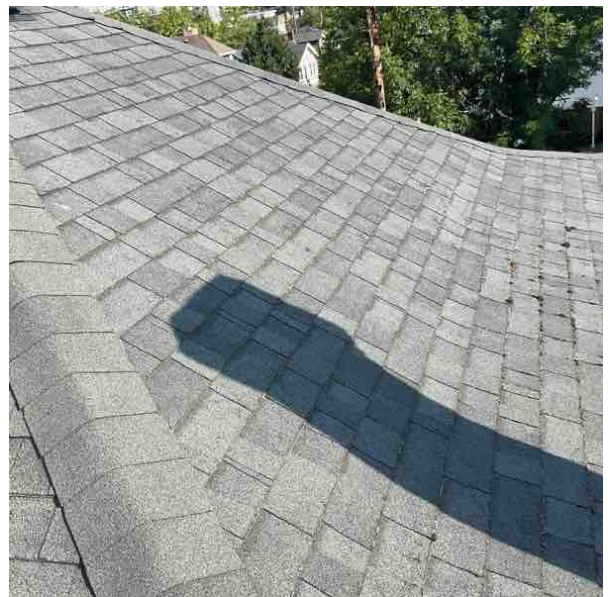
4.3.1 We recommend having the roof serviced and de-mossed to increase longevity.

4.3.2 Typical life expectancy of this roofing product is 25-35 years with routine maintenance.

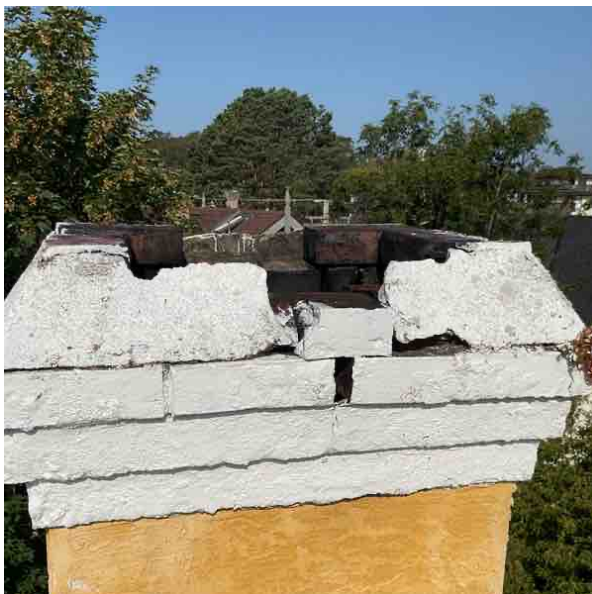
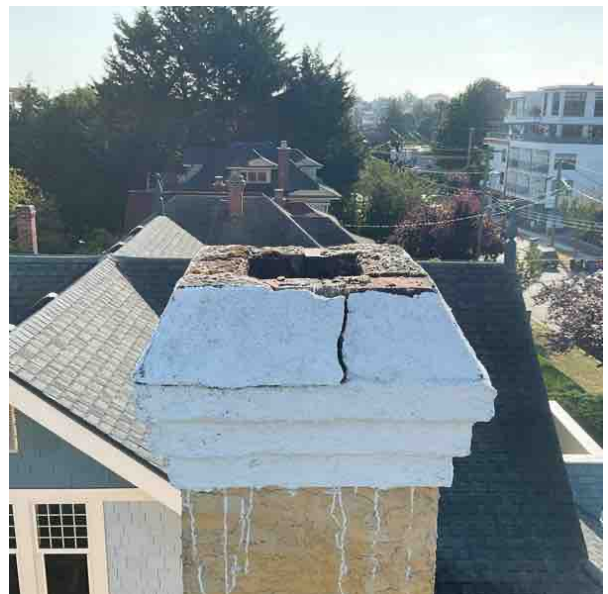
4.6.1 We inspected deterioration of the masonry chimney caps. We recommend budgeting to have a qualified mason conduct repairs to prevent stability issues and safety hazards.

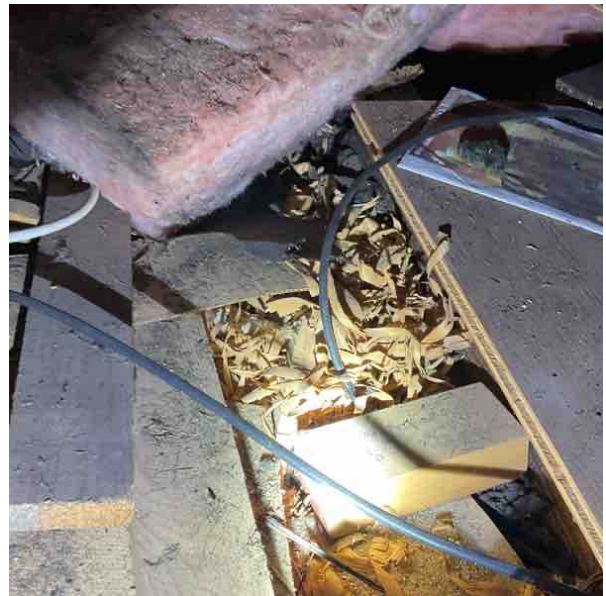
5.4.1 Home heating costs and interior comfort would benefit from increasing insulation levels to the current standard. Consult an insulation specialist for options and costs.

5.4.2 Approximate depth: 1-5"

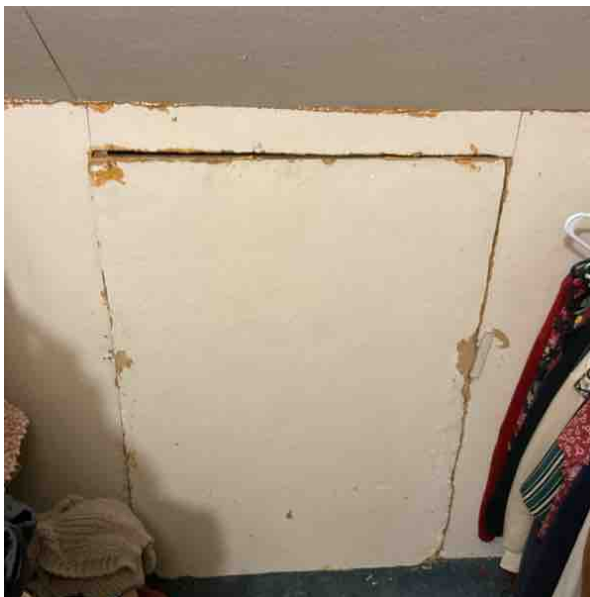
5.4.3 Attic hatch should be weatherstripped and/or insulated to reduce heat loss.

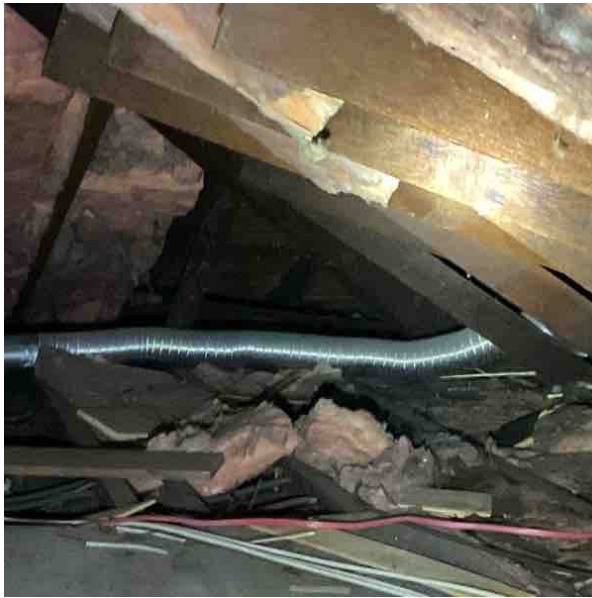
5.7.1 Ducting requires insulation when passing through an unheated space to reduce condensation build up and drips. Pre-manufactured insulated ducting works well. Repairs are recommended.

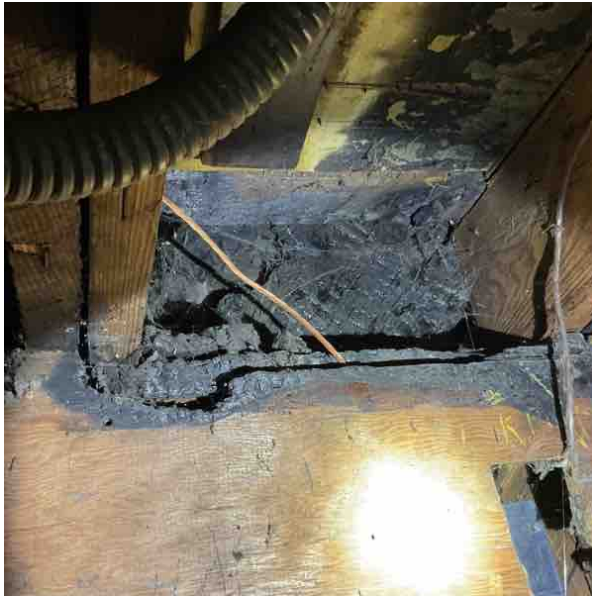
6.2.1 Inspected evidence of past fire damage. It appears to be localized to one small area. Obtain a history of events from the vendor. **(Basement)**

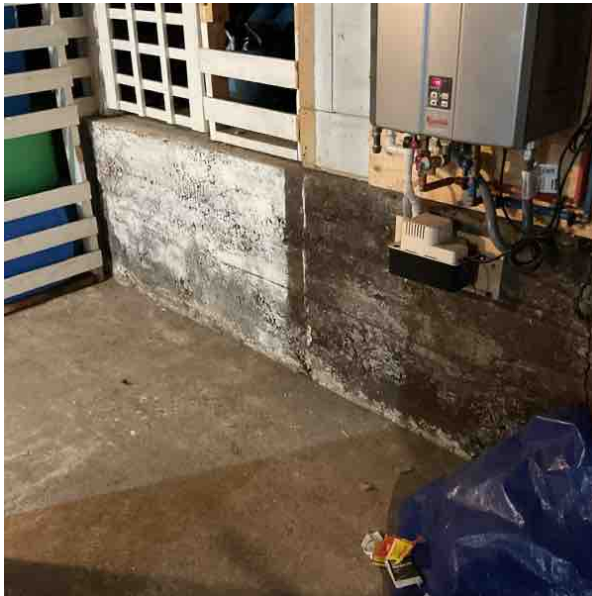
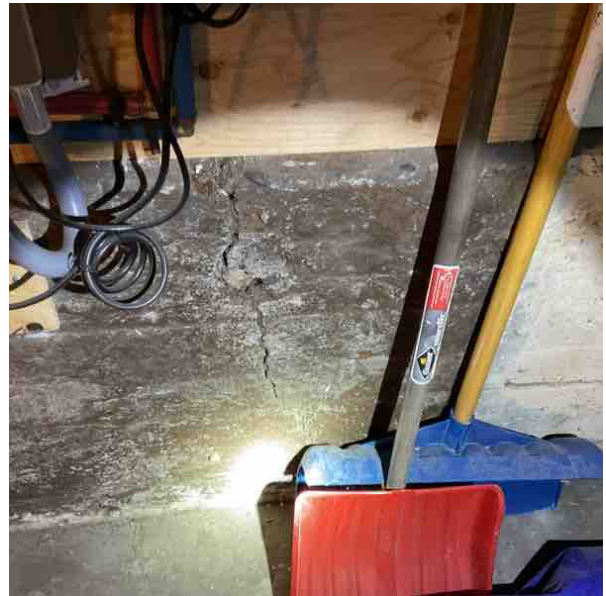
6.3.1 Foundations appear to be in typical condition for the age. Seal foundation cracks from the exterior to reduce the risk of seepage.

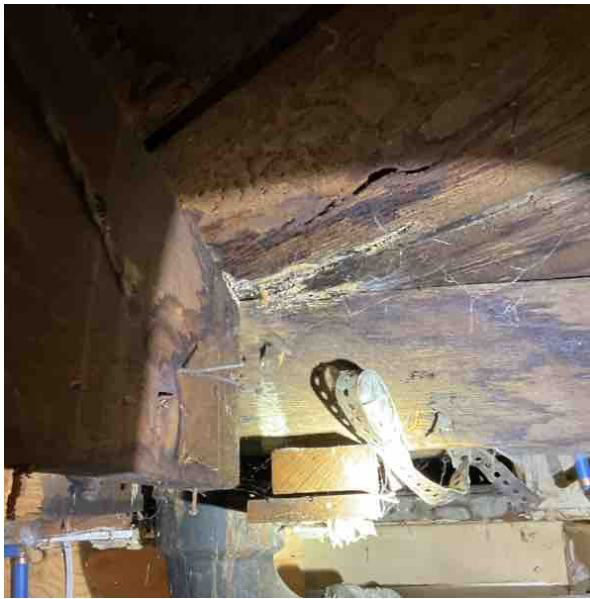
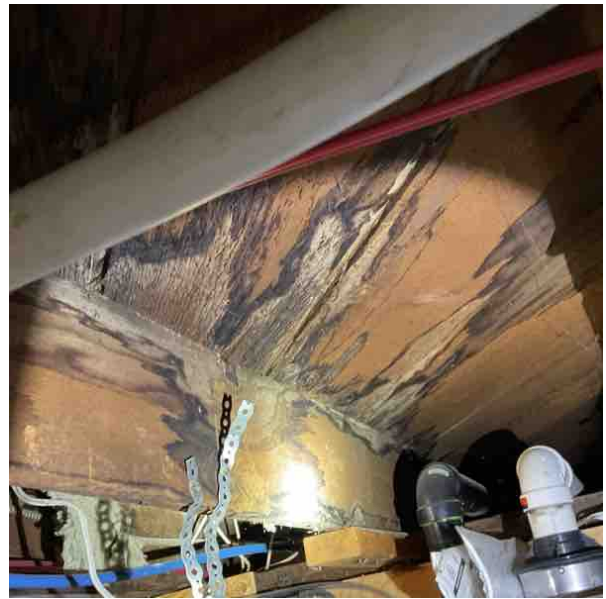
6.5.2 Stains throughout are evidence of past leakage. The stains are dry.

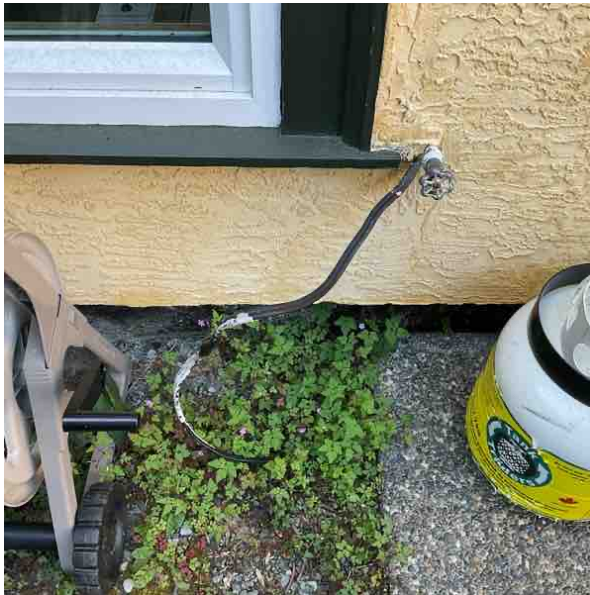
7.8.1 Circuit wire is not guarded, have properly repaired by a qualified electrician to prevent injury. **(Exterior Back)**

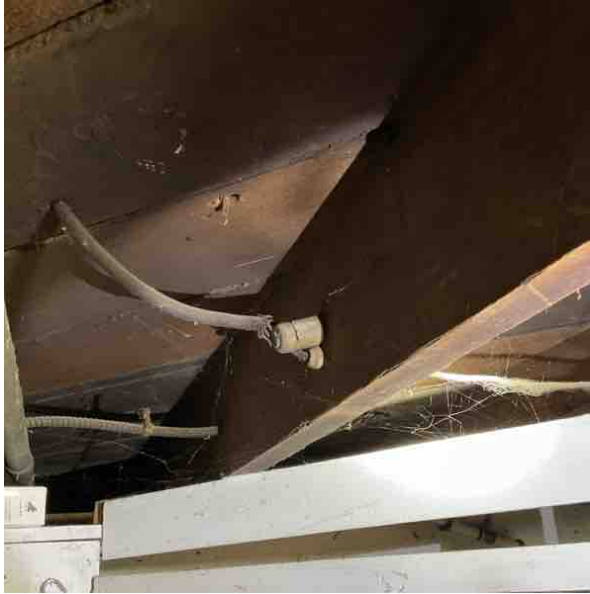
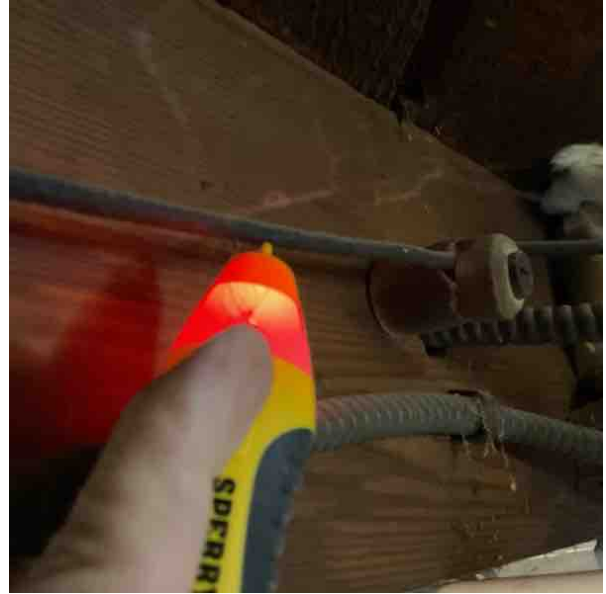
7.8.2 Knob and tube wiring is present in the home. Knob and tube wiring is not as safe as modern systems. Check with your Insurance provider to ensure coverage. Inspection and service records from an electrician may be needed.

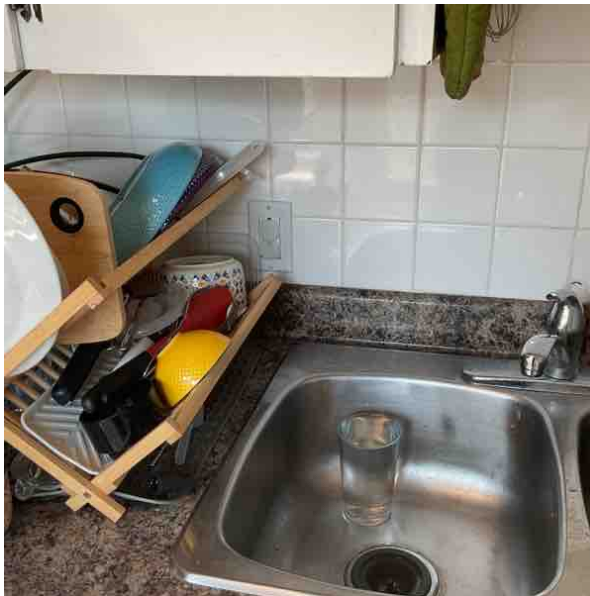
7.9.1 Receptacle had no power when tested. We recommend having a licensed electrician conduct further review. (unit 4)

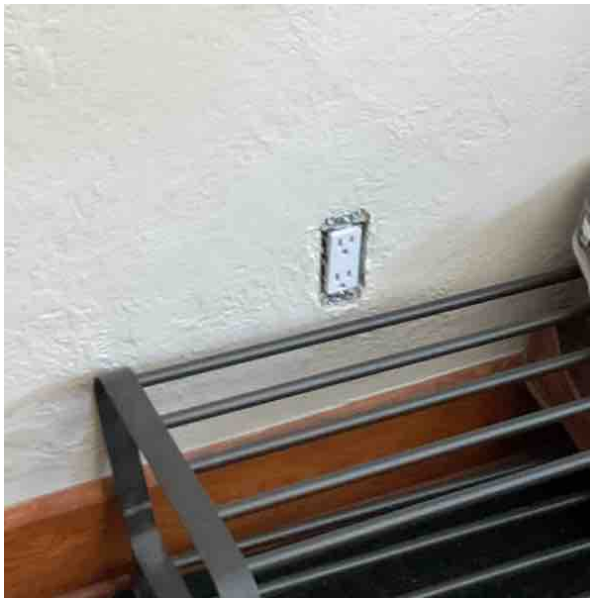
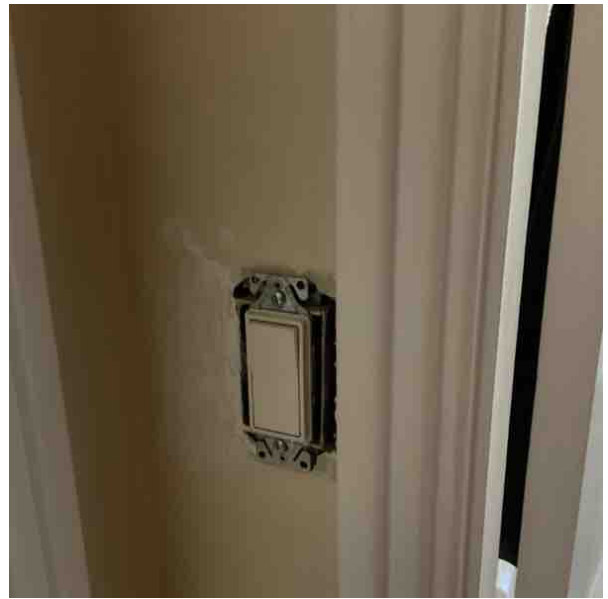
7.9.2 Missing cover plates should be installed for safety. **(unit 1)**

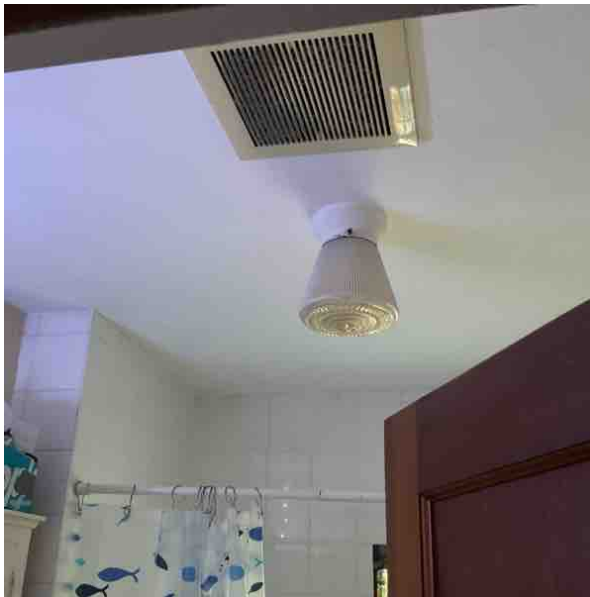
7.10.1 Light fixture did not respond to normal activation, check bulbs or have a licensed electrician conduct further review as required. **(Unit 3)**

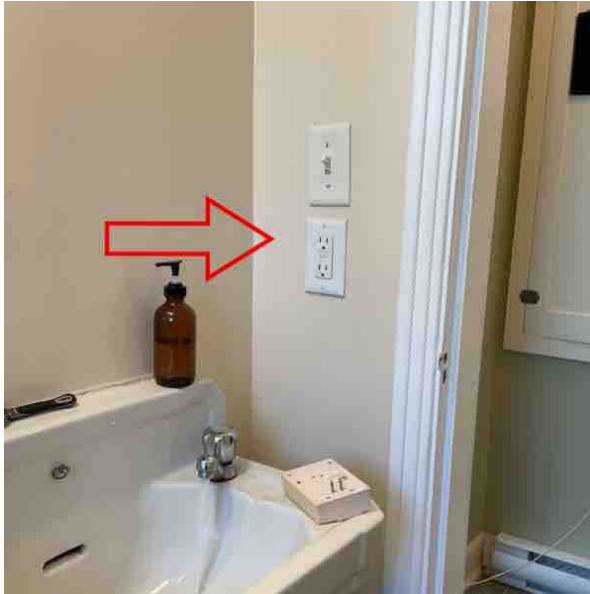
7.11.1 GFCI receptacle is damaged, inoperative or does not trip power as intended. It is faulty or wired improperly. Budget for repair or replacement. **(Unit 2)**

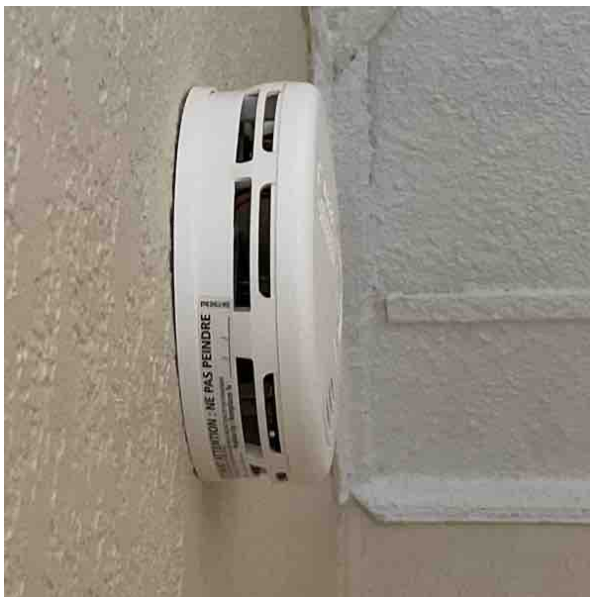
7.12.1 Older smoke detectors are likely expired. Replacement is recommended for safety of occupants. **(unit 4)**

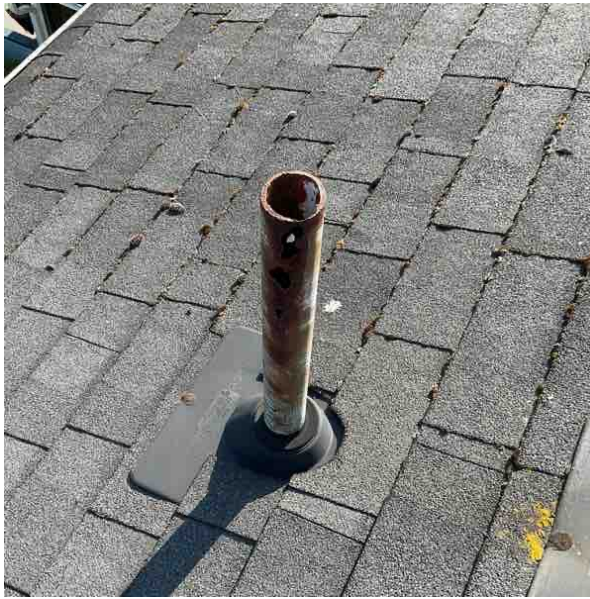
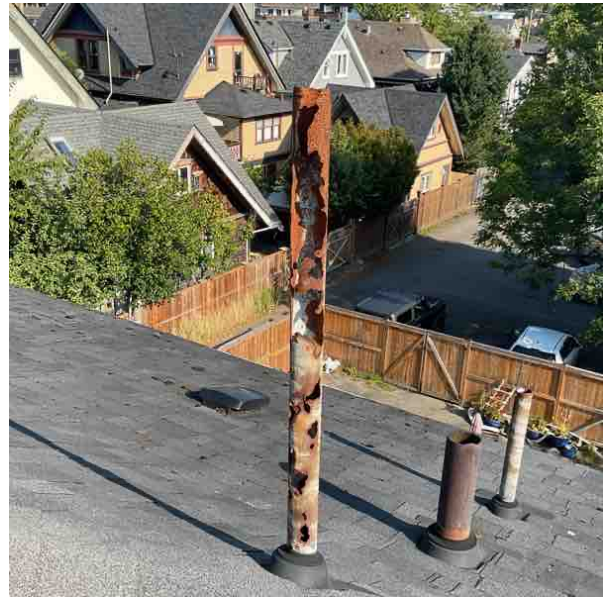
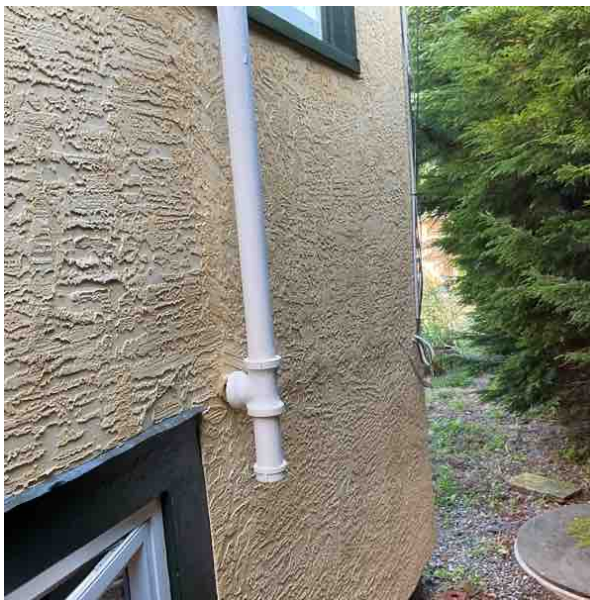
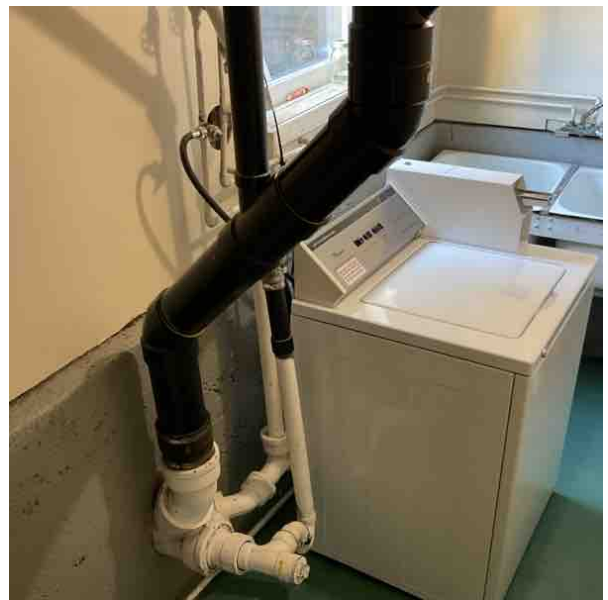
9.4.2 Cast iron drain piping is past its typical life expectancy but appears functional. There are old drip marks which is common, but there is no evidence of current leakage. Some of the plumbing has been updated over time, likely as needed. It is recommended to budget for replacement of the old pipes before they become problematic. **(Roof)**

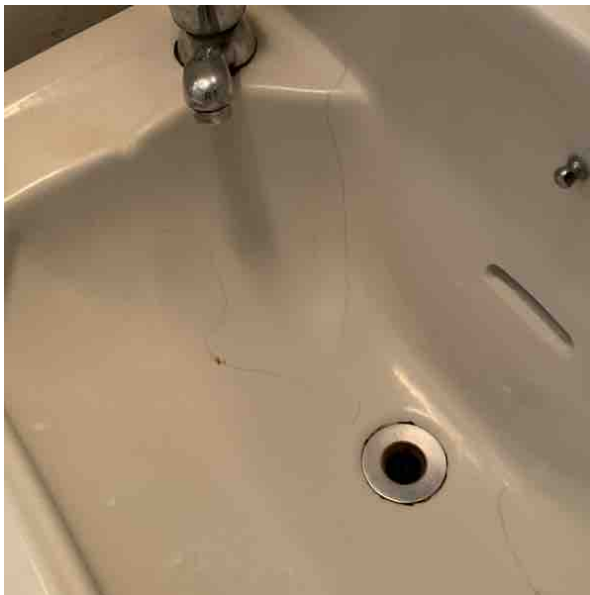
9.7.1 Sink is worn, corroded or damaged, recommend repairs or replacement. **(unit 5)**

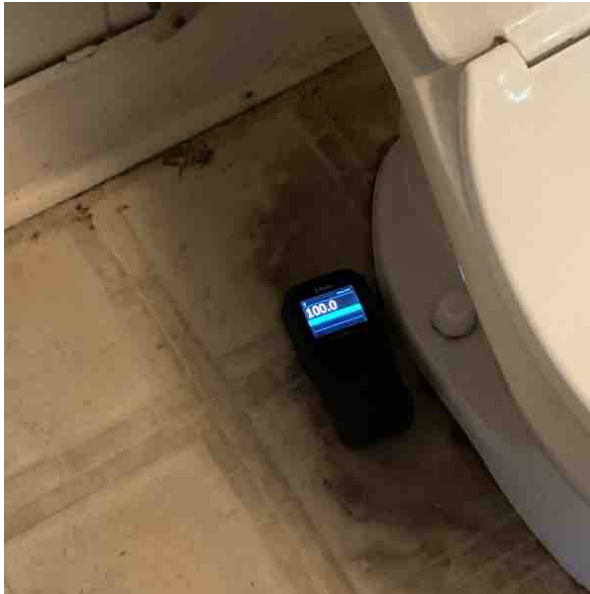
9.8.1 Detected active dampness at the base of the toilet. This condition may cause concealed damage. Locate the source of the leak and conduct repairs. We are not able to determine the condition of concealed areas.

Toilet base/tank is loose, secure to prevent leaks. **(unit 5)**

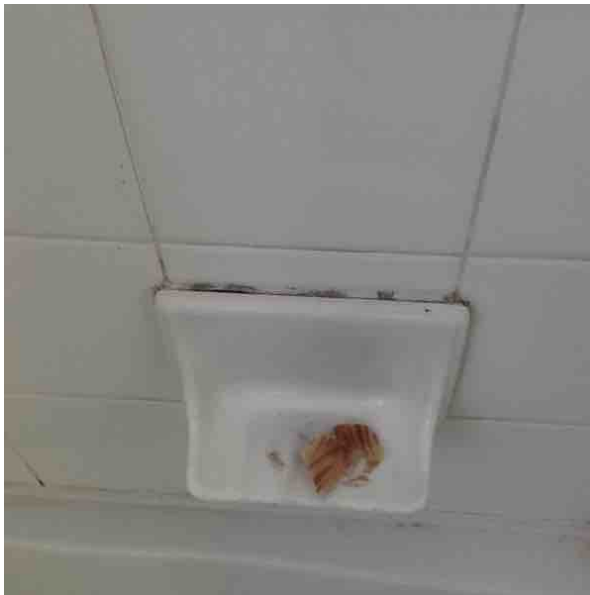
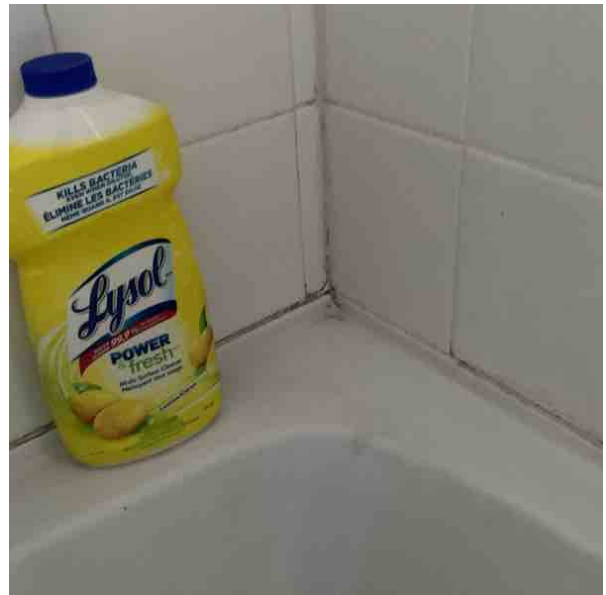
9.9.1 Sealant is worn, missing or damaged and should be repaired to prevent moisture ingress. **(Unit 3)**

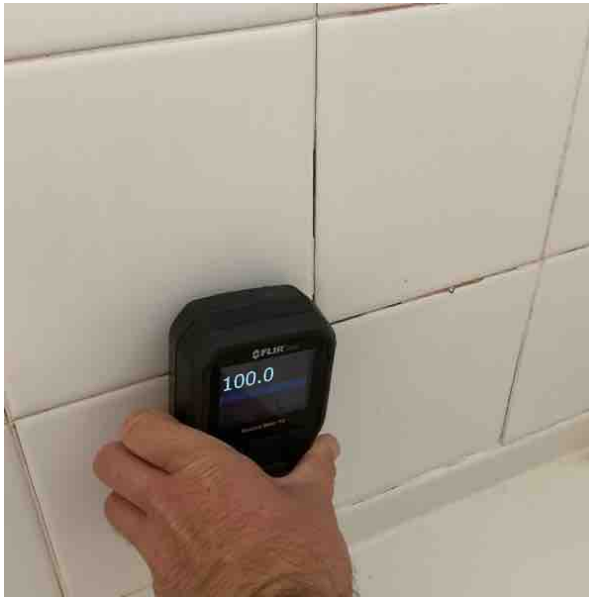
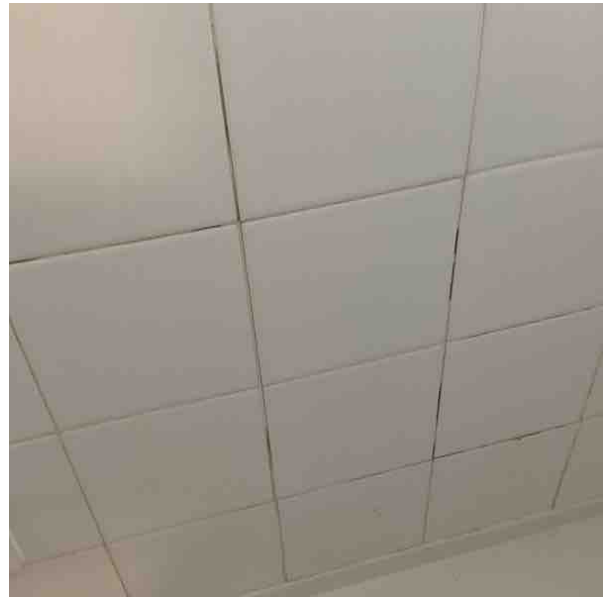
9.9.2 We detected excess dampness behind the wall finish indicating possible trapped moisture. This condition may cause concealed damage. Conduct further review as required, budget accordingly for repairs.

Grout or sealant is worn, missing or damaged and should be repaired to prevent further damage. **(Unit 2)**

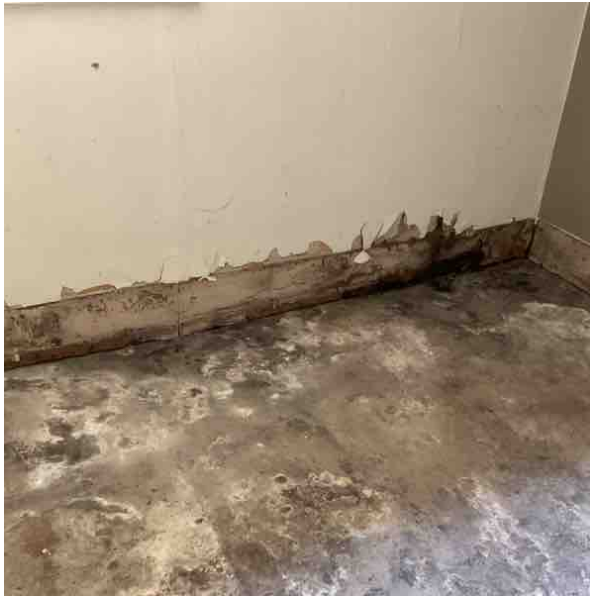
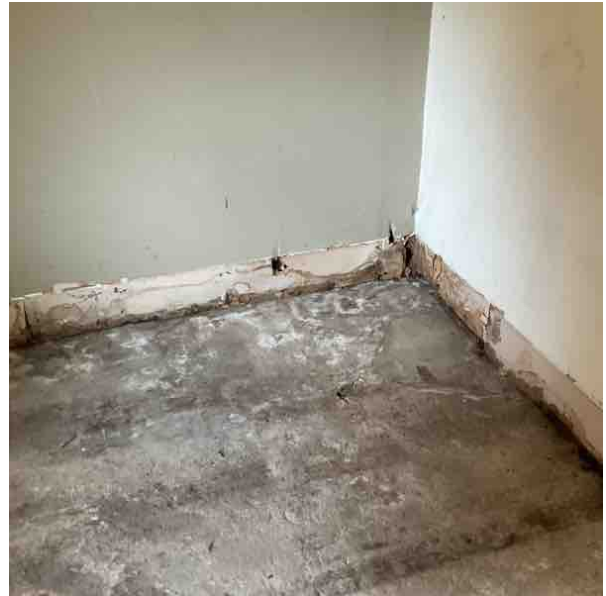
10.4.1 Stains are evident, however no moisture readings were detected. Obtain a history of events from the seller or monitor the area for possible concealed leak activity. **(Basement)**

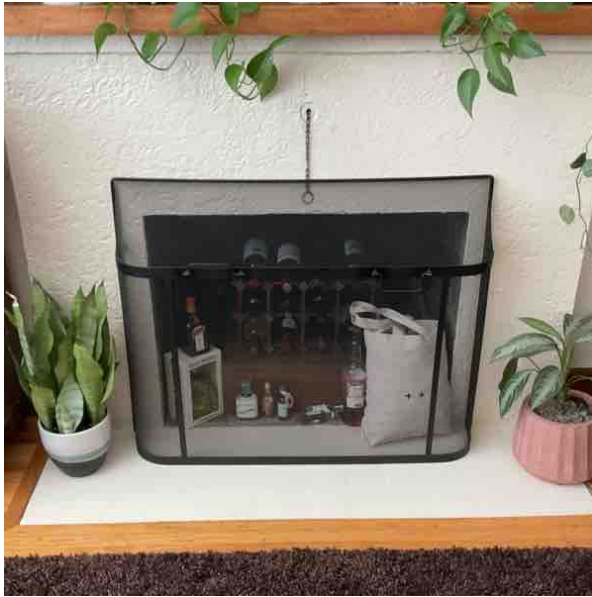
11.1.1 Fireplace appears abandoned, recommend further review. **(unit 1)**

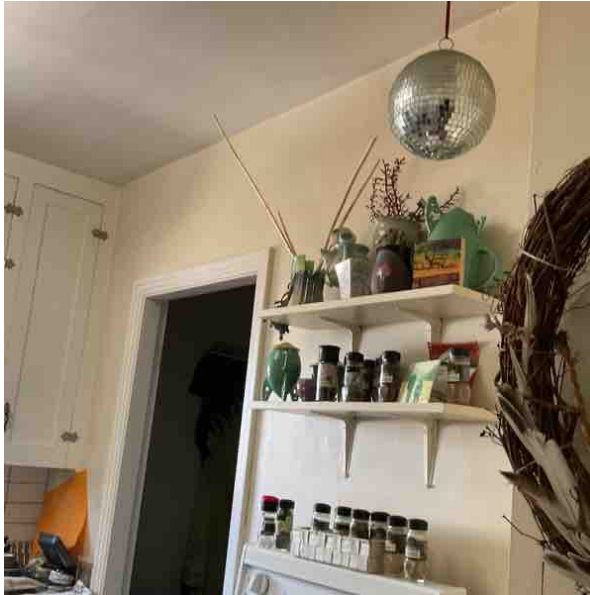
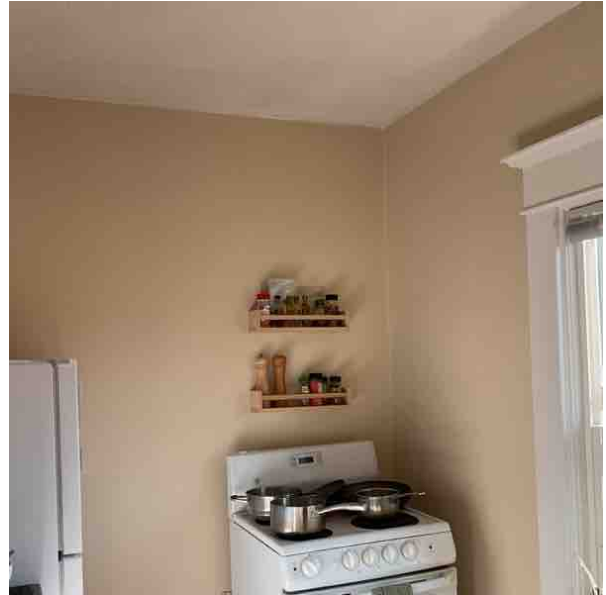
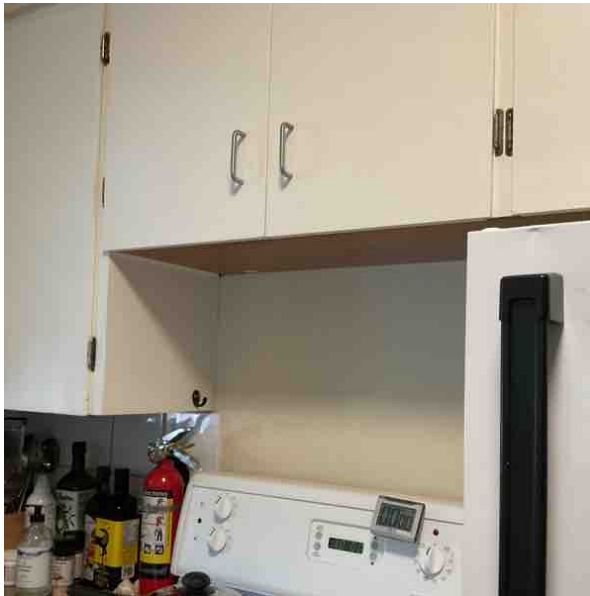
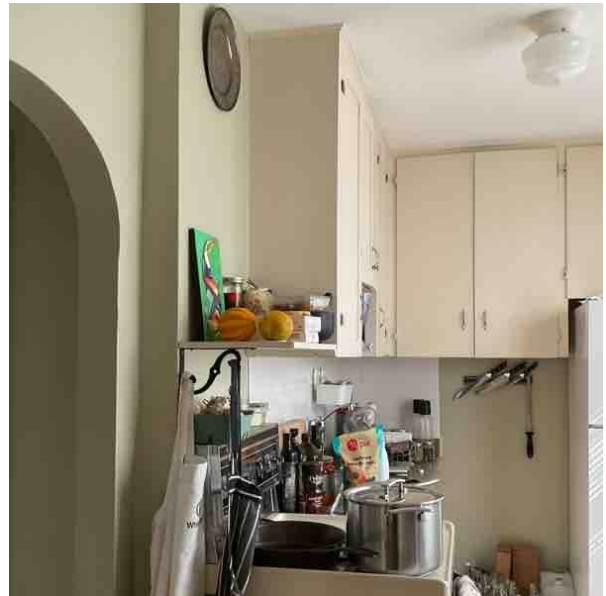
- Unit 2
- Unit 3
- unit 1
- unit 4

12.4.1 Recommend installing range hood to rid the home of excess humidity and cooking odors.
