Arborist Report & TPP – 330 Irving Rd., City of Victoria – White Birch @ 332 Irving Rd

## **Arborist Report**

330 Irving Road  
Victoria, BC V8S 4A2

**RE: Tree Assessment & Tree Protection Plan – (1) White Birch Species  
(*Betula* sp.)****Executive Summary**

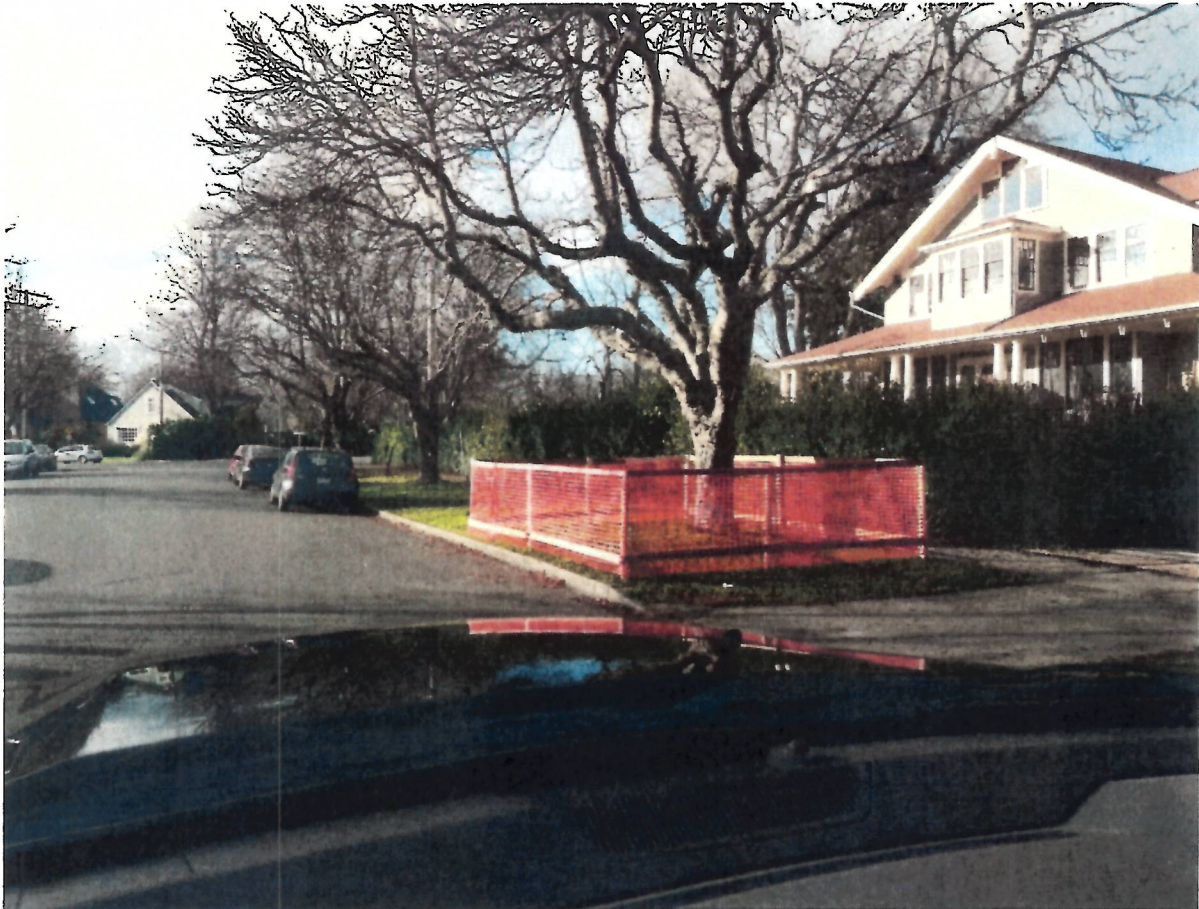
Photo #1 – Fencing Construction

In this photo you can observed a typical Tree Protection Fence. This type of construction is considered to be square with right angles.

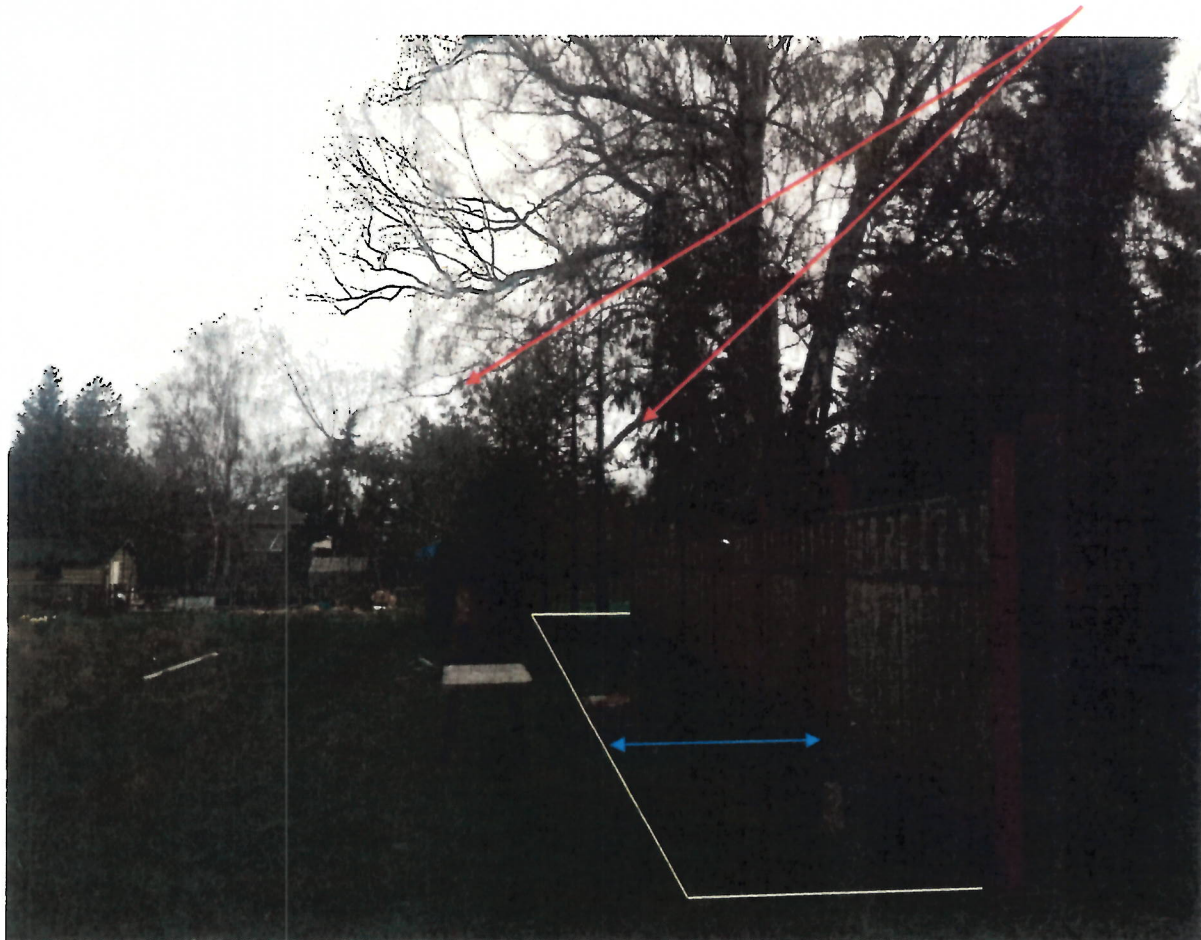
Photo # 2 – Property Line Fence  
White Birch

You can see the birch trees position on the neighbouring property. A few of the limbs are excessively long and overhang the client property. Pruning must occur to remove low limbs which may be damaged during the project.

In this photo you can see the blue arrow line which indicates the three (3) metre protection distance required from the existing fence. This fencing shall be installed and kept in place until the final stages of the project. Graphics are not to scale.

- Provide pruning to remove 3 to 4 limbs from the tree which hang in and over the proposed project area. Utilize a qualified arborist who is familiar with ANSI A300 pruning standards for the Tree Care Industry. Limb reduction pruning and standard elevation pruning can be utilized to achieve clearances of 4 to metres above grade.
