Attachment B:

Ship Point Pier Existing Condition Photos

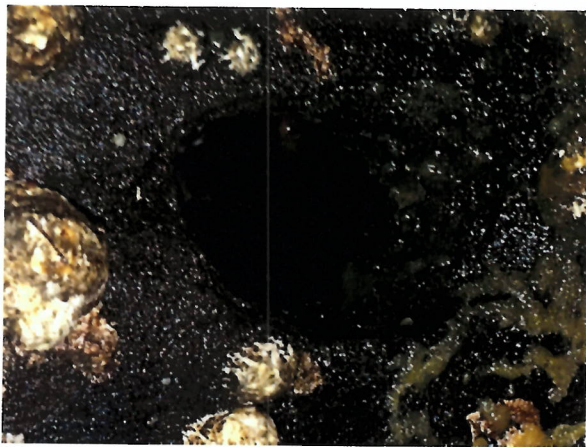
View through hole in hollow timber pile

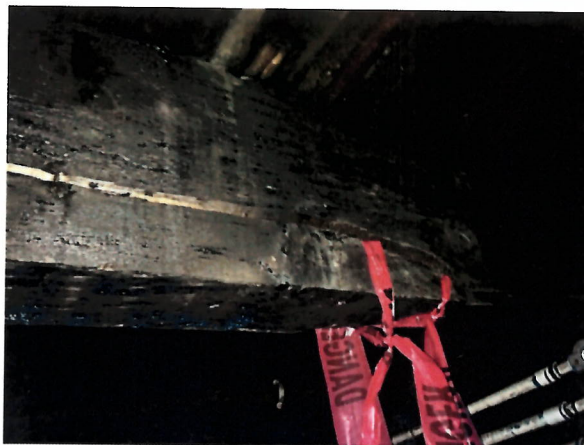
Damaged timber beam

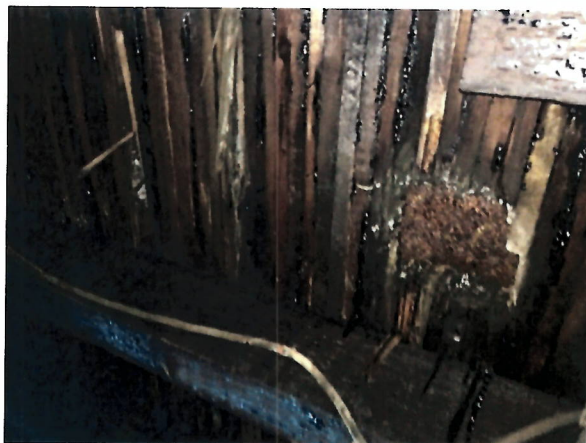
Damage to timber decking

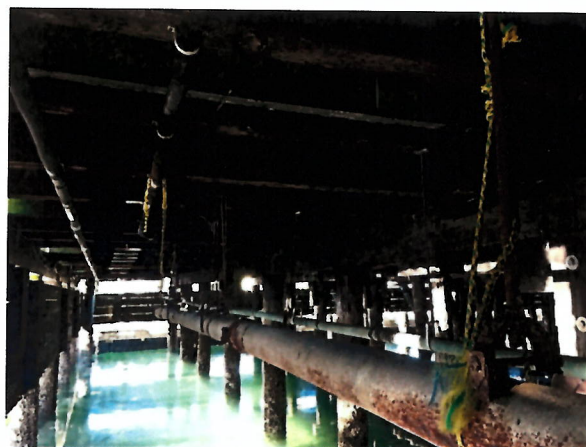
Suspended Services below pier

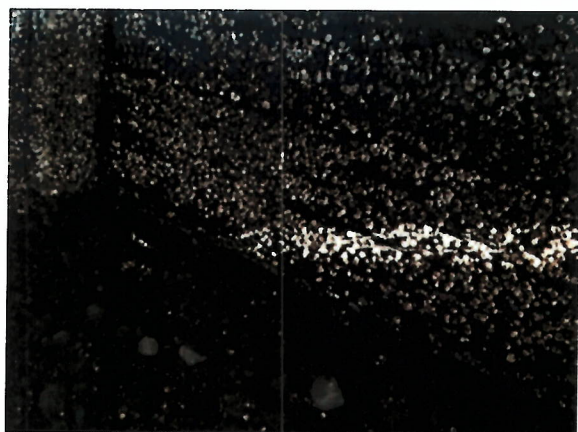
Deteriorated timber retaining wall

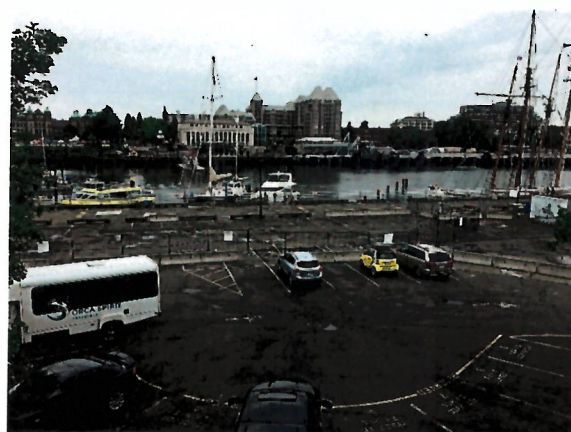
Pier Closure
