HALL BLOCK

727-729 YATES STREET, VICTORIA, BC

CONSERVATION PLAN

AUGUST 2017

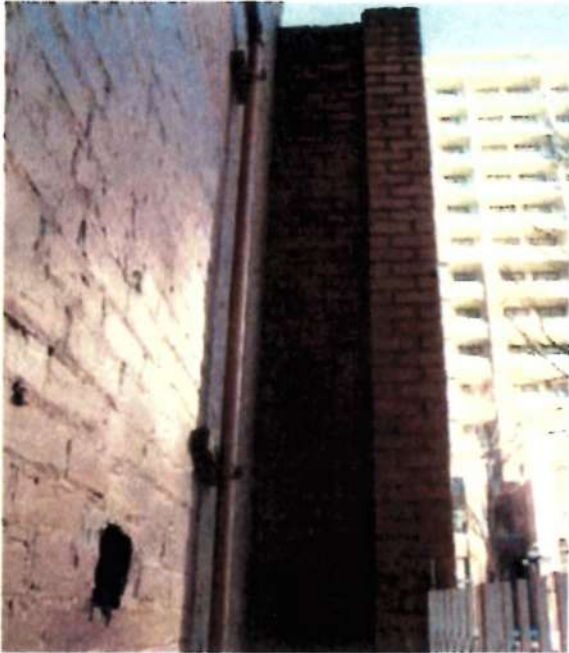
Detail photo of storefront wall east extension, as viewed from behind along the side pathway.

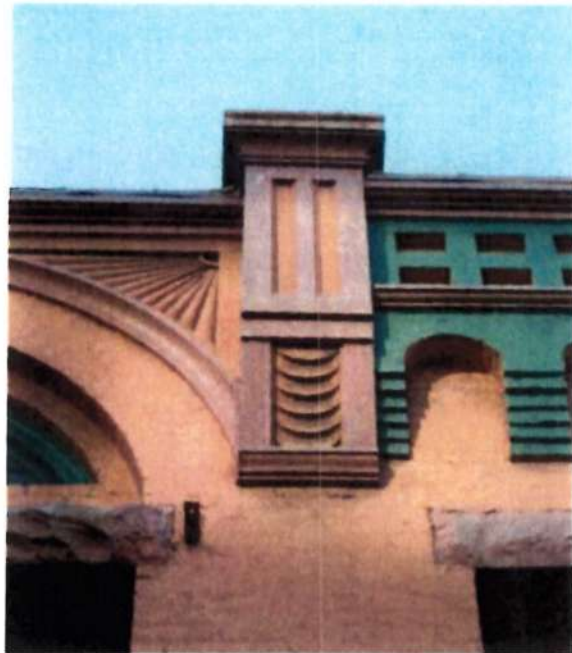
Detail photo showing existing conditions of parapet with architectural metalwork and original masonry elements.

The top of the parapet is integrated with architectural metalwork characterized with late-Victorian era decorative elements. The surviving decorative pieces resemble the profile found in archival photos, and appear to be in good condition. The roof was inaccessible during the initial site visit, and further investigation is required to determine its condition and structural integrity. Viewed from street level, they appear to be in good condition, with evidence of some biological growth, and bird deposit staining.

- Evaluate the overall condition of the parapet cap flashing, if any, to determine whether more than protection, maintenance and limited repair or replacement in kind is required.
- Remove corrosion that may be discovered upon close inspection, patch and repair, caulk joints as required and apply appropriate primer for galvanized surfaces.
- Repair or replace deteriorated flashing, as required. Repairs should be physically and visually compatible.
- If new flashings are installed, ensure that the colour is compatible with the overall colour scheme.

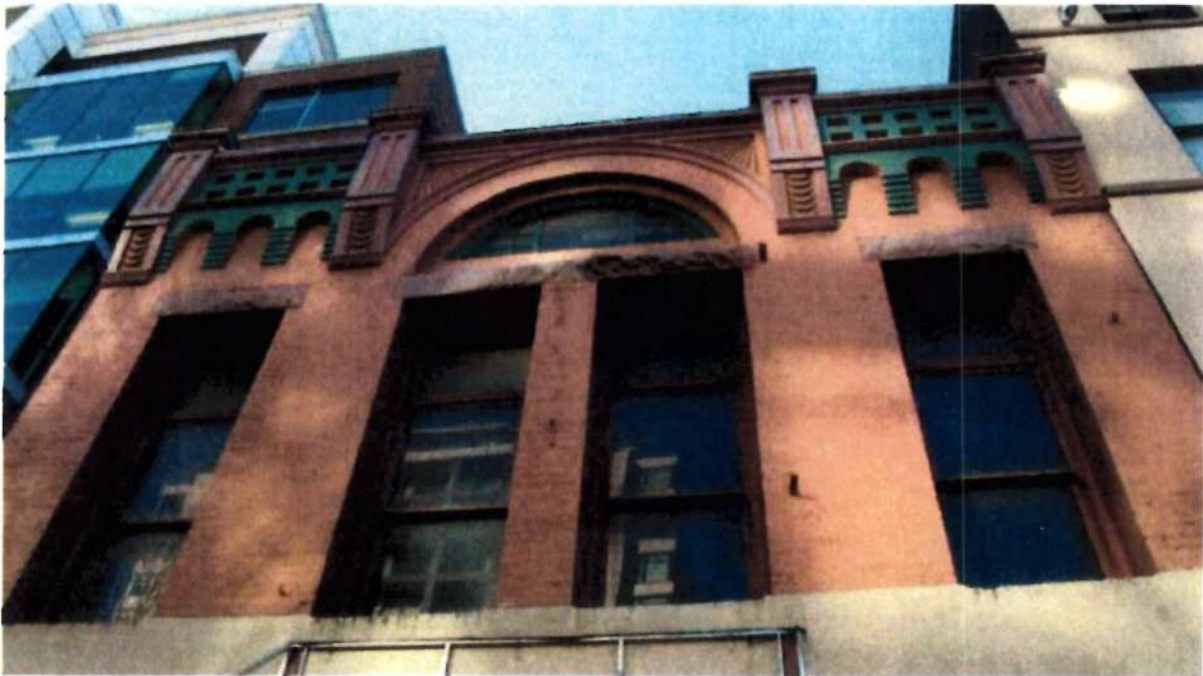
Detail photo showing existing condition of the masonry elements and architectural metalwork above storefront level of the historic front facade. Note existing parged concrete cladding at window sill to be removed.

In general, the later cladding and surviving, original masonry elements above the storefront level appear to be in good condition, with signs of minor deterioration in localized areas, as evident by spalling, mortar deterioration (or loss altogether), peeling paint, holes in various sizes from redundant fasteners, discolouration, bird deposit staining, and some biological growth.

- Preserve all surviving, original masonry elements whenever possible, and restore elements that are too deteriorated for safe use, or missing altogether.
- Undertake complete condition survey of condition of all masonry surfaces.
- Ensure drip kerf is cut at underside of sandstone sills to improve water-shedding capabilities.
- Determine whether or not it is feasible to remove the unsympathetic parged concrete cladding, including paint, to expose the original brick. Undertake test samples for paint

- Overall cleaning of the masonry on the exterior front façade and rear elevation should be carried out. Do not use any abrasive methods that may damage the fireskin surfaces. Use a soft natural bristle brush and mild water rinse. Only approved chemical restoration cleaners may be used. Sandblasting or any other abrasive cleaning method of any kind is not permitted.

- If repointing of brickwork is required, rake out loose mortar material to a uniform depth. Take care that the arrises of the brick are not damaged. Work should only be undertaken by skilled masons. Do not use power tools to cut or grind joints; hand-held grinders may be used for the initial raking of horizontal joints after test samples have been undertaken and only if approved by the Heritage Consultant. Repoint mortar joints with new mortar that matches existing in consistency, composition, strength, colour and pointing profile; note the finely tooled profile of the original mortar joints.

- All redundant metal inserts and services mounted on the exterior walls should be removed or reconfigured.
- Any holes in the brick should be filled or replaced to match existing.

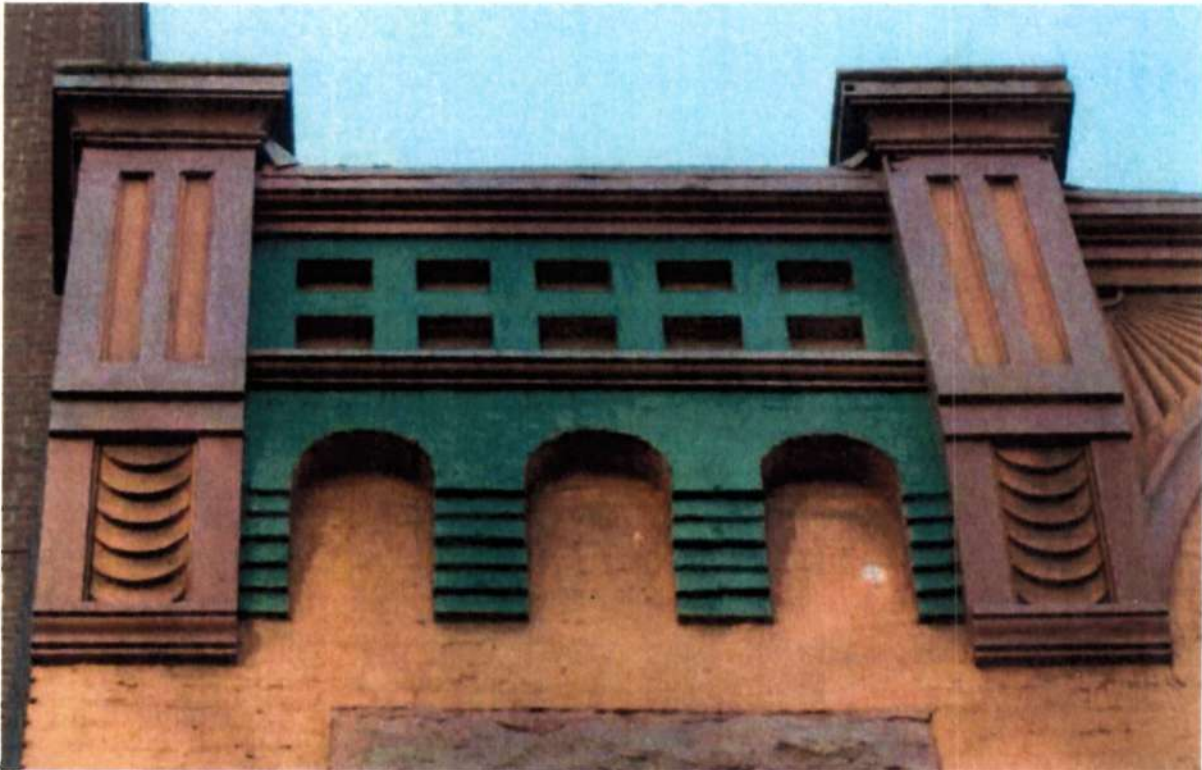
Existing condition of rehabilitated architectural metalwork that resembles original based on archival photos.

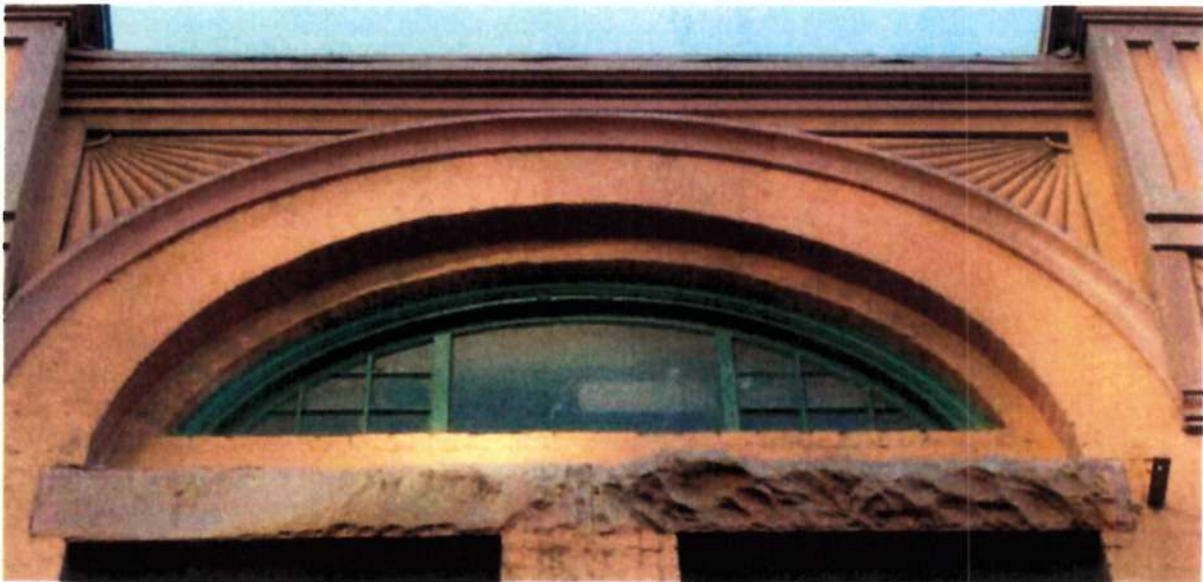
In general, the extant original windows are in good condition, with minor signs of deterioration as a result of natural weathering. All original wood windows contribute to the historic character of the Hall Block, and should be preserved, and repaired as necessary.

Top: Photo showing typical existing condition of original double-hung wood window assembly with transom light.

Bottom: Photo showing arched window opening and original multi-light wood-window assembly at central bay of the Hall Block.

- Inspect for condition and complete detailed inventory to determine extent of recommended repair.
- Retain existing window sashes; repair as required.
- Preserve and repair as required, using in kind repair techniques where feasible.

- Overhaul, tighten/reinforce joints. Repair frame, trim and counterbalances.
- Each window should be made weather tight by re-puttying and weather-stripping as necessary.

- Retain historic glass, where possible. Where broken glass exists in historic wood-sash windows, the broken glass should be replaced. When removing broken glass, the exterior putty should be carefully chipped off with a chisel and the glazier's points should be removed. The wood where the new glass will be rested on should be scraped and cleaned well, and given a coat of linseed oil to prevent the wood from absorbing the oil from the new putty. The new glass should be cut 1/16-1/8th smaller than the opening to allow for expansion and irregularities in the opening,
