Tree Preservation Plan

Regarding 944 Heywood Ave, Victoria BC.

Prepared by Conan O'Dell. ISA Certified

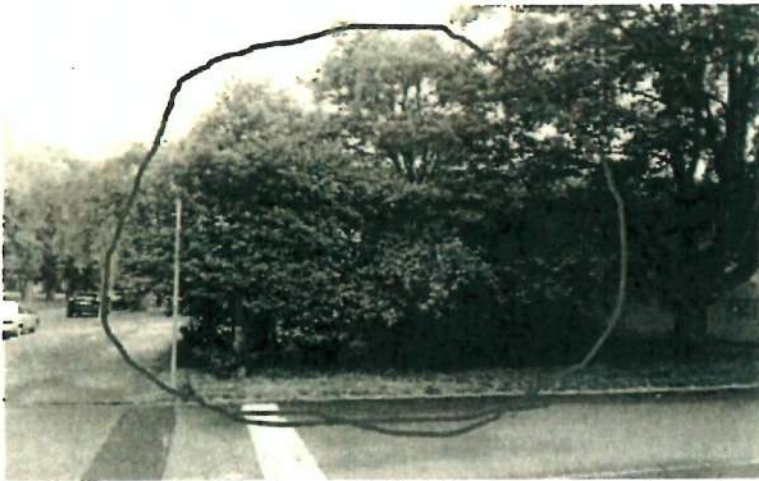
Photo I showing cluster of holly, laburnum and hawthorne (trees 2,3,4,5,6,7,8) at the south west corner of the property

**Recommendations:** It is recommended that the mitigation measures set forth in this report be followed. Regarding the proposed sidewalk placement along Pendergast St., the placement of the sidewalk will necessitate the removal of all the laburnum, hawthorne and holly on the south property line. It will also require the removal of a large low limb on the maple (tree #9). Moving the sidewalk to the edge of the street will prevent the large limb removal as well as allow for the retention of some of the laburnum/ hawthorne. The sidewalk should be constructed at existing grade with minimal excavation to prevent damage to the roots of tree #9. Any excavation within the root zone shall be done under the supervision of the project arborist.

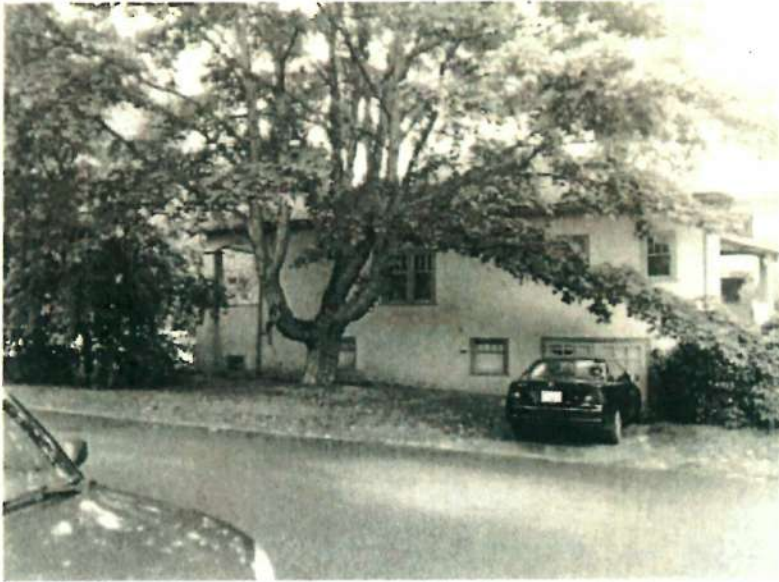
The root excavation on tree #9 revealed that the building footprint is unlikely to affect the critical roots. The additional root excavation for the driveway revealed few roots extending into the footprint of the proposed driveway, and based on the smaller diameter of these roots in relation to the trunk size, pruning these roots back from the footprint is unlikely to negatively affect the health and stability of the tree. It is recommended that the over-excavation be reduced to 0.5m to reduce impact to tree #9. The exploratory excavation shows that no special excavation is needed (ie. Air spade, hydro-vac) and that excavation will be done by standard excavator. The contractor and project arborist will be onsite to supervise all excavation in the root zone.

Photo 2 showing South side of property showing tree #9) 71.5cmDBH Douglas maple

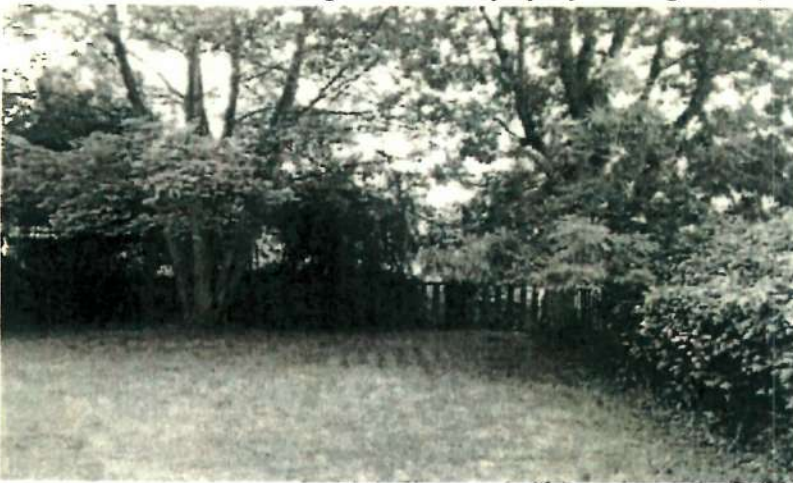
Photo 3. South east corner of yard showing multi-stemmed tree #11) Douglas Maple on left and tree #10) European ash on right.

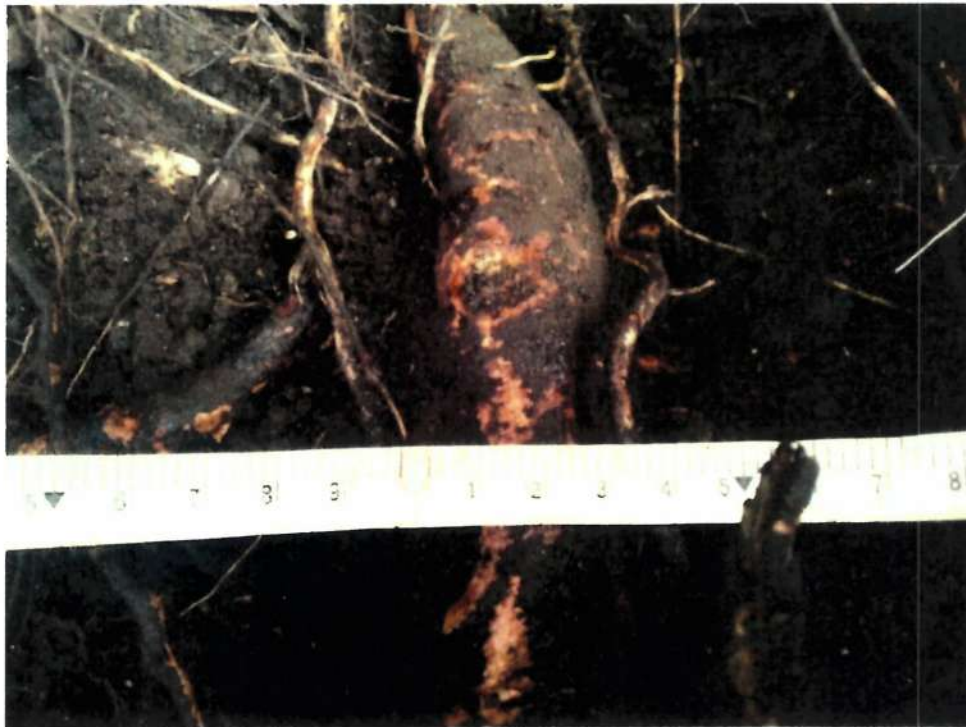
Photo 4. Largest root from maple found at edge of existing building.

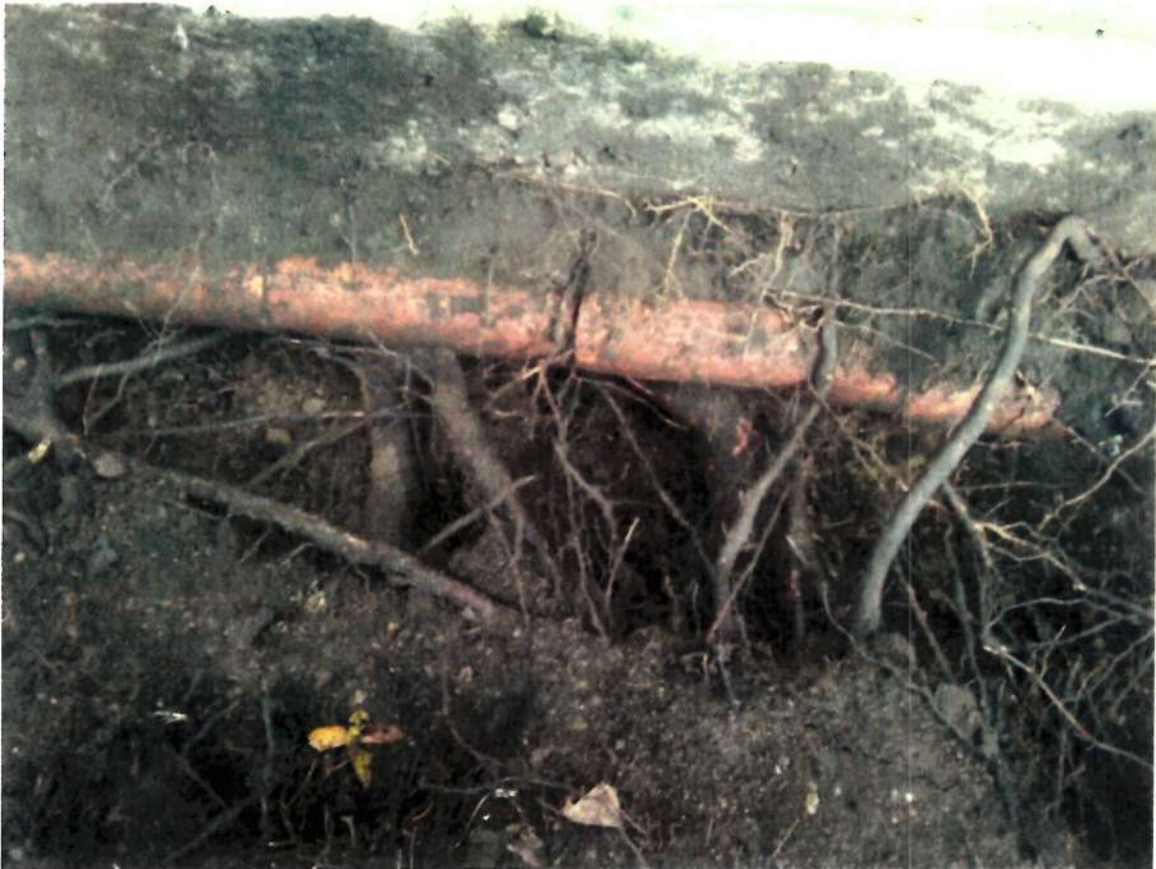
Photo 5. Showing exposed roots from maple hitting perimeter drain and foundation

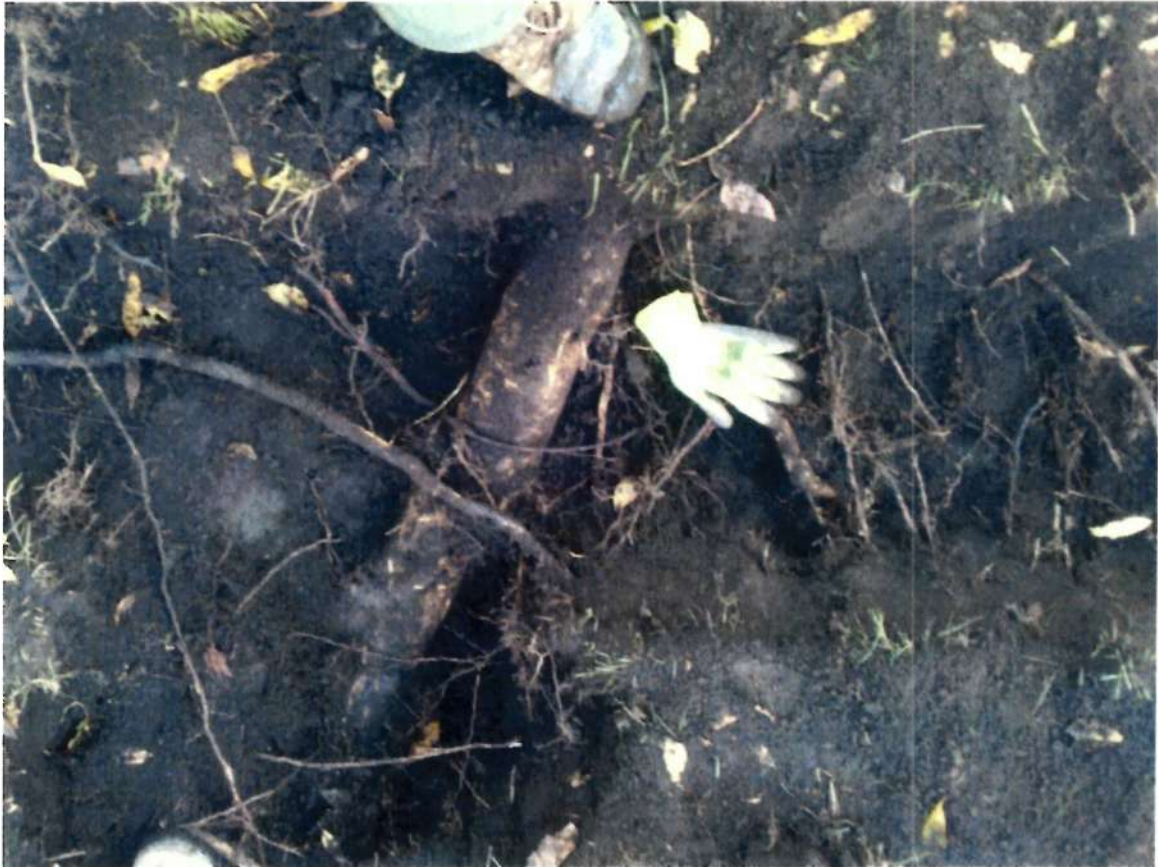
Building footprint. Severing a root this size and in this close proximity (2.7m) to the stem will destabilize the tree and likely cause significant stress resulting in premature mortality.

Photo 5. Large root (13cm diameter) from the ash extends into proposed footprint.

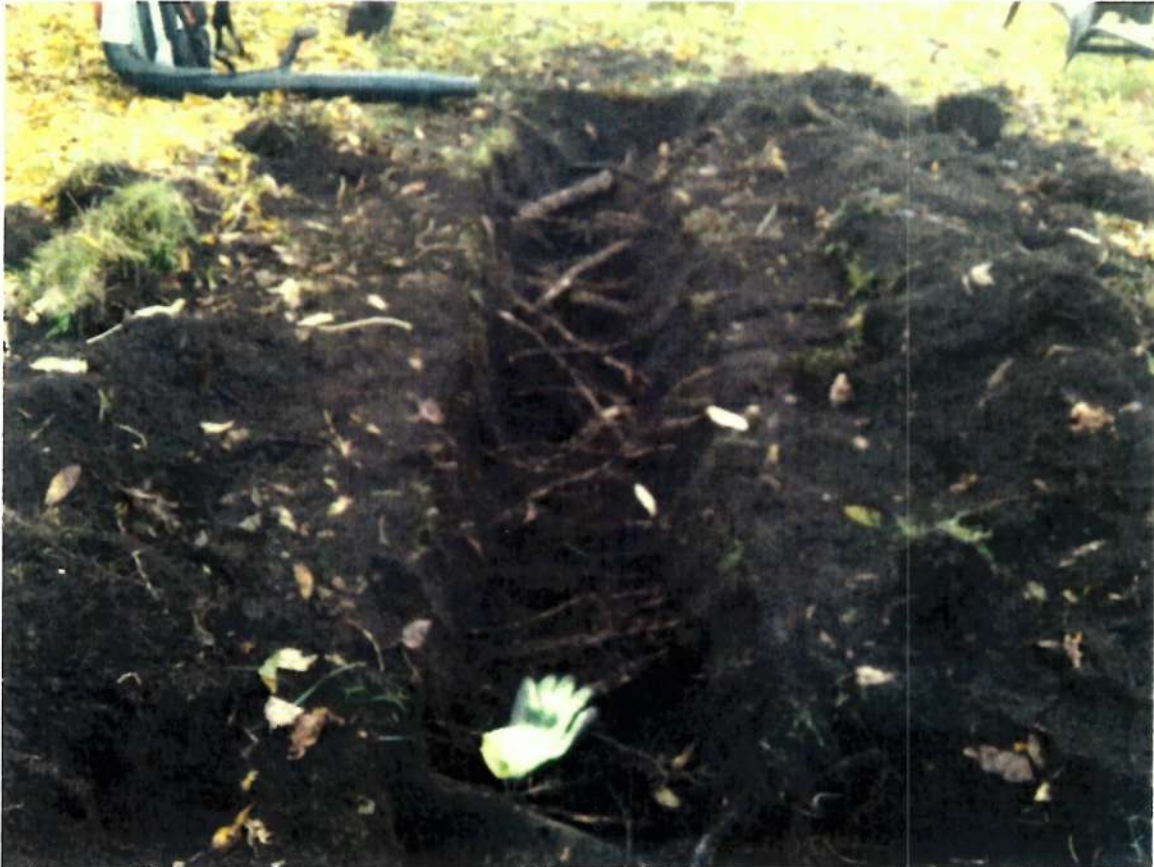
Photo 6. Exploratory excavation along proposed footprint. Roots are from ash.

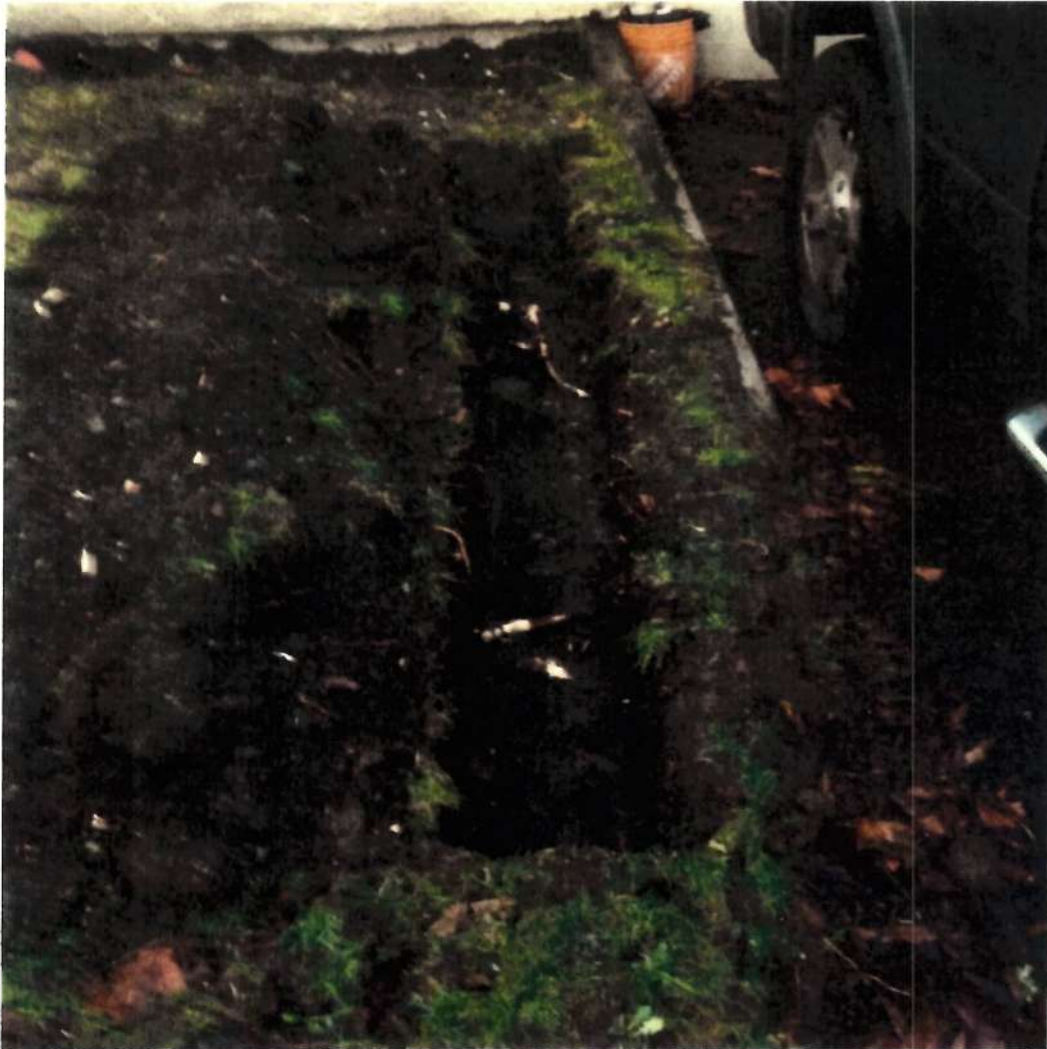
Photo 7.) Exploratory trench along proposed driveway footprint.
