# **CONSTRUCTION IMPACT ASSESSMENT AND TREE PRESERVATION PLAN**

**505-521 Quadra St. & 931 Convent Pl.,  
Victoria (Beacon Hill Residential)**

## ARBORIST SUPERVISION REPORT

REPORT DATE	PROJECT NAME/ADDRESS	ARBORIST	IN ATTENDANCE
June 15, 2018	505 Quadra Street Victoria, BC	Graham Mackenzie ISA #: PN-0428A TRAQ – Qualified  Noah Borges ISA #: PN-8409A	Farmer Construction Cats Eye Contracting Talbot Mackenzie & Associates

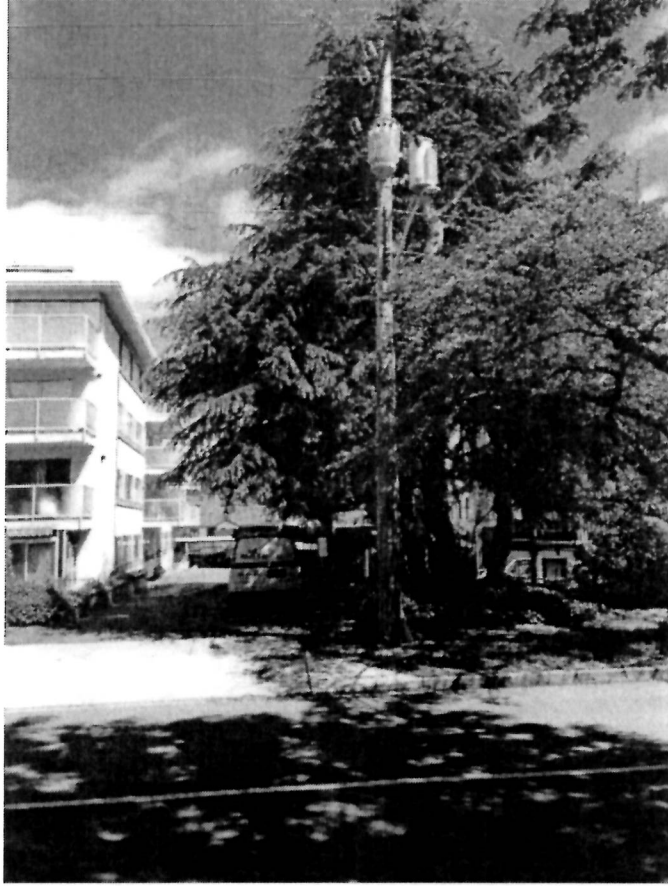
- NT9 Deodar Cedar: 64cm DBH, 1.5m from property line
- NT10 Deodar Cedar: 34, 28, 24cm DBH, 3m from property line
- NT11 Deodar Cedar: 51cm DBH, 1.5m from property line
- NT13 Pin Oak: 53cm DBH (measured over ivy), 2m from property line

**Photo #1:** Three Deodar Cedars (NT9-NT11) and one Pin Oak (NT13) are located within 3m of the property line.

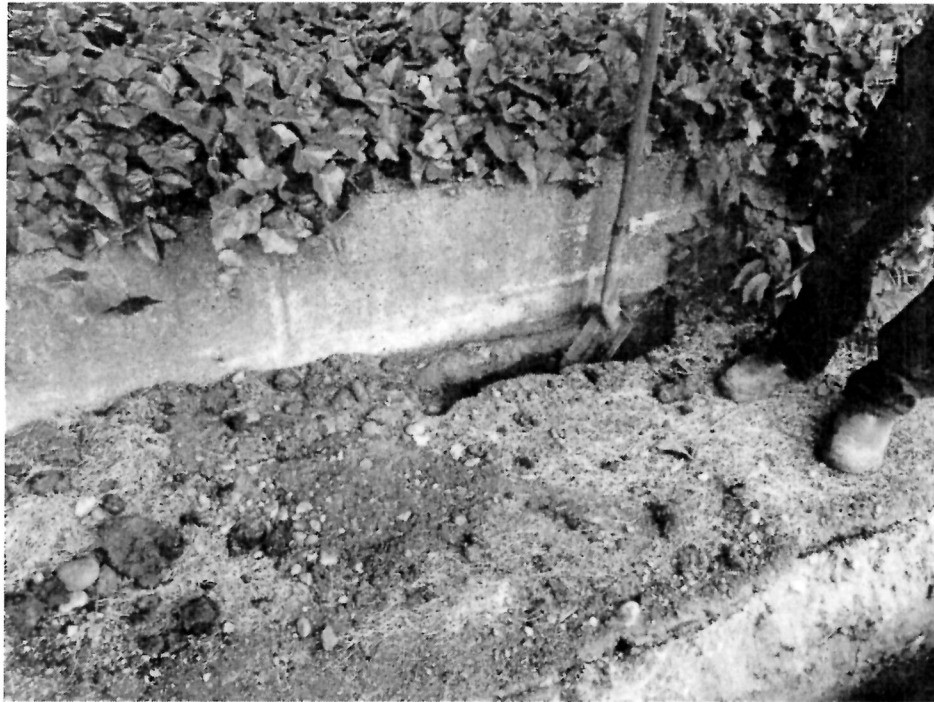
A small area of uplifting pavement was removed immediately adjacent to the retaining wall, directly west of Cedar NT9. We encountered a 5-6cm diameter *Cedrus* root beneath the pavement. The root sustained minor bark damage during pavement removal but was retained.

*Picture #2: A small area of uplifting pavement was removed west of Deodar Cedar NT9. A 5-6cm diameter root was encountered directly underneath the pavement.*

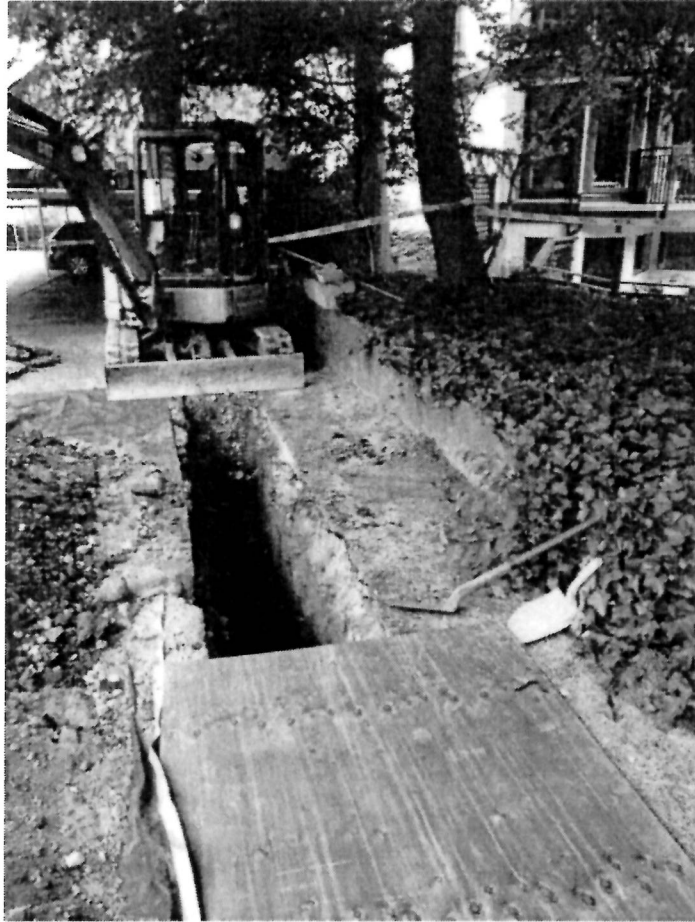
A 60cm wide trench, 90cm in depth, was excavated 60cm from the concrete retaining wall demarcating the property boundary. The site is an at-grade parking area and driveway with asphalt pavement. The trees are on neighbouring property, at a slightly elevated grade (30-60cm). Areas of uplifting pavement are visible in the parking area near the trees, particularly along the retaining wall.

*Picture #3: A 60cm wide trench, 90cm in depth, was excavated 60cm west of the retaining wall.*

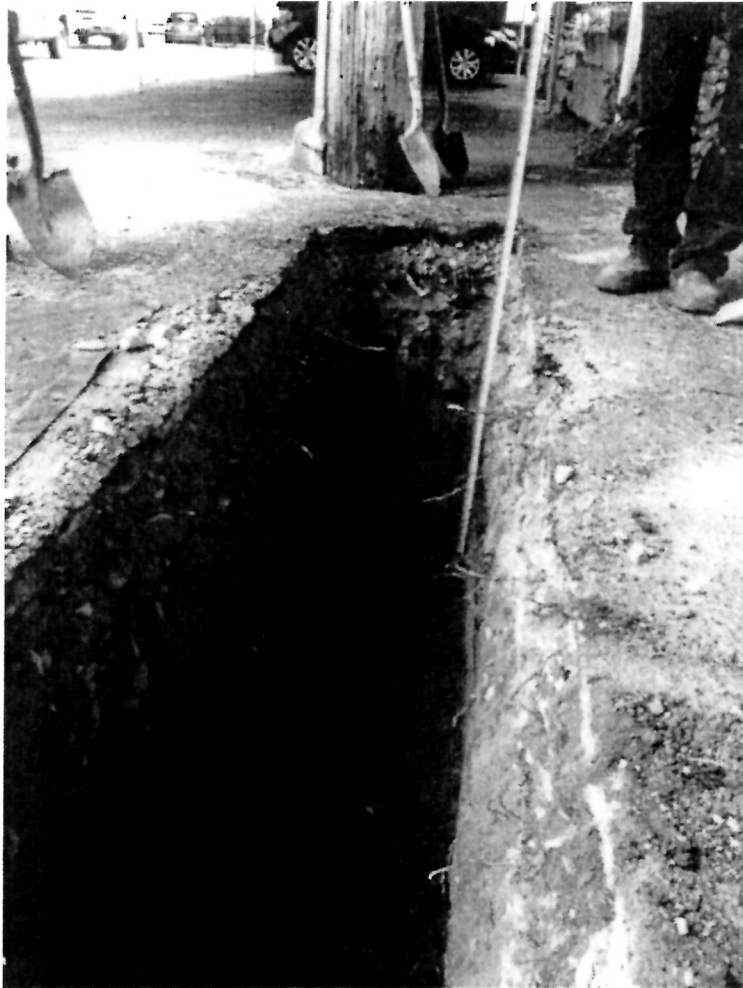
Excavation of the trench started from the south, at the municipal sidewalk. One root, 2-3cm in diameter and oriented vertically, was encountered at the east end of the trench. A trench was excavated north up to approximately 0.5m south of the hydro pole. Only small roots, 1cm or less in diameter, were encountered. They were all located within the upper 60cm of soil.

*Picture #4: Several small roots, 1cm or less in diameter, were encountered up to the hydro pole.*

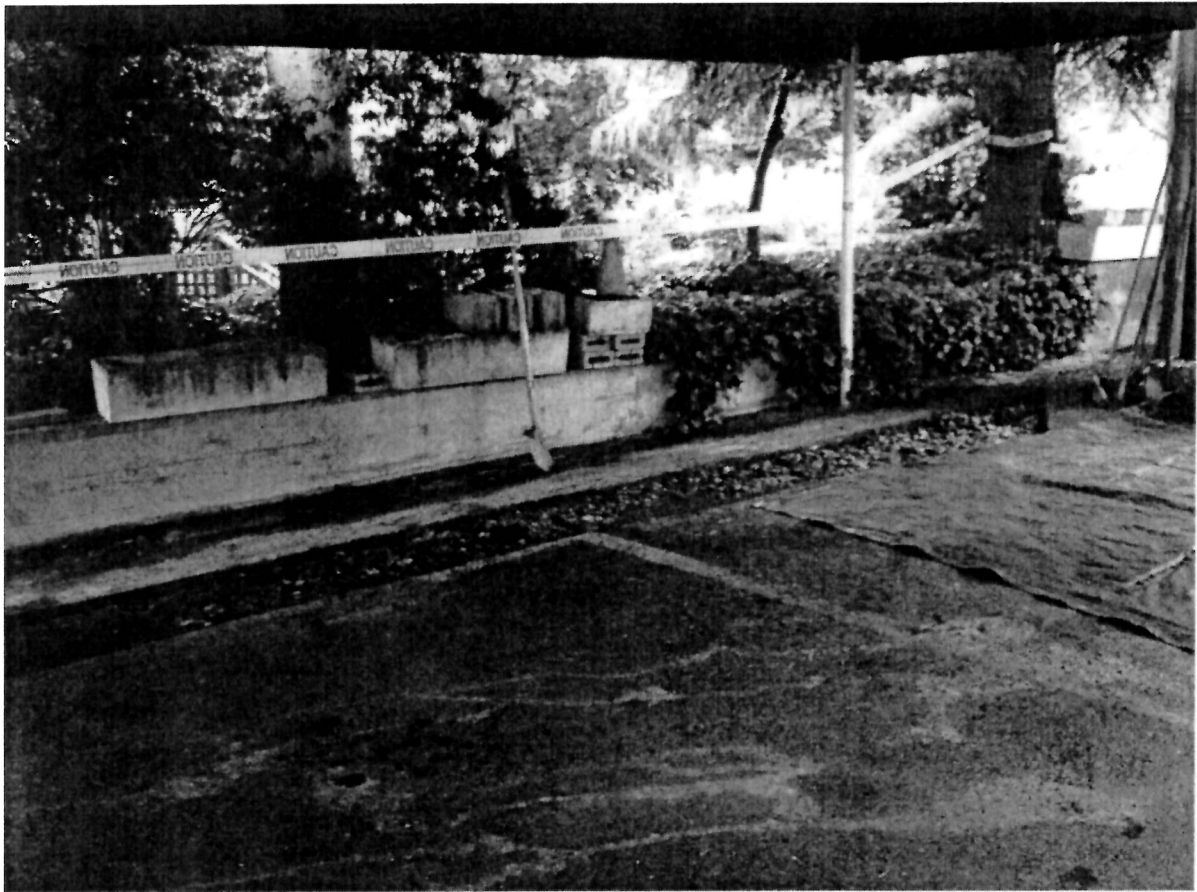
*Picture #5: 50-75cm south and north of the hydropole were undisturbed. Excavation proceeded north to 4-5m north of Pin Oak NT13.*

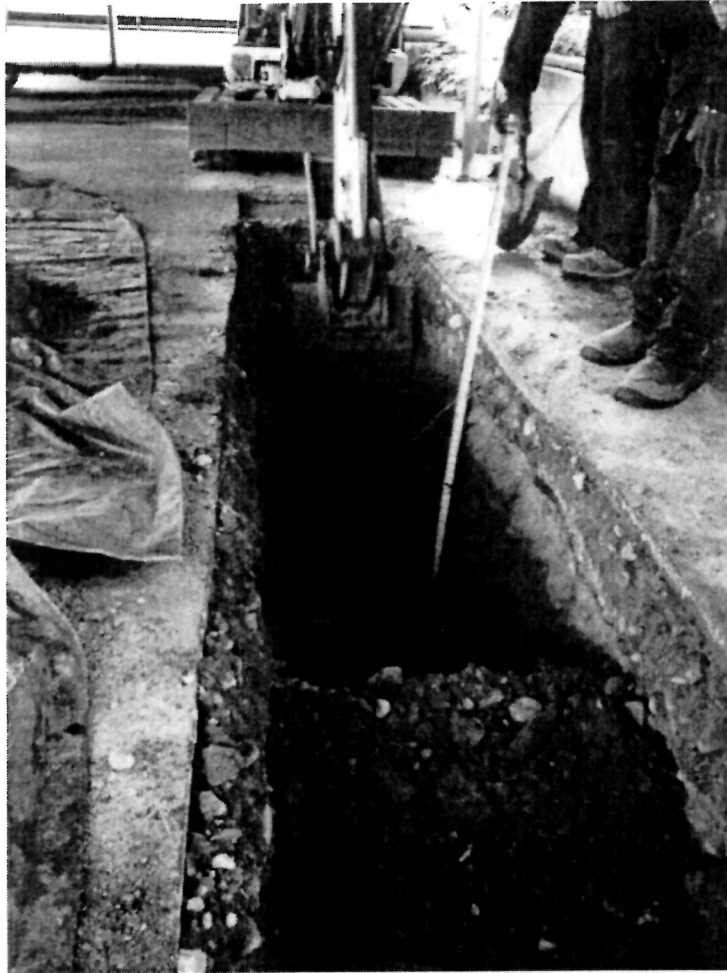
We resumed excavation north of the hydro pole, immediately south of an area of uplifting pavement. Two 3cm diameter roots, which we identified as from one of the *Cedrus* trees, were encountered just below the pavement. There is a discontinuous path of cracking and uplifting pavement that traces back to the retaining wall. These two roots may have been from the 5-6cm diameter root we encountered near Cedar NT9. Excavation stopped approximately 4-5m north of Oak NT13. Eight additional roots were encountered, all 1cm or less in diameter, all within the upper 60cm of soil.

Given the size of the trees and the distance from the trench, fewer roots were encountered than we anticipated. The concrete retaining wall and/or the asphalt pavement is likely restricting root growth onto the subject property. We anticipate that there will be a higher density of roots located on the neighbour's side and possibly directly below the existing retaining wall.

*Picture #6: Two 3cm Cedrus roots were pruned 1m north of the hydro pole. An additional eight 1cm diameter roots were encountered north of the hydro pole.*

We anticipate construction of the proposed underground parking will likely require additional excavation closer to the property line, potentially up to the retaining wall. Based on the number and size of roots we encountered, we do not believe that the neighbour's trees will be significantly impacted by the proposed construction. To mitigate additional impacts, we recommend not excavating beyond the existing retaining wall location, if possible, leaving a 30cm strip west of the retaining wall undisturbed to preserve any roots growing along the wall.

We further recommend the project arborist be on site to supervise any additional excavation within the trees' critical root zones and, if required, removal of the retaining wall. As noted in our Tree Preservation Plan, we recommend shoring and blind-forming techniques be used to minimize the extent of excavation. This may also require that any proposed services such as perimeter drains be located inside the parking structure on this side of the building.
