MORGAN BLOCK

1314-1324 DOUGLAS STREET, VICTORIA, BC

CONSERVATION PLAN

FEBRUARY 2018

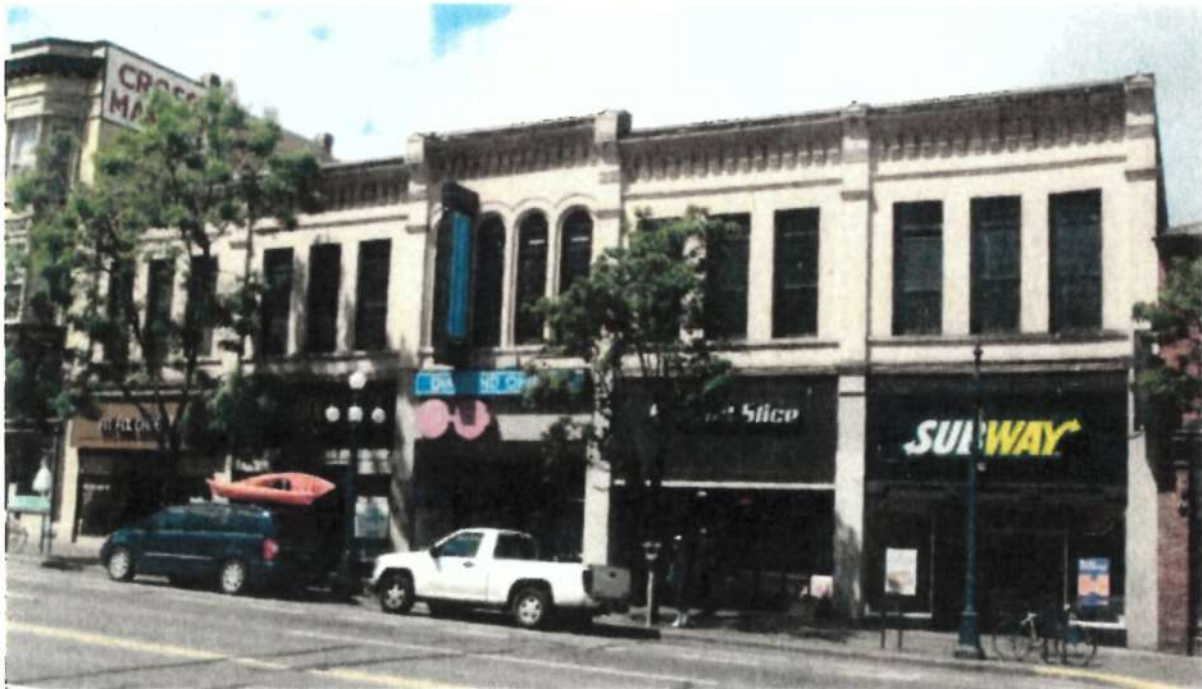
Historic front facade of the Morgan Block along Douglas Street.

In general, the painted brick masonry facade appears to be in fair condition, with notable signs of natural weathering and deterioration in localized areas, as evidenced by mortar loss, spalling, staining and discolouration, organic growth, and redundant holes. Further investigation is required to determine if the removal of paint and stucco cladding are feasible, followed by an assessment of the existing condition of the brick masonry units beneath.

- Undertake complete condition survey of condition of all brick surfaces.
- Determine whether or not it is feasible to remove the paint and expose the original brick. Undertake test samples for paint removal in an inconspicuous area using only approved restoration products. If paint removal is determined to be feasible, prepare removal specification. If not, prepare to repaint.

- If the brickwork on the front façade would require repainting, the colour of the front façade will be determined by the Heritage Consultant. When preparing the existing painted surface for repainting, be aware of the risk of existing lead paint, which is a hazardous material.

- Cleaning, repair and repointing specifications to be reviewed by Heritage Consultant.
- All redundant metal inserts and services mounted on the exterior walls should be removed or reconfigured.

- Any holes in the brick should be filled or replaced to match existing.

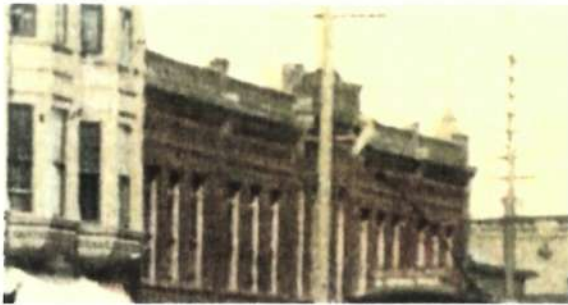
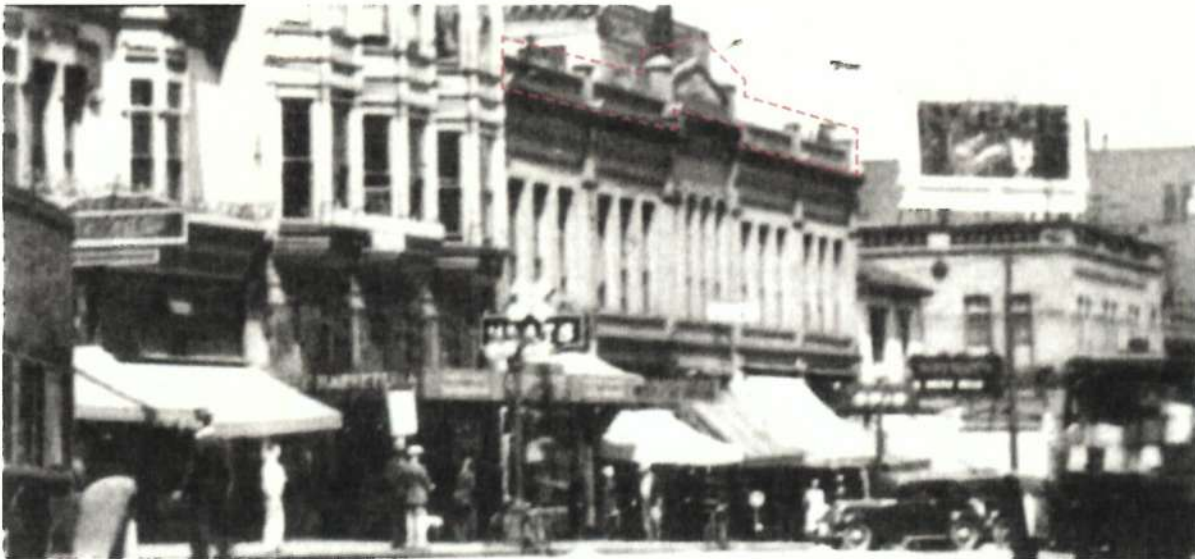
heavy deterioration were noted. Archival photos of the Morgan Block indicate that the parapet walls extend beyond the existing parapet cornice. The central bay originally featured a pediment, and the pilasters extended beyond the parapet walls. The parapet walls would have been presumably capped with stone coping or pressed metal cap flashing.

Detail photos showing original parapet wall (outlined in red) that is no longer extant.

Conservation Strategy: Preservation & Restoration

- Restore the original brick parapet wall based on archival documentation.
- Preserve the brick whenever possible, and replace in kind brickwork that is too deteriorated for safe use.

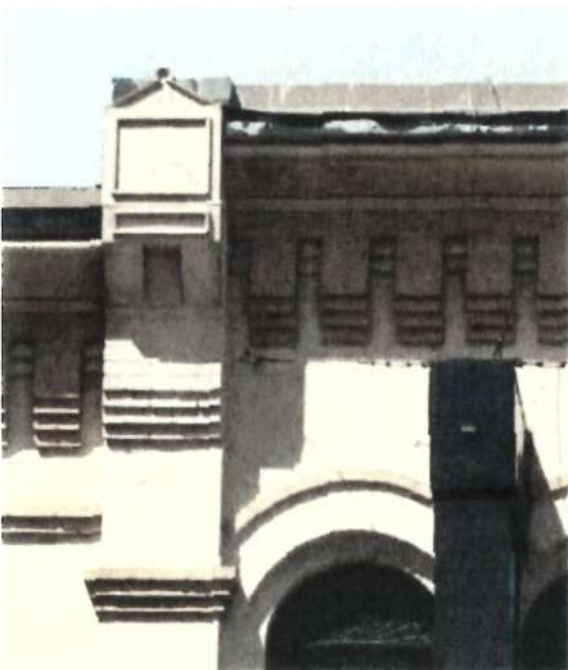
Detail photo showing typical condition of architectural brickwork detailing and metalwork along parapet level.

The Morgan Block features later, replacement architectural metalwork along the parapet cornice. The existing cornice is finished with paint, and appears to be in good condition, with signs of minor deterioration, as evidenced by staining and discolouration, organic growth, build-up of bird deposits, and peeling paint.

The metal parapet cornice is an important feature of the Morgan Block's historic street facade, and should be preserved and repaired in-kind, or replaced to match original based on archival photos, as possible.

- Evaluate the overall condition of the existing cornice and parapet cap flashing to determine whether more than protection, maintenance and limited repair or replacement in kind is required.

- The current attachment of all sheet metal cornices and cap flashings should be inspected, and should be re-anchored as appropriate.
- Repair and stabilize deteriorated architectural metal elements by structural reinforcement or correction of unsafe conditions, as required, until any additional work is undertaken. Repairs should be physically and visually compatible.

- Remove corrosion that may be discovered upon close inspection, patch and repair, caulk joints as required.
- If the evaluation of the existing metal elements would determine that they are deteriorated beyond repair, remove and replace the elements with one that matches the historic appearance.

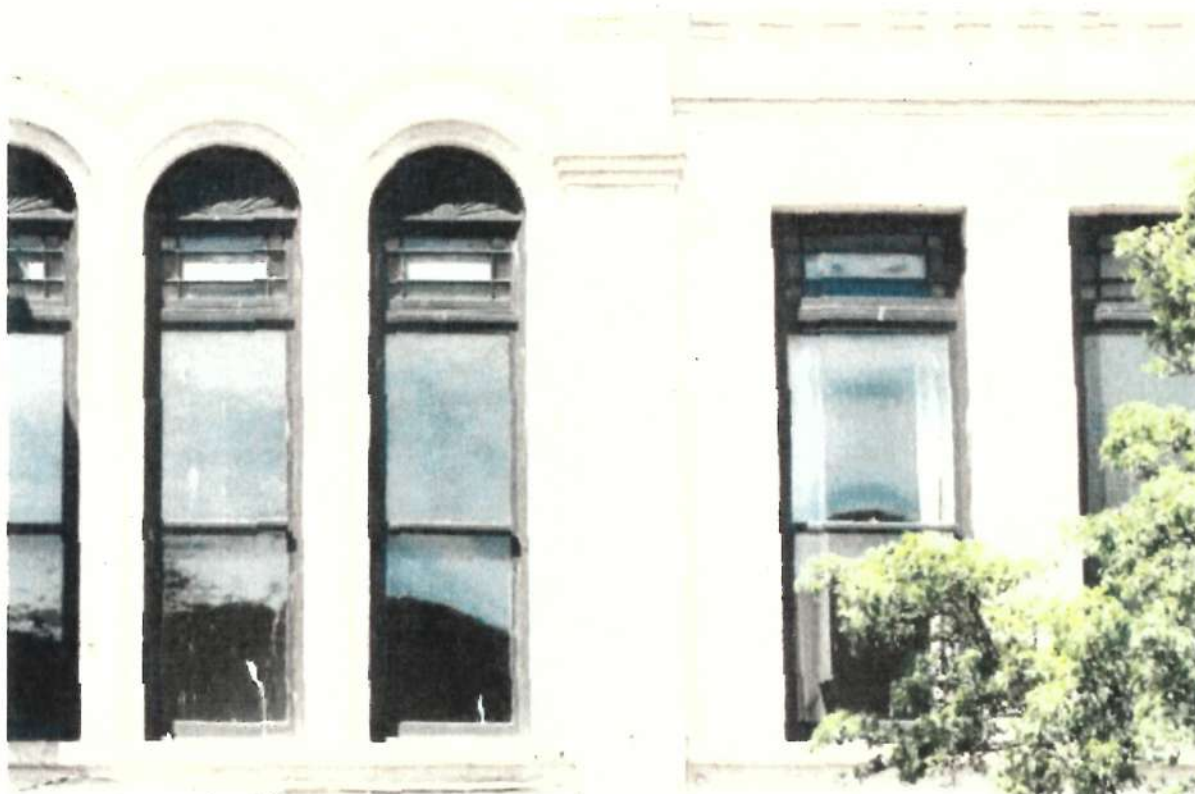
central bay feature additional arched panel with sunburst motif. Based on initial visual inspection from the ground level, the surviving original windows are intact, and appear to be in good condition. Further review and assessment are required to confirm the existing condition of each assemblies, and to determine the appropriate extent of conservation work required.

Detail photo partially showing existing window openings, with surviving original wood window assemblies at the upper level of the historic street facade.

- Inspect for condition and complete detailed inventory to determine extent of recommended repair or replacement.
- Retain existing window sashes; repair as required; install replacement matching sashes where missing or beyond repair.
- Preserve and repair as required, using in kind repair techniques where feasible.
- Overhaul, tighten/reinforce joints. Repair frame, trim and counterbalances.
- Each window should be made weather tight by re-puttying and weather-stripping as necessary.
- Retain historic glass, where possible. Where broken glass exists in historic wood-sash windows, the broken glass should be replaced. When removing broken glass, the exterior putty should be carefully chipped off with a chisel and the glazier's points should be

removed. The wood where the new glass will be rested on should be scraped and cleaned well, and given a coat of linseed oil to prevent the wood from absorbing the oil from the new putty. The new glass should be cut 1/16-1/8th smaller than the opening to allow for expansion and irregularities in the opening, to ensure the glazing does not crack due to natural forces. Window repairs should be undertaken by a contractor skilled in heritage restoration.

- Replacement glass should be visually and physically compatible with existing.
- Prime and repaint as required in appropriate colour, based on colour schedule devised by Heritage Consultant.
