CONSERVATION PLAN PLAZA HOTEL

603 PANDORA AVENUE, VICTORIA, B.C.
MAY 2013

DONALD LUXTON
ASSOCIATES INC.

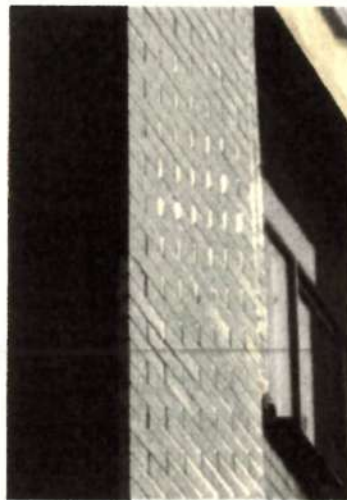
Brick return at northwest corner.

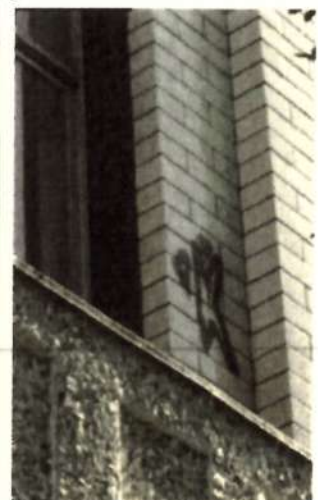
Graffiti on glazed brick.

of the projecting pilasters, which can be repaired with special repair mortar. Graffiti is also visible on glazed bricks in several locations and should be removed.

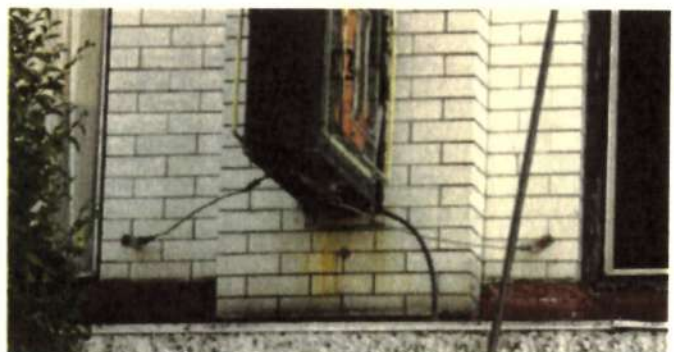
Staining on glazed brick below blade sign.

- Remove exposed metal items partially embedded in masonry and make water tight with repair mortar to restore the original glaze of the façade brick (recommended product: Jahn M100 Brick Repair Mortar / TerraCoat Glaze Repair by Cathedral Stone).

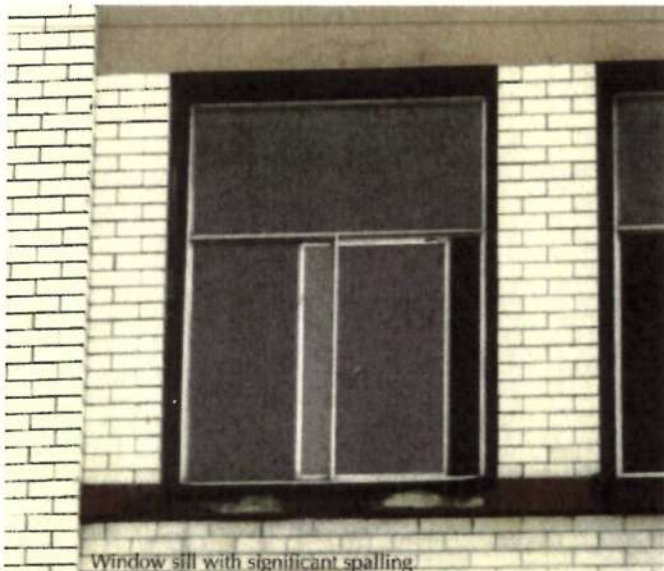
The painted windows sills on the upper floors of the main façade are made of pre-cast stone and run below each set of windows. The substrate is severely deteriorating and spalling, and loss of material is notable in many locations. This is presumably due to corrosion jacking of the embedded cramps caused by water penetration through unsealed joints. The damaged areas are sporadically protected with wood panels, but remediation of the sills should commence in collaboration with a structural engineer.

Window sill with significant spalling.

- Review condition of each stone sill and its connection to the façade; consult with structural engineer.
- Cut out section of stone sills that are too deteriorated to be repaired. Where necessary remove entire stone sill and replace with new concrete sill to match existing in size and shape.
- Structurally tie new and existing sound sills to the façade. Seal joints to prevent water ingress.

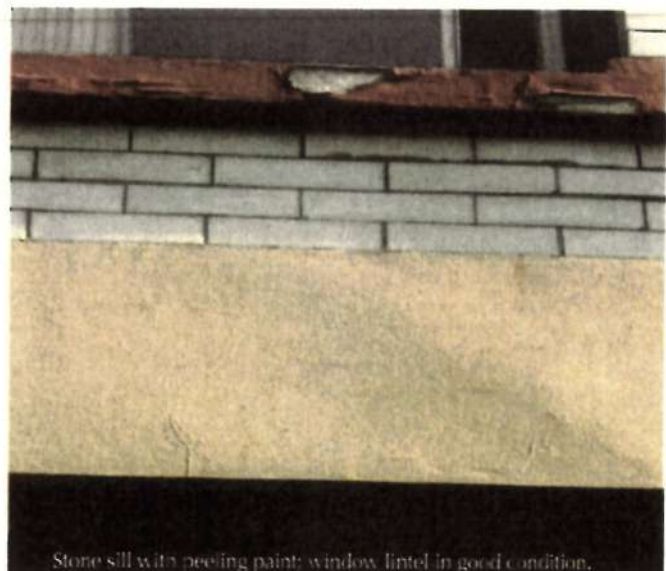
Stone sill with peeling paint; window lintel in good condition.

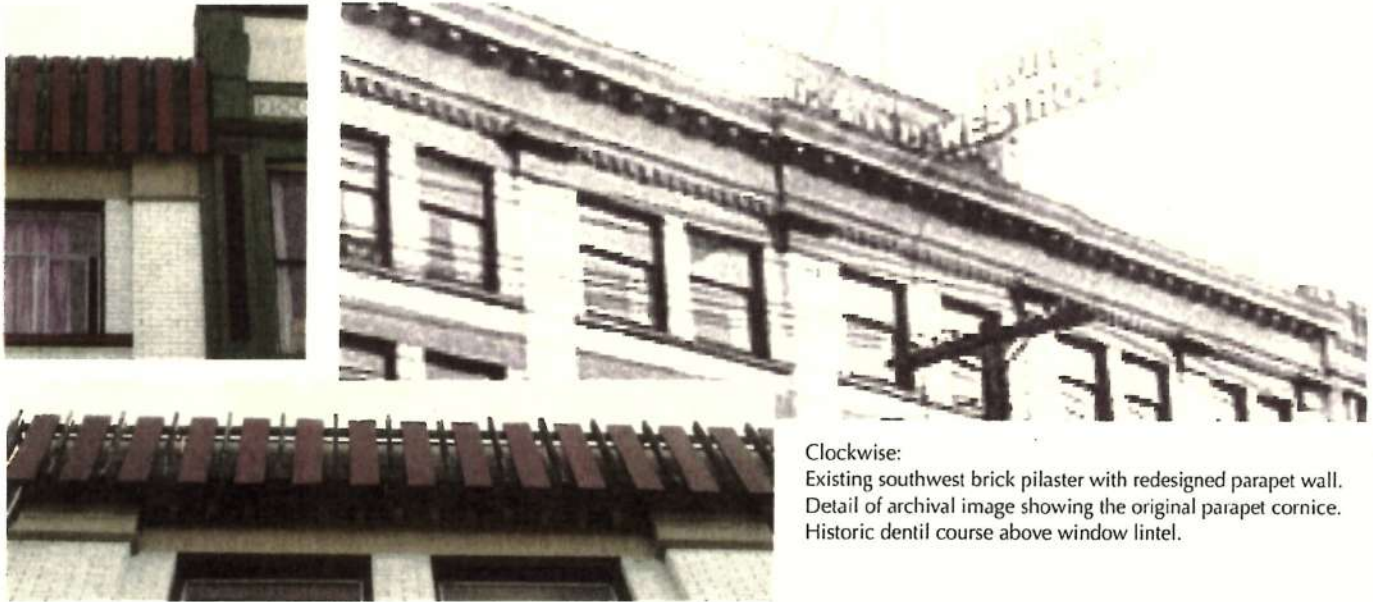
Clockwise:
Existing southwest brick pilaster with redesigned parapet wall.
Detail of archival image showing the original parapet cornice.
Historic dentil course above window lintel.

- Restore upper cornice and storefront cornice to match original appearance. Metal is the preferred material.
- Method and condition of existing dentil course attachment to building should be investigated and repaired, as necessary.
- Clean, repair and patch existing portion of the parapet dentil course as required. Remove loose paint by hand scraping until sound material has been reached. It is not necessary to remove all the paint but sufficient to allow for repainting. Tests for hazardous materials should be carried out before work commences.
- Remove surface deterioration and patch any existing holes using a two-part epoxy such as auto-body putty. Repaint dentil course.
- Replicate missing sections of the parapet and storefront cornices in kind to match historic profile based on archival documents.
- Installation of a bird control system is recommended.

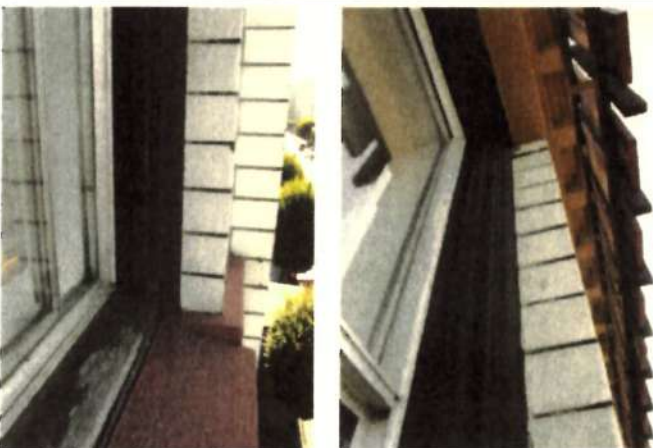
The main façade is five bays wide with regular fenestration of paired windows at each bay. The original double-hung one-over-one wooden sash have been replaced with aluminum sliding units that are not sympathetic to the historic appearance of the building. The historic wooden frames, mouldings and sills are extant and are painted with a dark coat that is failing at the wooden sills. The wooden sills show also signs of splitting. The original window sashes on the north and east elevations were replaced with aluminum units. The historic frames and mouldings are still in situ although the paint is severely deteriorated

and missing on the wooden sills, which are exposed to the weather. The north and east elevations will be rehabilitated incorporating a contemporary window design utilizing modern technology.

Details of the wooden frames and mouldings on the main facade.

- Preserve original windows on the front facade. New window sash on this facade should match historic windows in terms of material, style, detail and profile thickness where archival evidence is available.
- Replicate details such as missing mouldings based on salvaged samples.

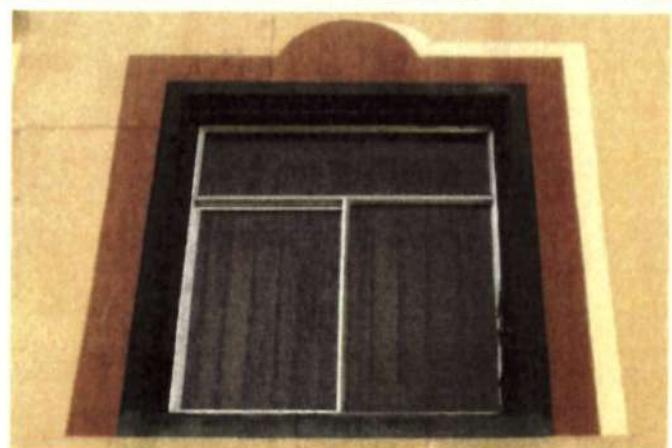
Later aluminum windows on the east elevation replaced the original sash.

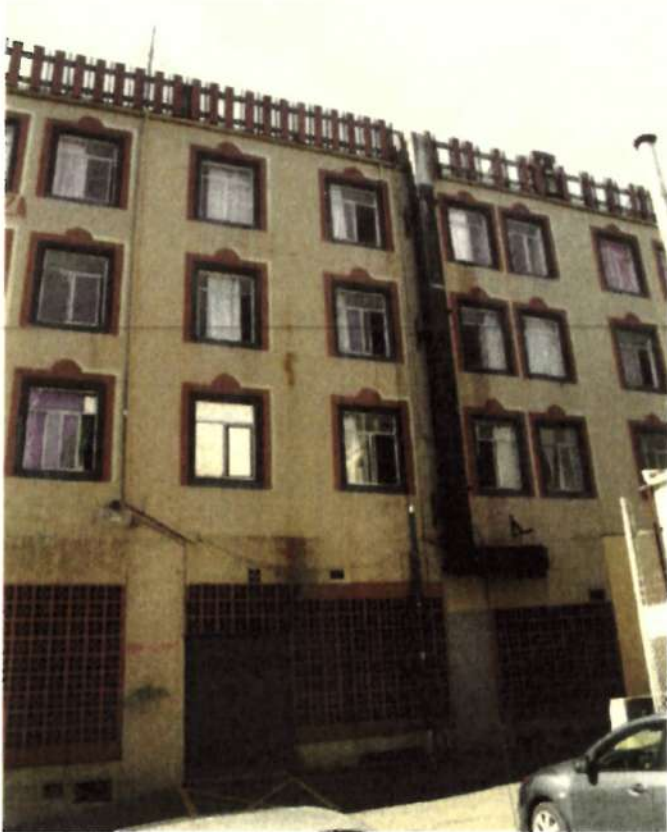
The east and north elevations are finished with painted stucco render. This finish shows signs of staining, water damage and cracking in several locations. The condition of the stucco appears to be poor partially due to failing rainwater disposal.

East elevation with stucco finish and breeze blocks.

- The north and east elevations will be rebuilt with contemporary materials and to applicable code requirements.
