Talbot Mackenzie & Associates

July 16, 2018

Subject: Exploratory excavation within critical root zone of Garry Oak #200

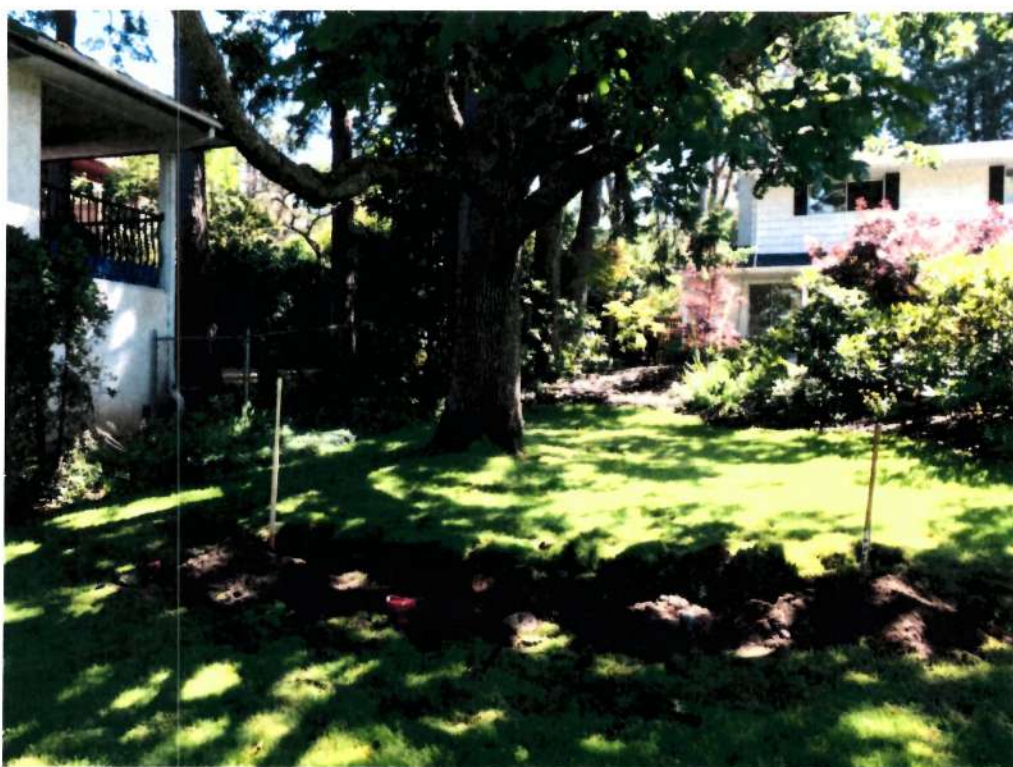
We excavated approximately 1m east of the location of the two pilings and 0.5m east of the grade beam to approximate the extent of excavation required for working room and perimeter drain installation. Therefore, excavation occurred as close as approximately 3.6m from the centre of the tree directly westward. We excavated to a depth of 45-50cm 1m from the location of the pilings (approximately the depth of a clay layer) and 30cm along the length of the grade beam to approximate cut slopes and areas for working room. The entire trench measured approximately 4m.

Image 1. We conducted an exploratory excavation at the northwest side of the proposed building to be constructed at 931 Redfern Street. Excavation occurred as close as 3.6m from the centre of the trunk of Garry Oak #200.

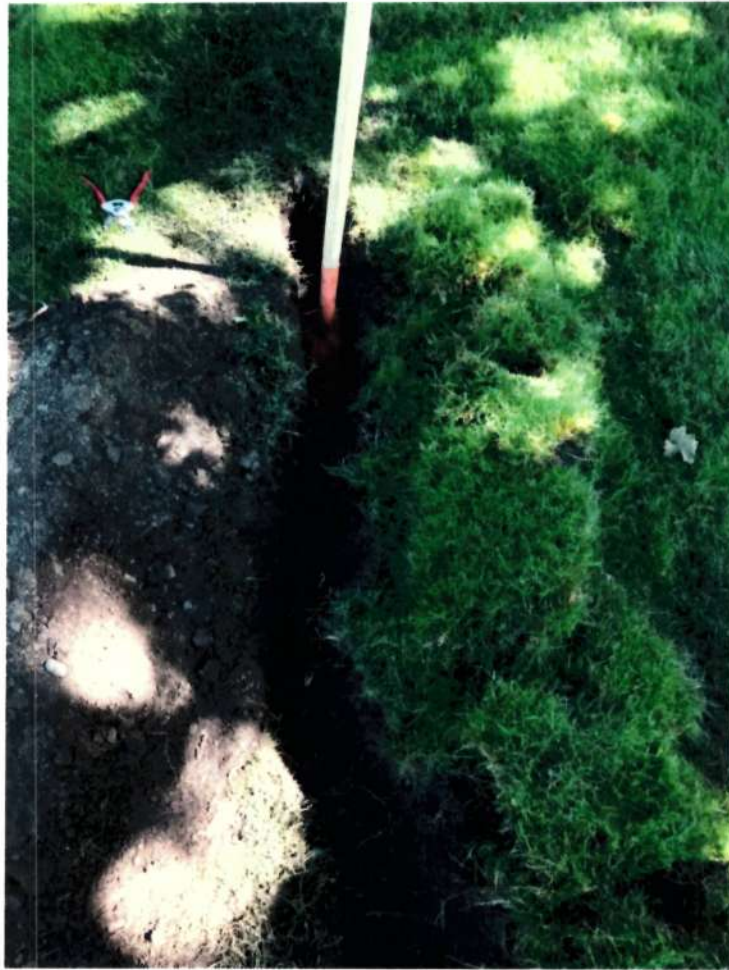
We encountered a high density of fibrous roots (less than 1cm in diameter) along the length of the trench in addition to two 2cm diameter roots and fifteen 1cm roots. Eleven of the 1cm roots and numerous fibrous roots were damaged during excavation and had to be pruned back to sound tissue at the edge of excavation. The two 2cm roots and remaining four 1cm roots were retained.

We do not anticipate the proposed installation of pilings and a grade beam at the northwest corner of the building footprint will have a significant impact on the health of the Garry Oak given the

Image 2. Two 2cm diameter roots, fifteen 1cm roots, and a high density of fibrous roots were encountered along the entirety of the trench (approximately 4m).

size and number of roots encountered. It is possible that additional roots may be encountered during excavation for the pilings that have grown underneath the 45-50cm we excavated to simulate a cut slope but anticipate the number of additional roots likely to be encountered will be negligible and the impacts to the health of the tree to remain minor. If the revised building plans are approved, we recommend an arborist be on site to supervise and direct excavation within the tree's critical root zone and to prune back any severed roots to sound tissue.
