Talbot Mackenzie & Associates
Consulting Arborists

Browns Crafthouse, Victoria West

Construction Impact Assessment & Tree Preservation Plan

DATE OF ISSUANCE: January 4, 2019

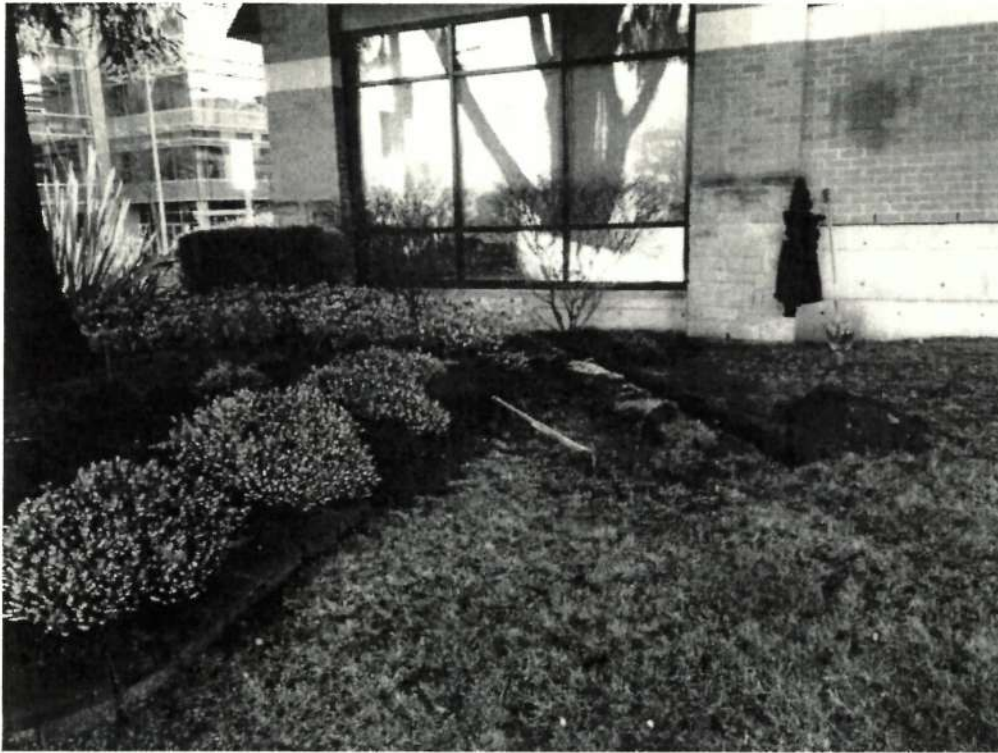
Methodology: We visually examined the municipal Atlas cedar tree (*Cedrus atlantica*), reviewed the proposed construction plans (see attached) and conducted an exploratory excavation to quantify the root densities in the corner of the proposed patio located closest to the tree (see pictures 1 and 2).

Picture 1: Proximity of exploratory excavation in relation to tree.

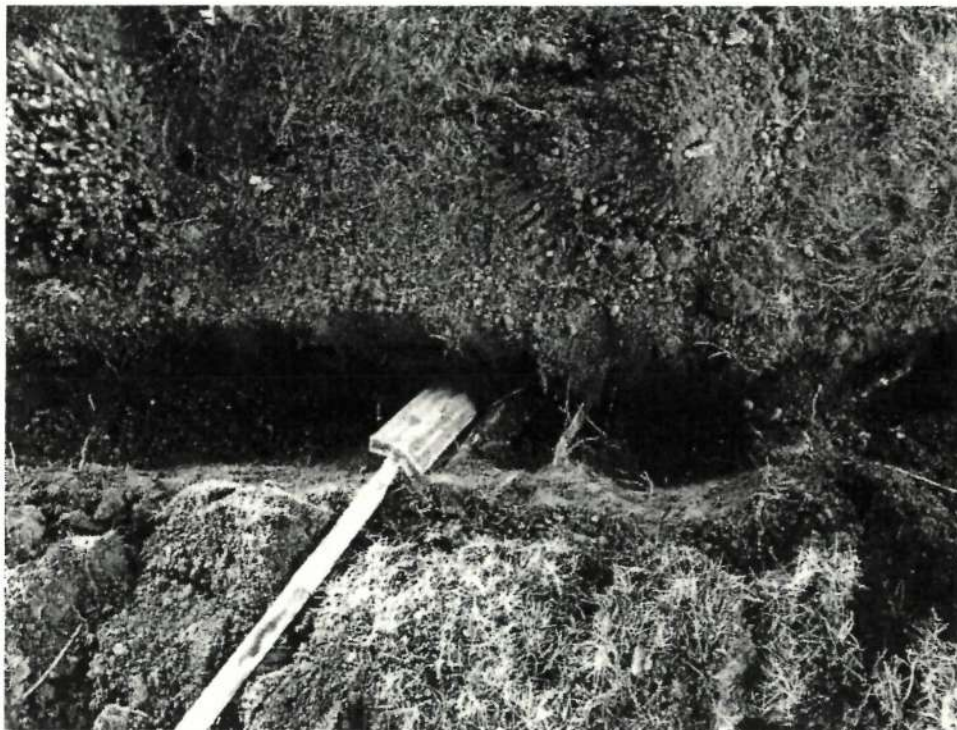
- Placing two layers of 19mm plywood.
 - Placing steel plates.
- **Patio Construction in area closest to Atlas cedar:** Based on the plans provided and the existing site conditions we anticipated that roots would be encountered in the northeast area of the patio where it is closest to the tree. Based on our exploratory excavation, we confirmed the presence of several significant roots in this area. In order to retain these roots and facilitate the proposed construction, a portion of the patio areas will have to be cantilevered over the root area or suspended using a grade beam and pad footings, or using similar construction techniques. Based on our experience in similar situations and our discussions with the owner and the project architect, we are confident the patio can be constructed while minimizing any impacts to the municipal tree.

Picture 2: roots encountered.

- **Arborist Supervision:** All excavation occurring within the critical root zones of protected trees should be completed under supervision by the project arborist. Any roots encountered that cannot be retained must be pruned back to sound tissue to reduce wound surface area and encourage rapid compartmentalization of the wound. Roots that are critical to the trees survival and stability must be retained and the patio must be designed to retain these roots. In particular, the following activities should be completed under the direction of the project arborist:

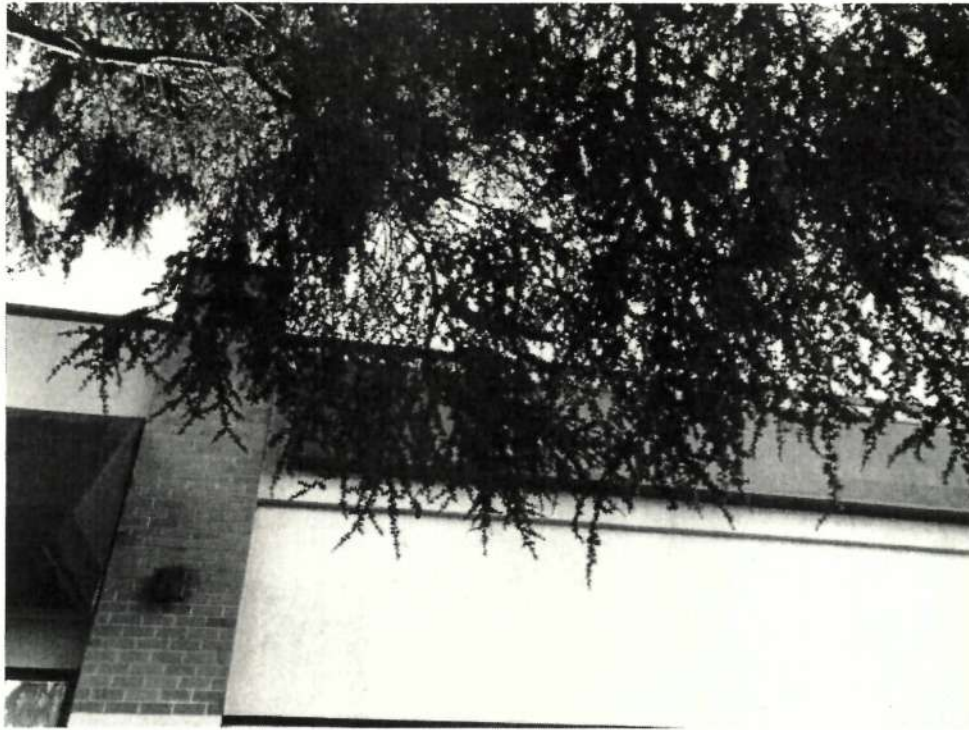
Picture 3: Small branches that will likely require pruning for awning clearance.

- Any excavation within the critical root zone of the Atlas cedar tree on municipal property.
- **Pruning:** We anticipate that some minor clearance pruning will have to be completed to facilitate the awning construction, but do not feel that this will have a negative impact on the health of the tree. The branches observed that are in conflict to the proposed structure are less than 10 cm in diameter (see picture 3). We recommend that any pruning be completed by an ISA Certified Arborist to ANSI A300 pruning standards.
