Consulting Arborists

945 Pembroke St, Victoria

Arborist Report:

Tree Preservation Plan

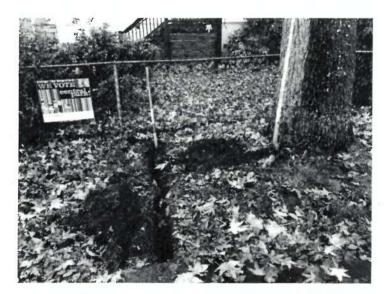
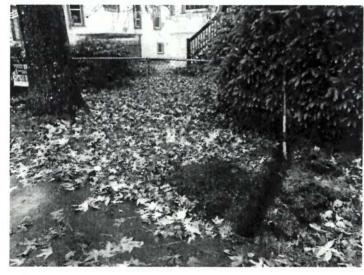
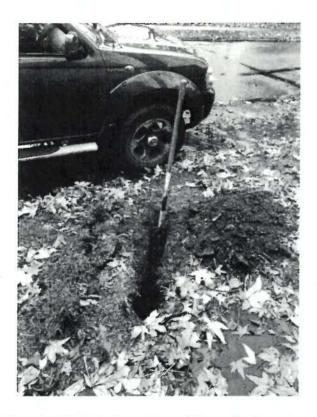
- Sweetgum NT2 (66cm DBH): An exploratory excavation was conducted to determine the impacts of constructing the common driveway and walkway to house A. Trenches were excavated using shovels to depths of 30-45cm. We dug in the following locations:
 - 1.5m east of the tree, in the approximate location of the proposed walkway to house A
 - south of the existing municipal sidewalk on the municipal frontage, 3.5m west from the base of the tree (in the location of the proposed driveway)
 - 4.5-5m northwest of the tree (in the approximate location of the driveway apron)

No roots were encountered in any of the trenches (see photos below). Therefore, in our opinion, the driveway and walkway can be constructed without impacting the health or stability of the tree. We recommend the project arborist be on site during excavations if it is to occur beyond 30cm in depth.
