Talbot Mackenzie & Associates
Consulting Arborists

1712 & 1720 Fairfield Rd, Victoria

Arborist Report: Construction Impact Assessment & Tree Preservation Plan

DATE OF ISSUANCE: May 25, 2018

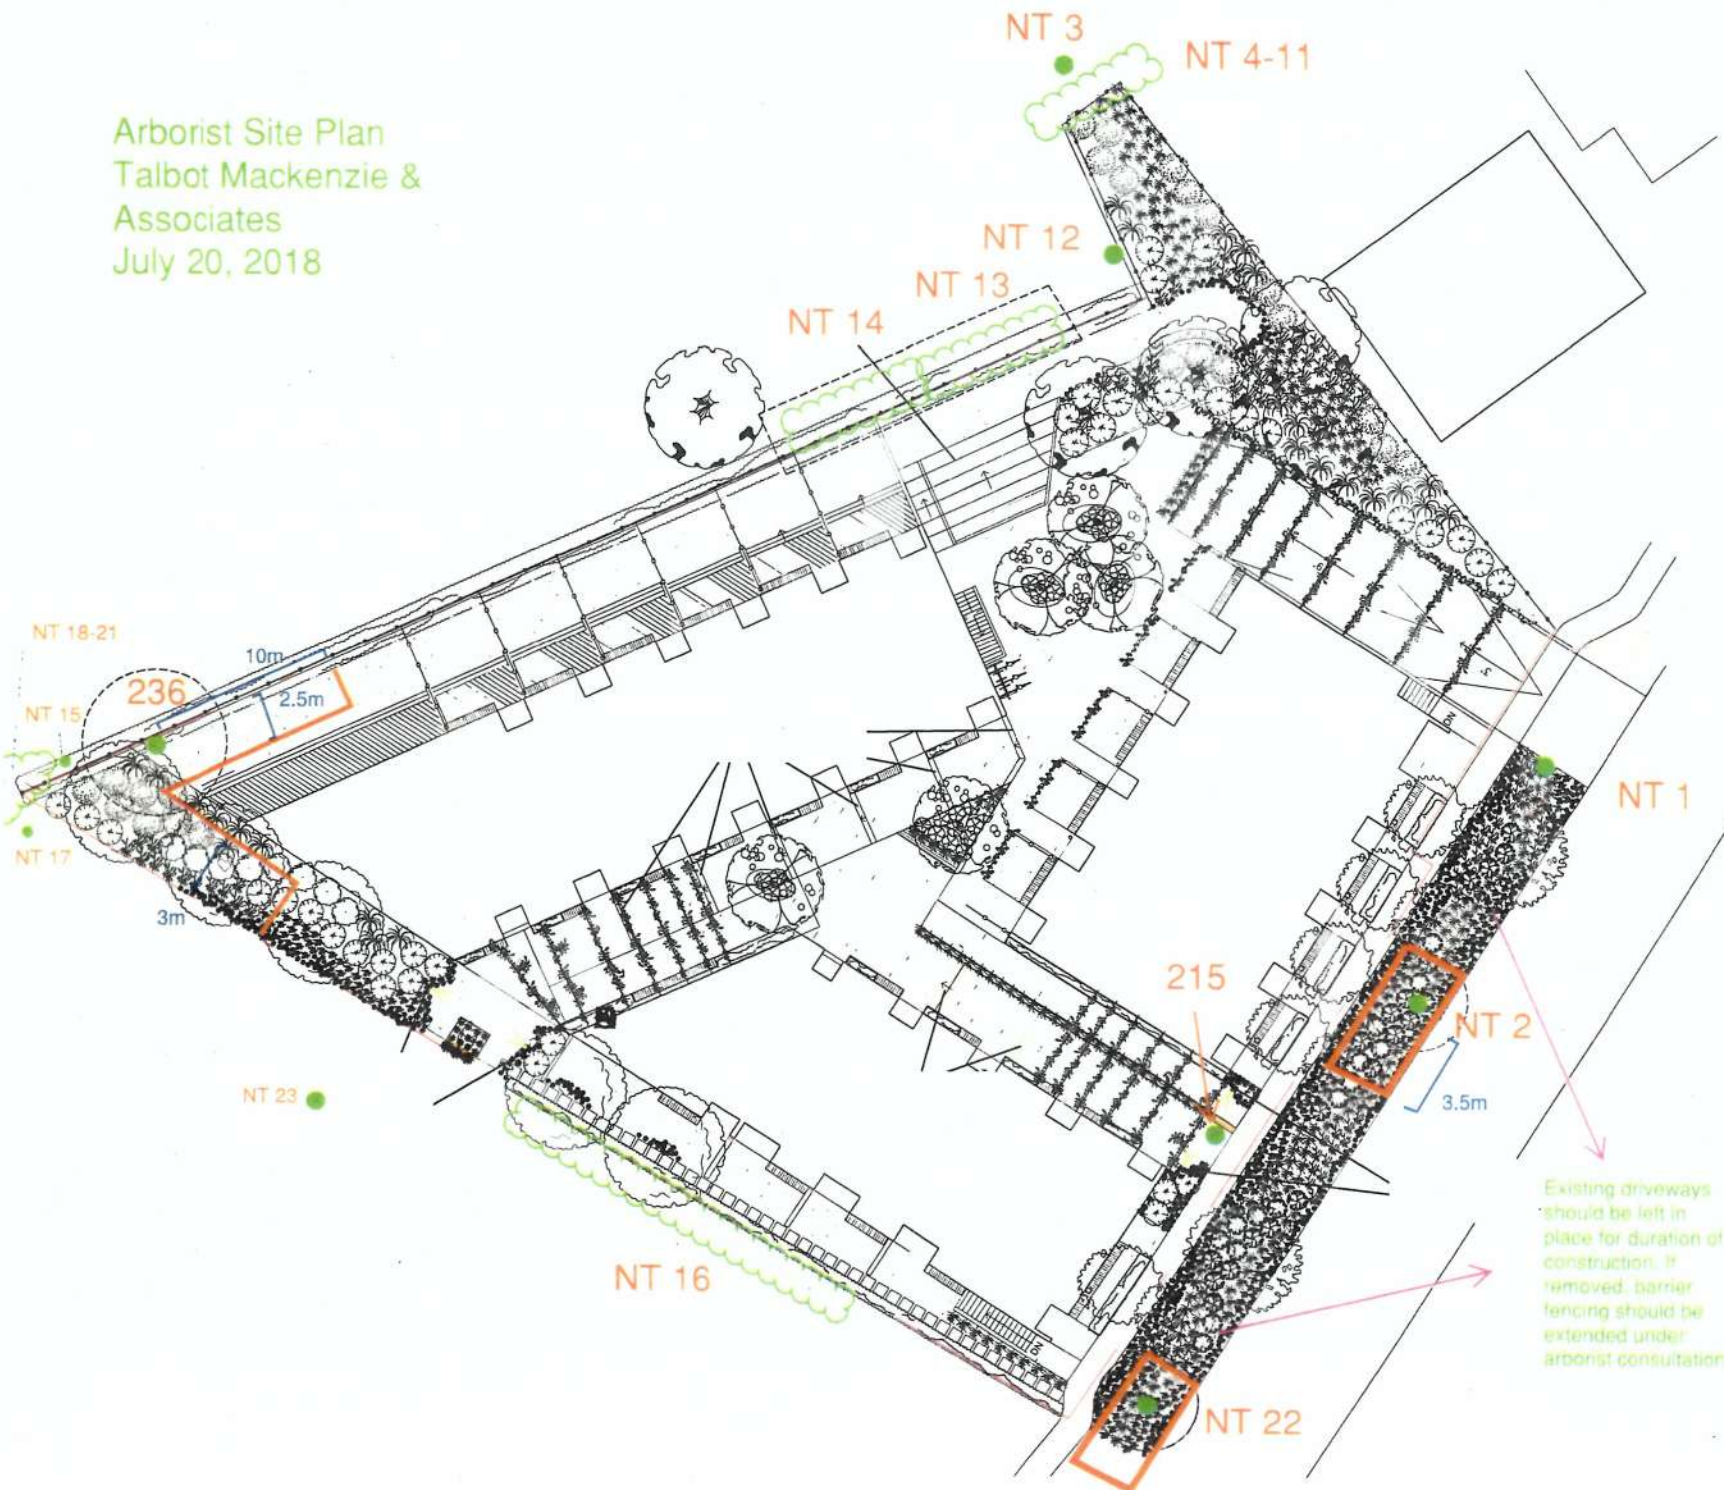
Arborist Site Plan
Talbot Mackenzie &
Associates
July 20, 2018

Existing driveways
should be left in
place for duration of
construction. If
removed, barrier
fencing should be
extended under
arborist consultation
