Subject: Second exploratory excavation within critical root zone of Garry Oak #450

# **1888 Gonzales Ave, Victoria**

## **Construction Impact Assessment &**

## **Tree Preservation Plan**

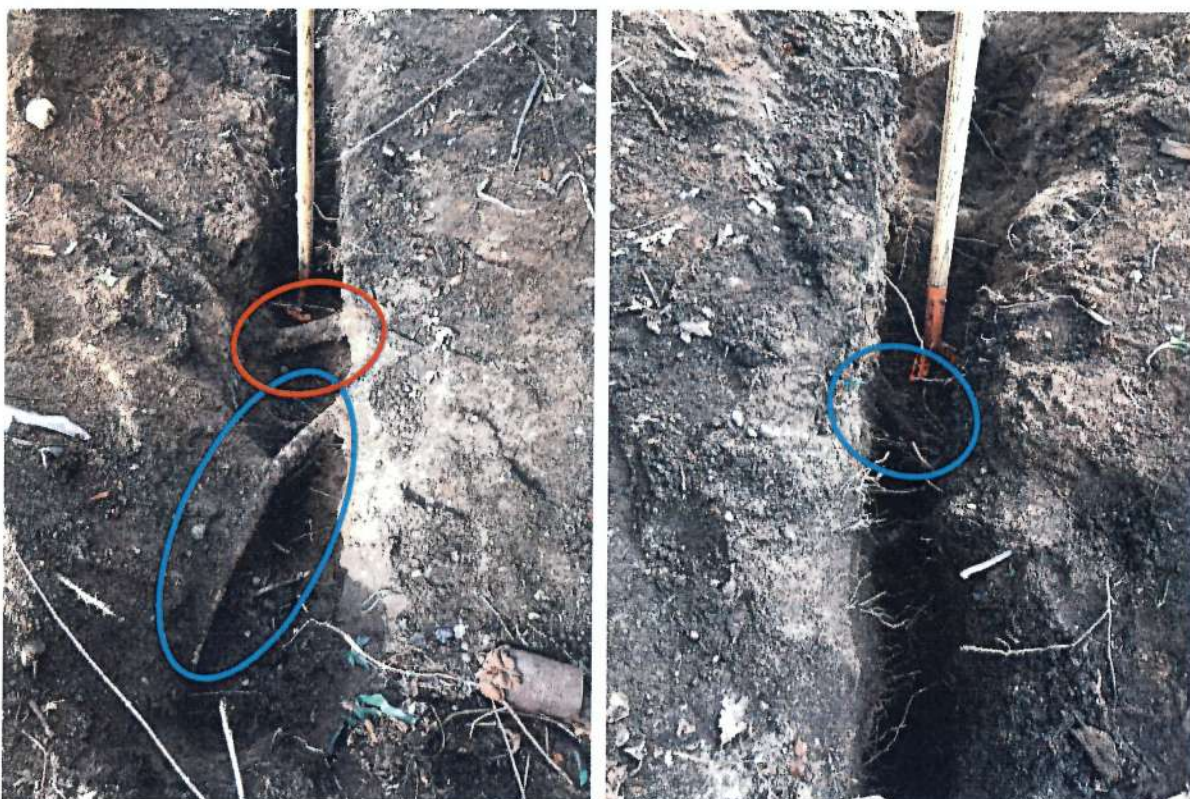
Two metres from the base of the tree (0.5m outside the master bedroom footprint), we encountered only one large root (5cm diameter), in addition to a moderate density of roots 1cm and smaller. Three metres from the base of the tree (0.5m outside the ensuite footprint), we encountered and retained roots of the following diameters:

- One 6.5cm
- Two 5cm
- Three 3cm

One 6.5cm (circled in red), two 5cm (circled in blue), and three 3cm diameter roots were encountered in the trench 3m from the base of the tree.

We believe we encountered bearing soils in the areas excavated. If excavation does not occur more than 0.5m outside the proposed building footprint and the soil we encountered is sufficient to construct the foundation, then, in our opinion, the new house can be constructed as proposed with only short-term health impacts. We anticipate some signs of health stress (e.g. areas of dieback, reduced annual shoot growth) may be observable as a result of the root loss and decrease in permeability within approximately one-third of the tree's CRZ, but that the tree's health will not decline in the long-term. The tree is currently in fair to good health and oaks typically exhibit good tolerance to root disturbance. We do not expect the tree's structural stability will be significantly impacted. If it is found that deeper excavation is necessary and large roots are encountered, alternative building techniques may be necessary. This evaluation assumes that the tree's remaining CRZ has not been previously impacted by historic excavation.

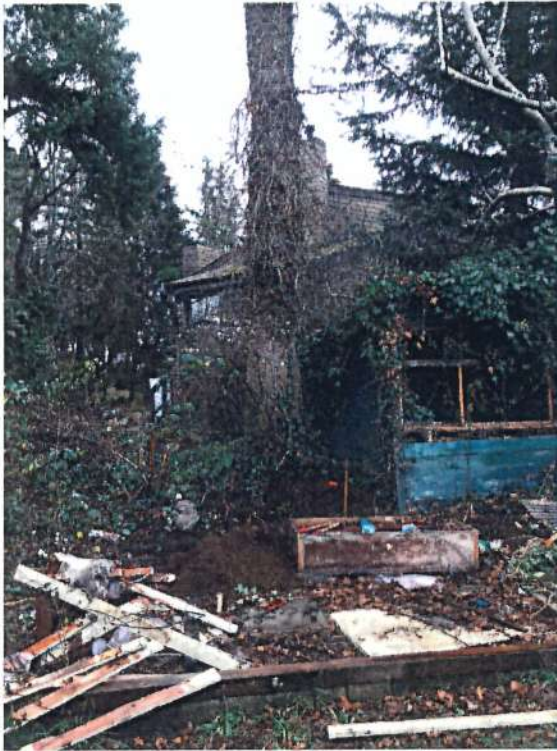
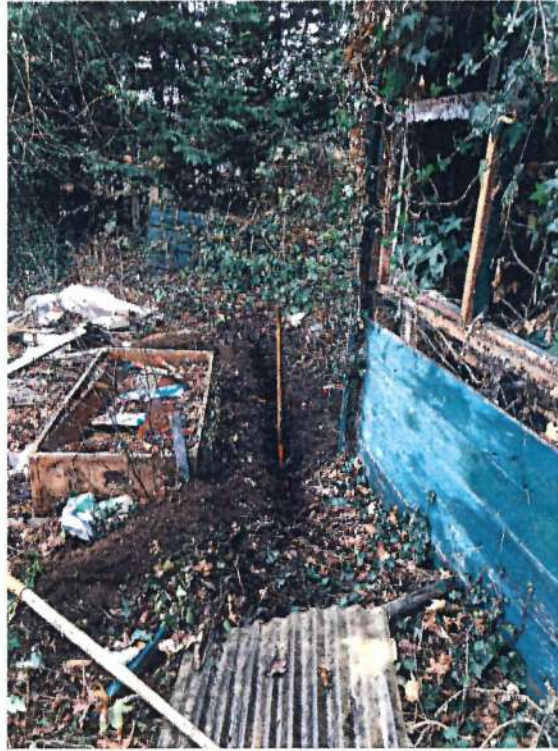
We hand-dug a 2.5m long trench 1.5m from the base of the 83cm DBH Garry Oak (#450), where we anticipate excavation will occur to for construction of the building on lot 2.

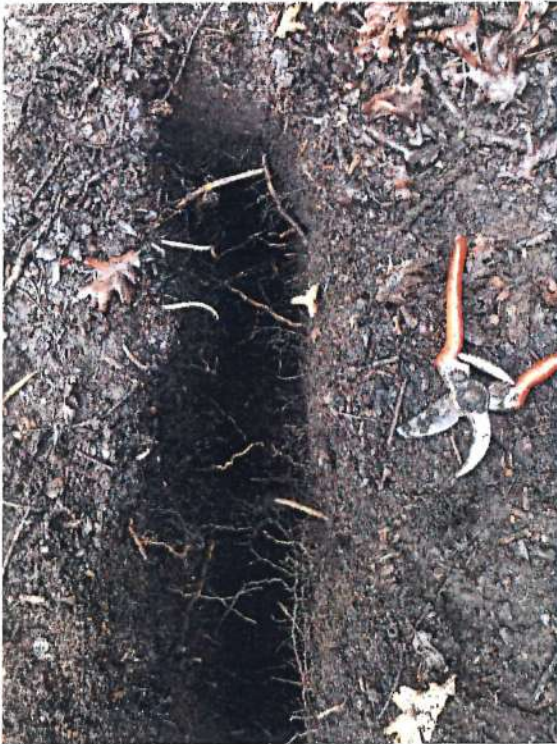
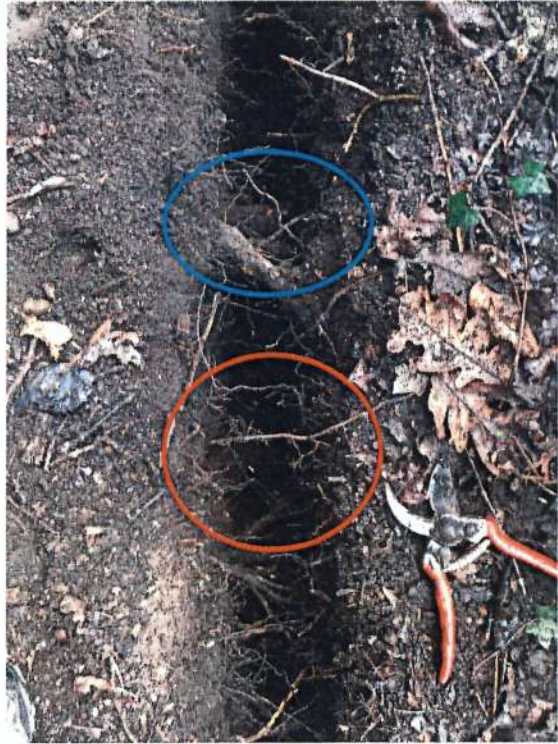
The large structural roots were all encountered at a depth of about 30cm. We determined that if these roots were severed, the health and structural stability of the tree would be significantly impacted. We recommended it be removed if the building were to be constructed as then proposed.

Several large structural roots were found, including one 12cm diameter root (left image), one 8cm root (right image circled in red), and two 6cm roots (one in right image circled in blue).

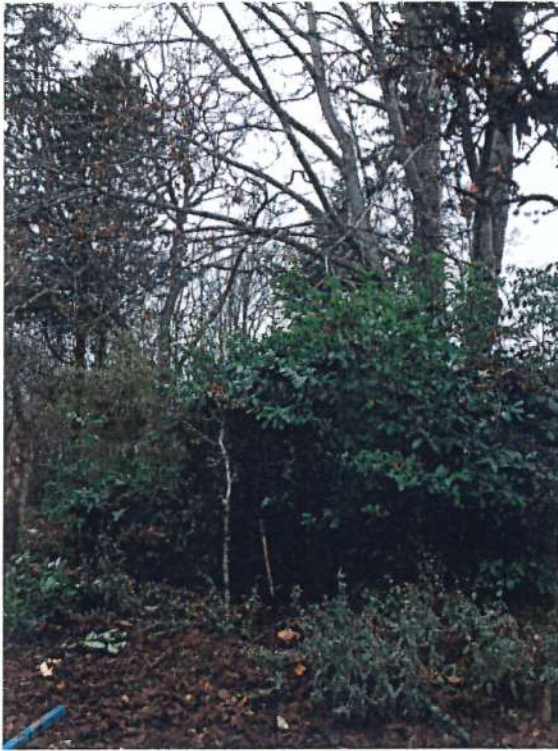
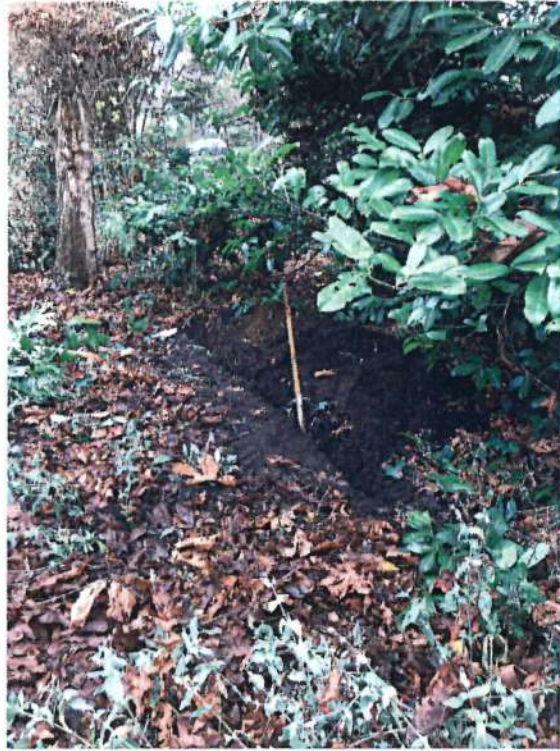
We hand dug a 2.5m long trench 3m from the fence line (5.5m from the base of Big Leaf Maple NT7), where the applicant informed us would be the limit of excavation.

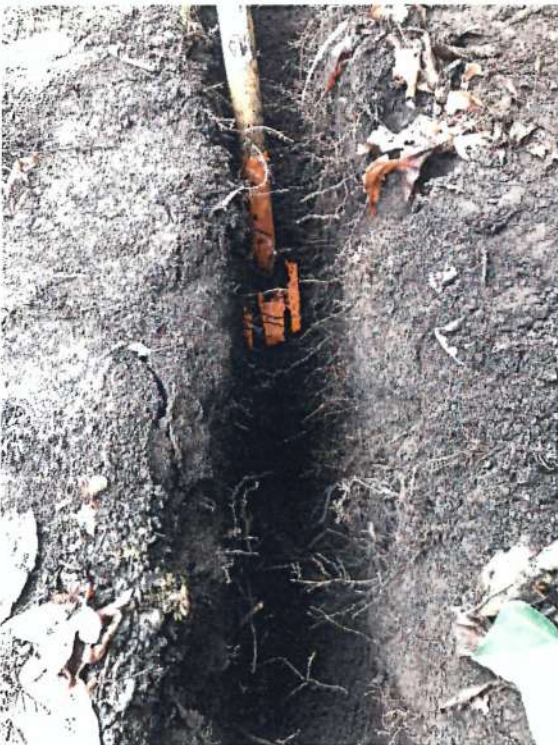
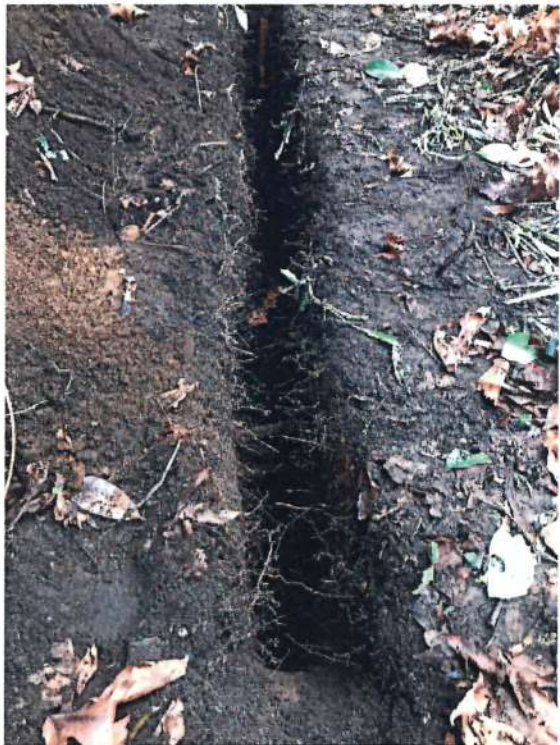
One 3cm (bottom of left image) and four 2cm roots were encountered and retained.
