## Talbot Mackenzie & Associates

Subject: 2832 and 2838 Shakespeare St - Exploratory excavation for proposed municipal sidewalk adjacent to municipal Red Horse Chestnut trees

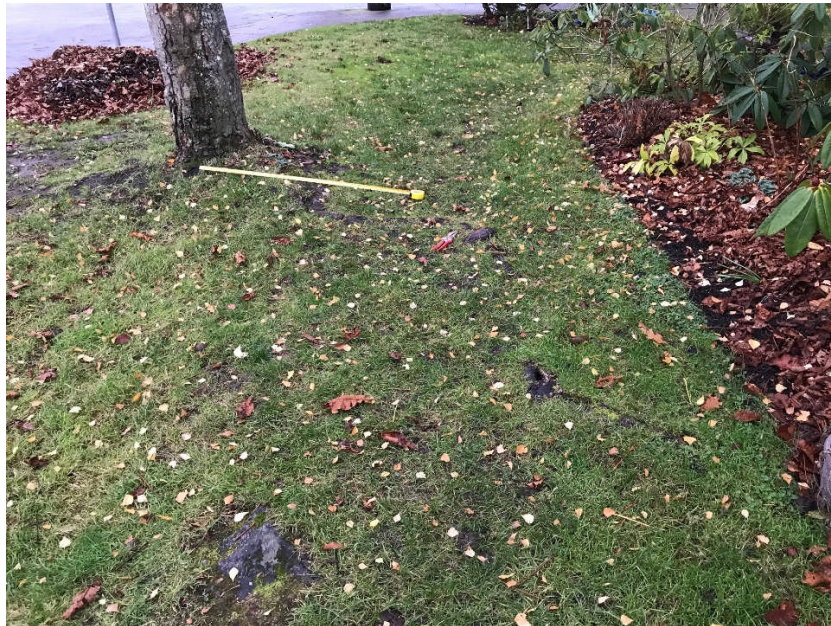
Multiple surface roots from Red Horse Chestnut NT #4 (municipal tree ID# 23054) were observed within the footprint of the proposed sidewalk. Exposed bedrock was also observed (Photo 1), which could indicate limited soil depth and explain the prevalence of surface roots in the area. Exploratory excavations were not deemed necessary as it is clear that the sidewalk will have to be built above the existing grade. Only limited excavation by hand, air-spade or hydro-excavation can take place if increased depth for sidewalk base is required between roots.

**Photo #1:** Multiple surface roots visible adjacent to Red Horse Chestnut NT #4. The tape measure roll is at the edge of the proposed sidewalk. Exposed bed rock was observed (bottom left side of photo) along with multiple surface roots, some of which had bark removed (likely from lawnmower damage).

The City of Victoria engineering department and concerned parties should be aware that if a sidewalk is to be constructed and the trees are to be retained without significant health impacts, the sidewalk and its base material will have to be raised above root systems as specified in our "floating sidewalk" specifications. If these specifications (or a similar approach which avoids significant root loss) is not followed, the trees will require removal if excavation down to bearing soil is required throughout the footprint of the sidewalk.

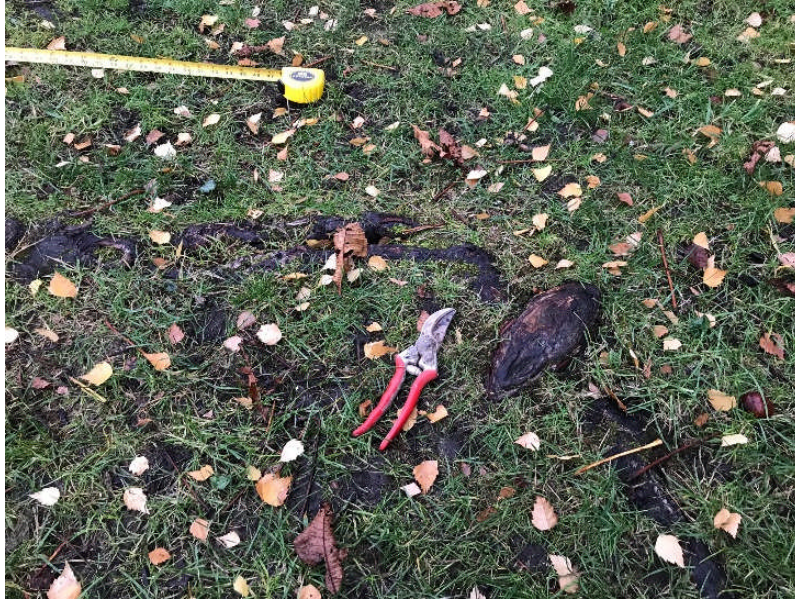
**Photo #2:** Close up of surface roots adjacent to Red Horse Chestnut NT #4.

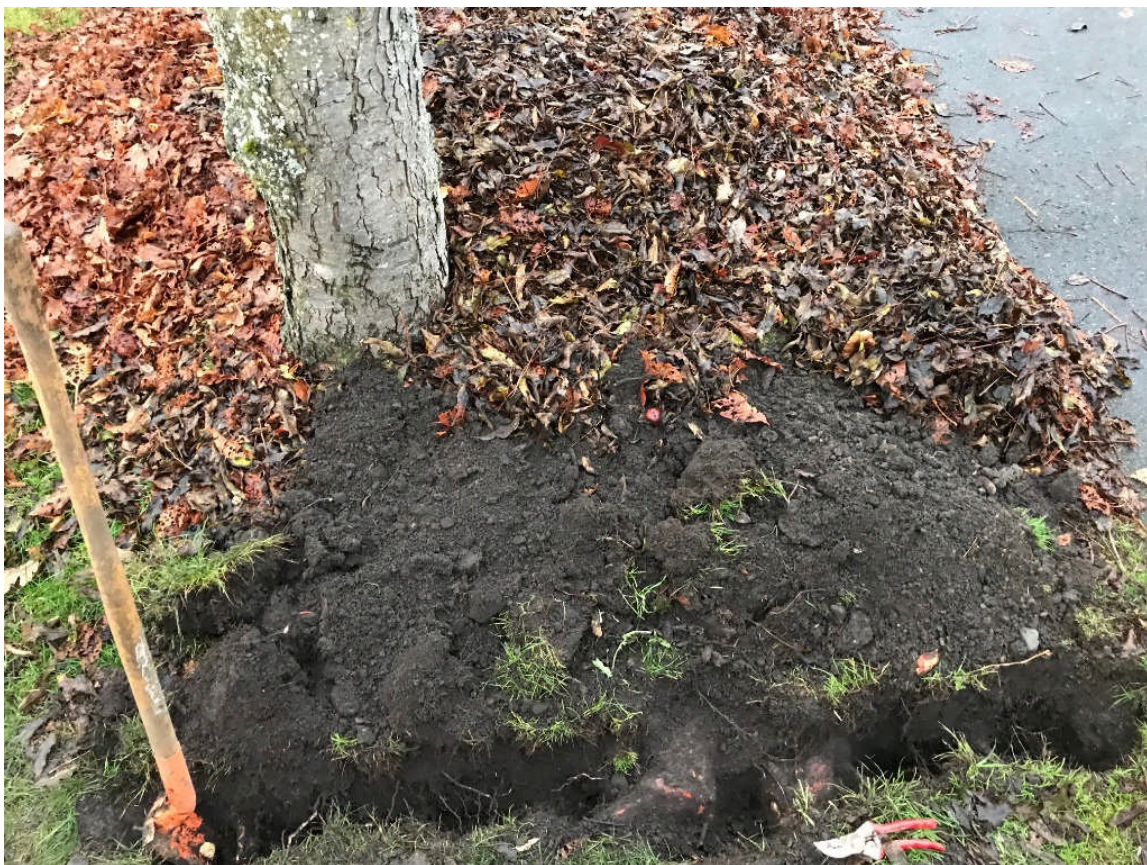
Exploratory digging was conducted between Red Horse Chestnut NT #3 (tree ID 23055) and the existing driveway to determine how steep a sidewalk slope might be necessary to preserve significant roots while maintaining the grade of the existing driveway. The trench was 2.1m in length and 30cm in depth, beginning from the edge of the driveway to just past the trunk of the tree (Photo 3). Roots with the following diameters were observed in the trench: one 15cm, one 14cm and two 2cm roots. No other roots above 1cm were observed. Both the 15cm and 14cm roots were approximately 5cm below the turf surface. The 15cm root was 74cm west of the driveway edge and the 14cm root was 97cm west. Both were approximately 1m south of the trunk of the tree. If the two large roots are to be preserved, the depth of the sidewalk paving material and base

**Photo 3:** Exploratory excavation adjacent to NT #3.

will have to be minimal in the area above the roots and there will likely be a slight slope from the driveway edge to where the roots are located.

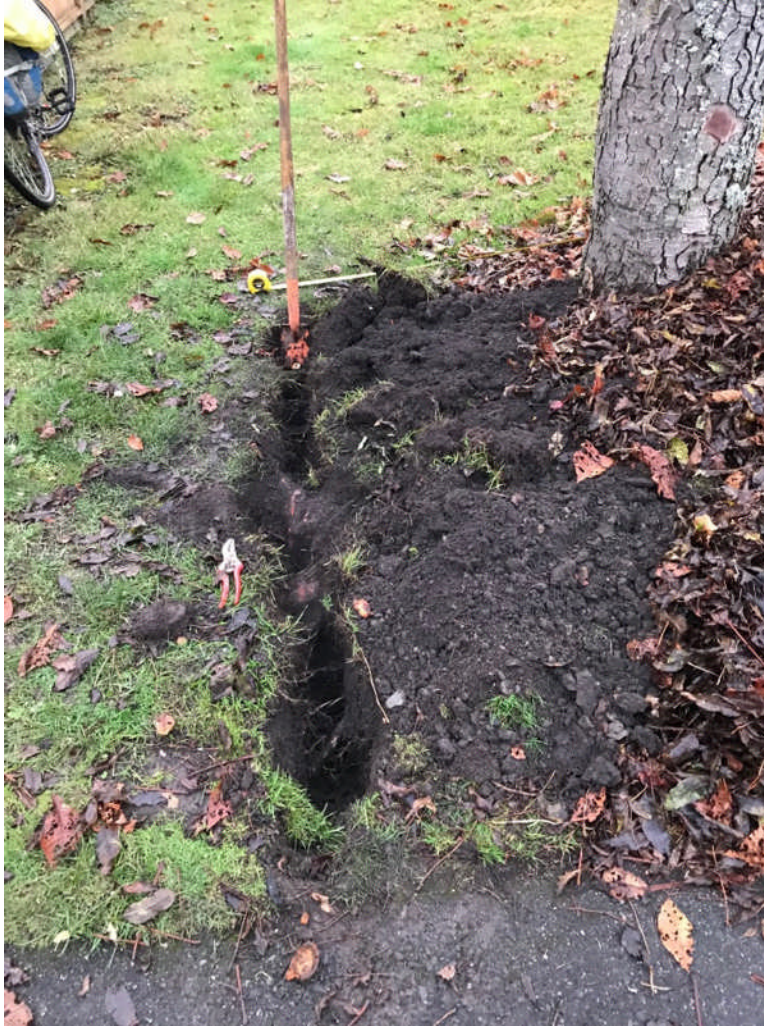
**Photos 4:** Exploratory excavation adjacent to NT #3.

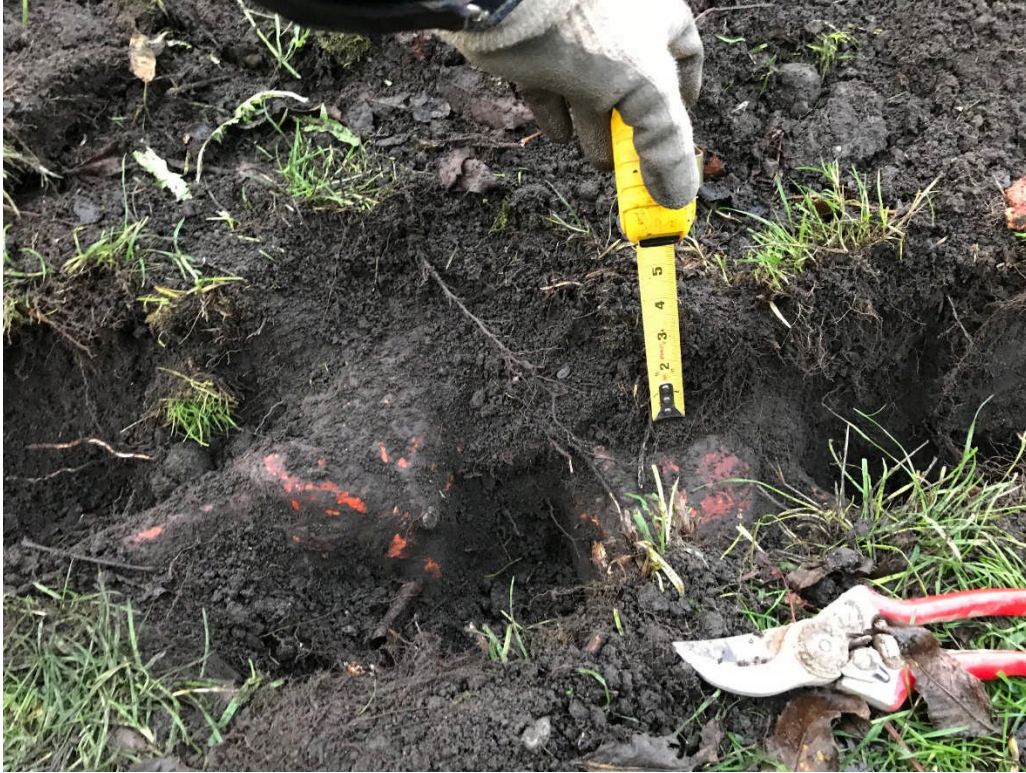
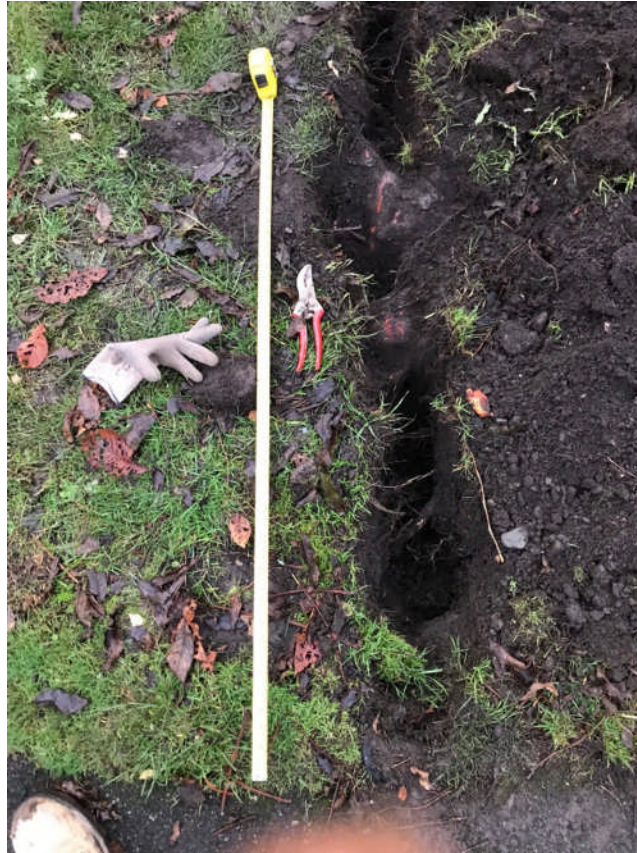
**Photos #5 and 6:** 15cm and 14cm roots were observed 5cm below the surface of the turf.

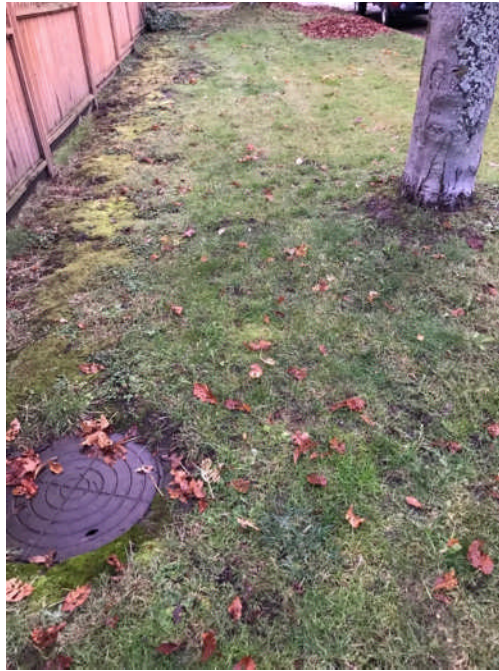
Exploratory excavations were not conducted around NT #2 (tree ID 23198) as there does not appear to be a reason why the grade of the sidewalk could not be raised gradually to accommodate roots below, provided the water meter east of the tree could be raised to meet the sidewalk grade.

**Photo #7:** A water meter is located east of Red Horse Chestnut NT #2. If this water meter opening can be raised to meet the grade of the sidewalk, we are not aware of a reason why the sidewalk could not be raised above the root system.
