Talbot Mackenzie & Associates

Re: 1068 Chamberlain Street

Assignment: To visually examine the recent excavation for house construction at 1068 Chamberlain Street that has occurred within the critical root zone of a 100 cm d.b.h. Garry oak tree located on the property at 1048 Chamberlain Street and comment on how it may have impacted the health or stability of the tree. Provide recommendations for mitigating any impacts the excavation may have had on the tree.

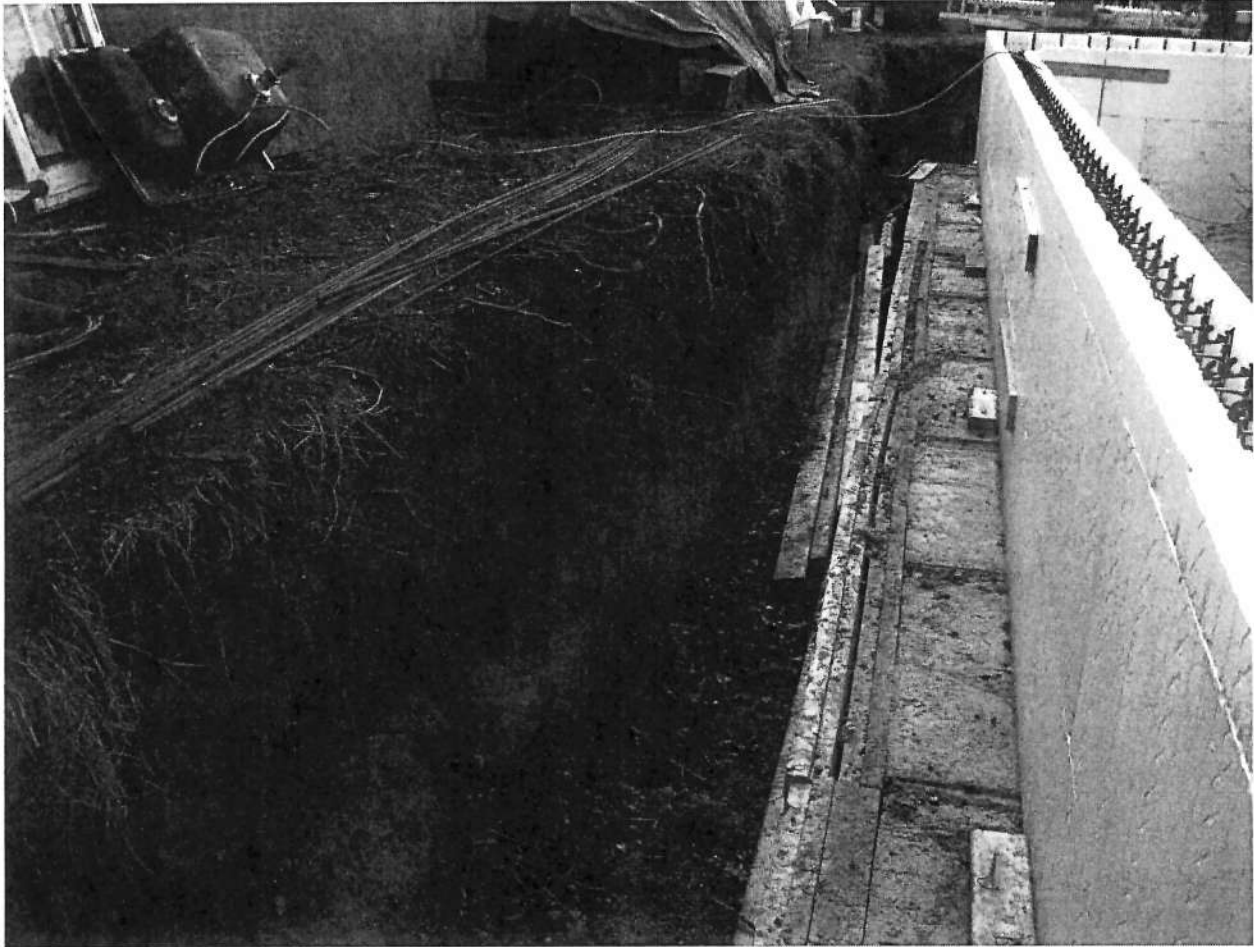
Picture 1: View of edge of excavation showing no large roots exposed (picture supplied by client).

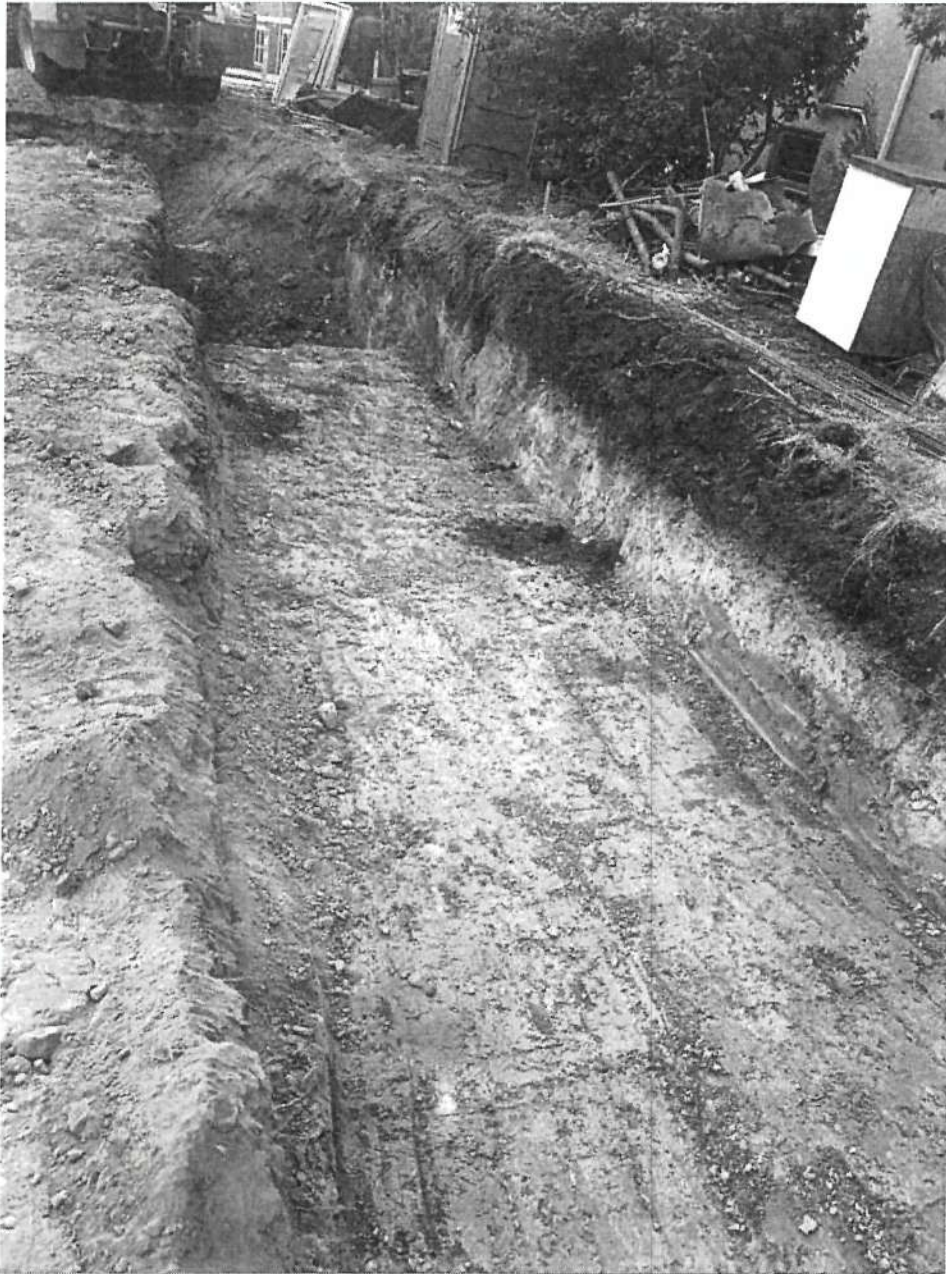
Picture 2: View of excavation from second angle showing no large roots exposed (picture supplied by client).

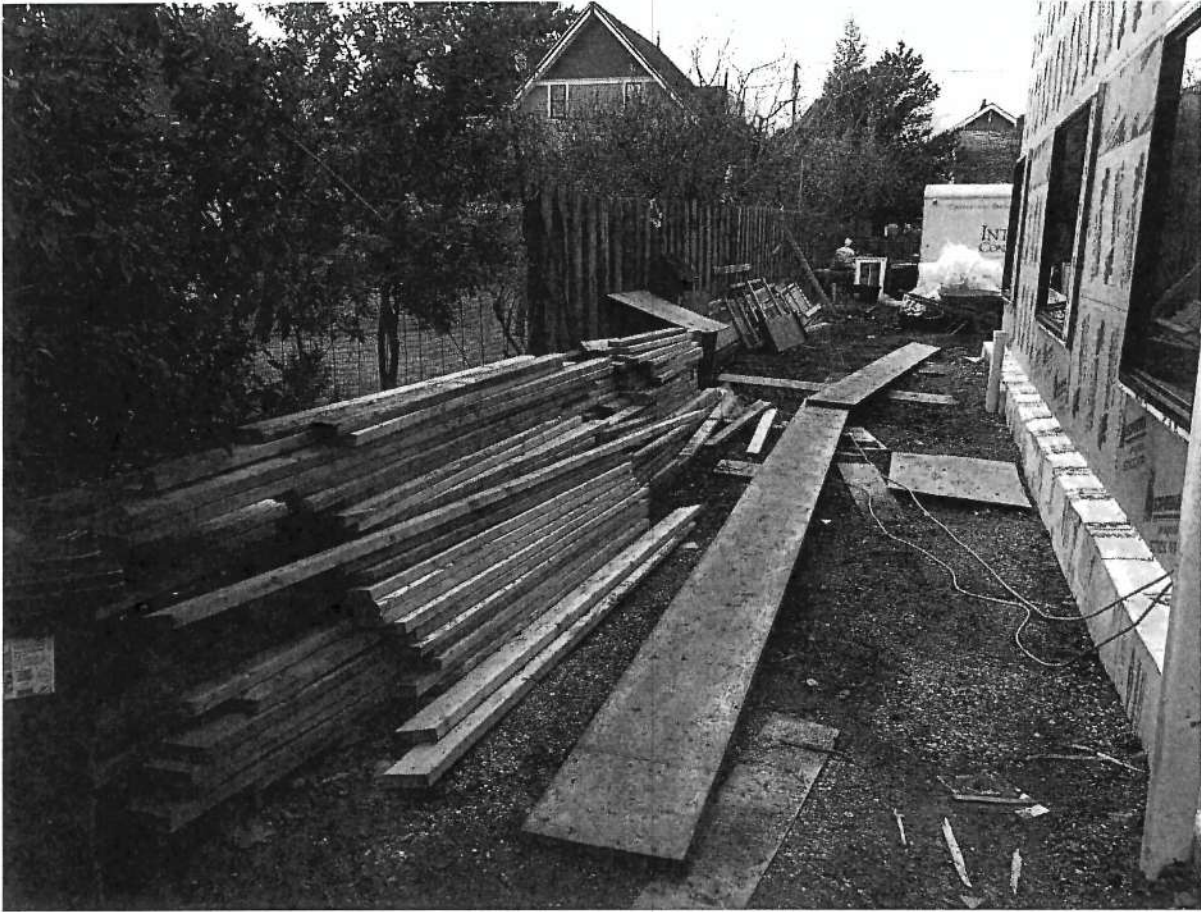
Picture 3: View of the area during our March 15, 2019 site visit.

- Remove all the construction material from the critical root zone of the tree and fence the area that has not been disturbed by the excavation. Alternatively, if the area must be used for construction foot traffic, a layer of hog fuel or coarse wood chips at least 20 cm in depth must be installed and maintained in good condition until construction is complete.
