D. Clark Arboriculture  
 2741 The Rise Victoria B.C. V8T-3T4  
 (250)474-1552 (250)208-1568  
 clarkarbor@gmail.com  
 www.dclarkarboriculture.com  
 Certified Arborist PN-6523A  
 ISA Tree Risk Assessor CTRA 459

To: Erin Flanagan  
 CC: Jane Waters  
 From: Darryl Clark  
 Permit #: In application  
 Date: 3/13/2019  
 Re: 1708 Coronation Ave.

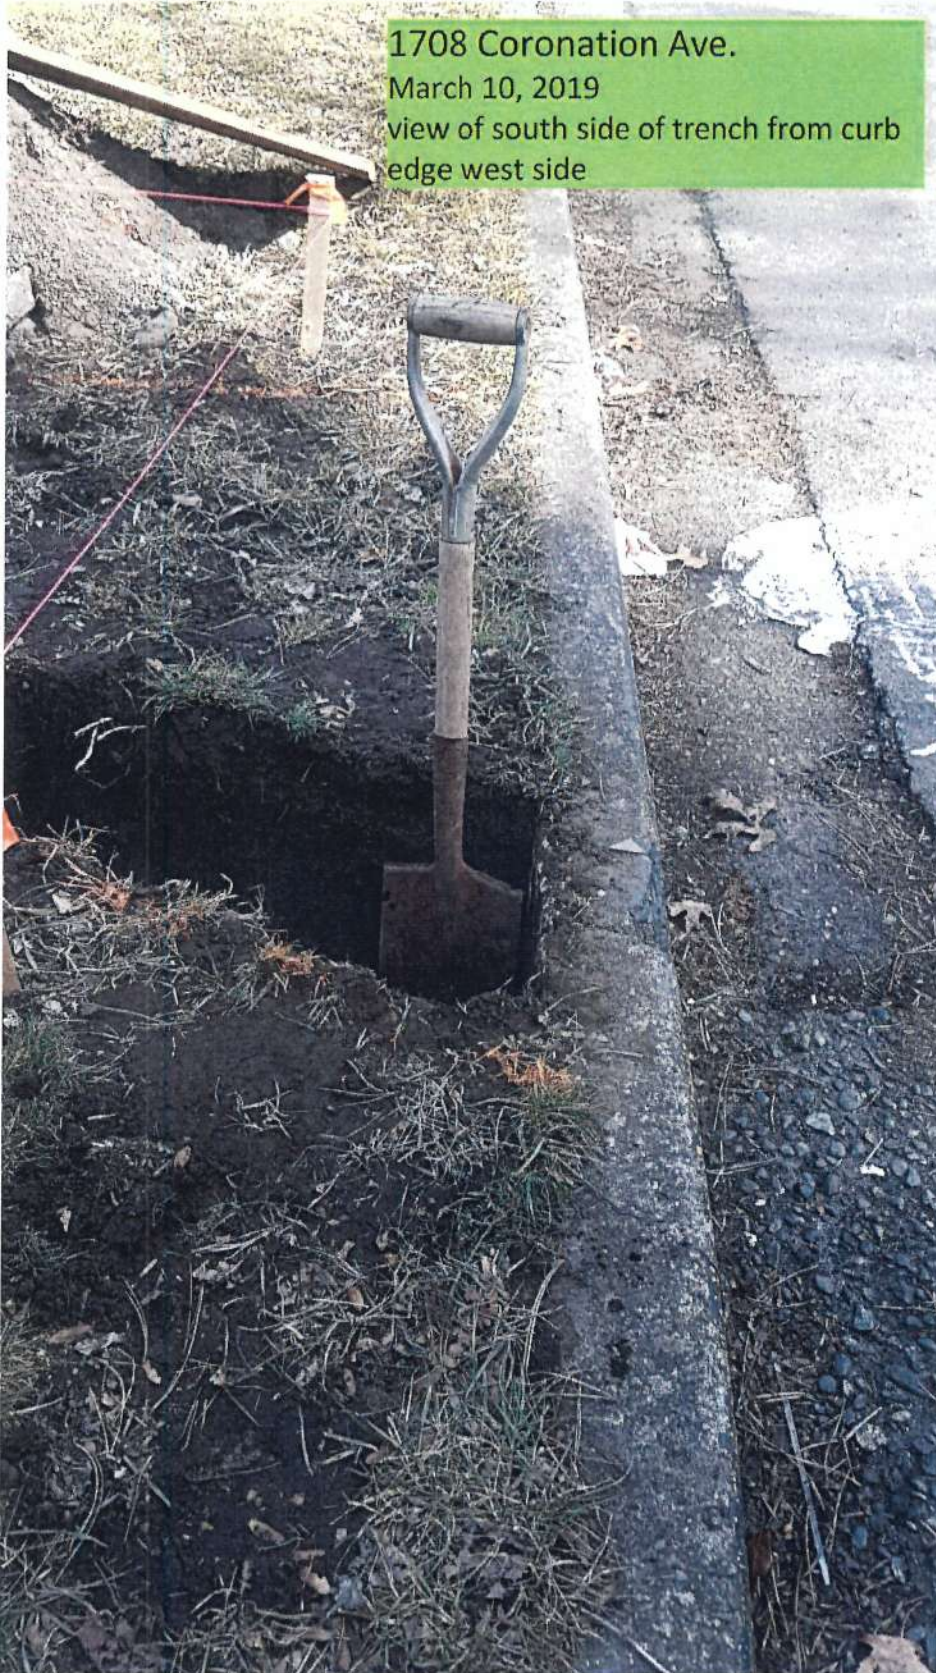
- The purpose of this trench was to expose any roots that may cause a conflict with a proposed driveway
- Excavation was undertaken by hand (shovel) 1.6m east of tree #25385
- Excavation was observed to a depth of approximately 38cm at the deepest point
- (2) roots approximately 1cm in diameter were exposed

view of south side of trench from curb  
edge west side

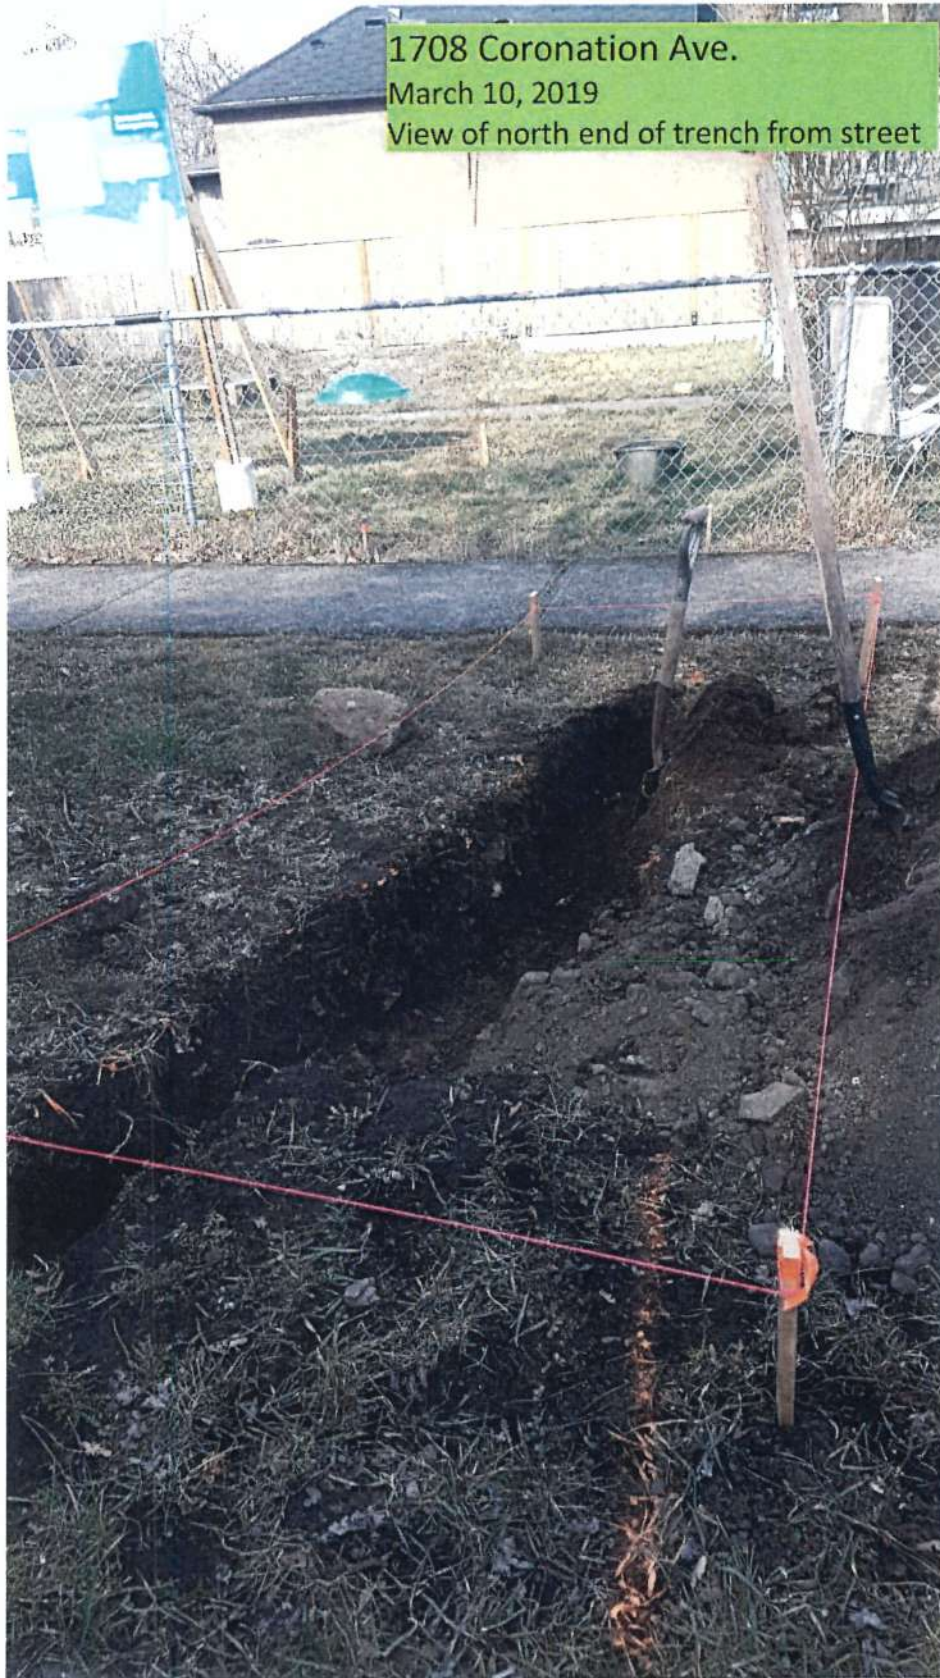
View of north end of trench from street
