# **208-240 Wilson St, Victoria**

## **Construction Impact Assessment & Tree Preservation Plan**

Date of Issuance: March 14, 2019

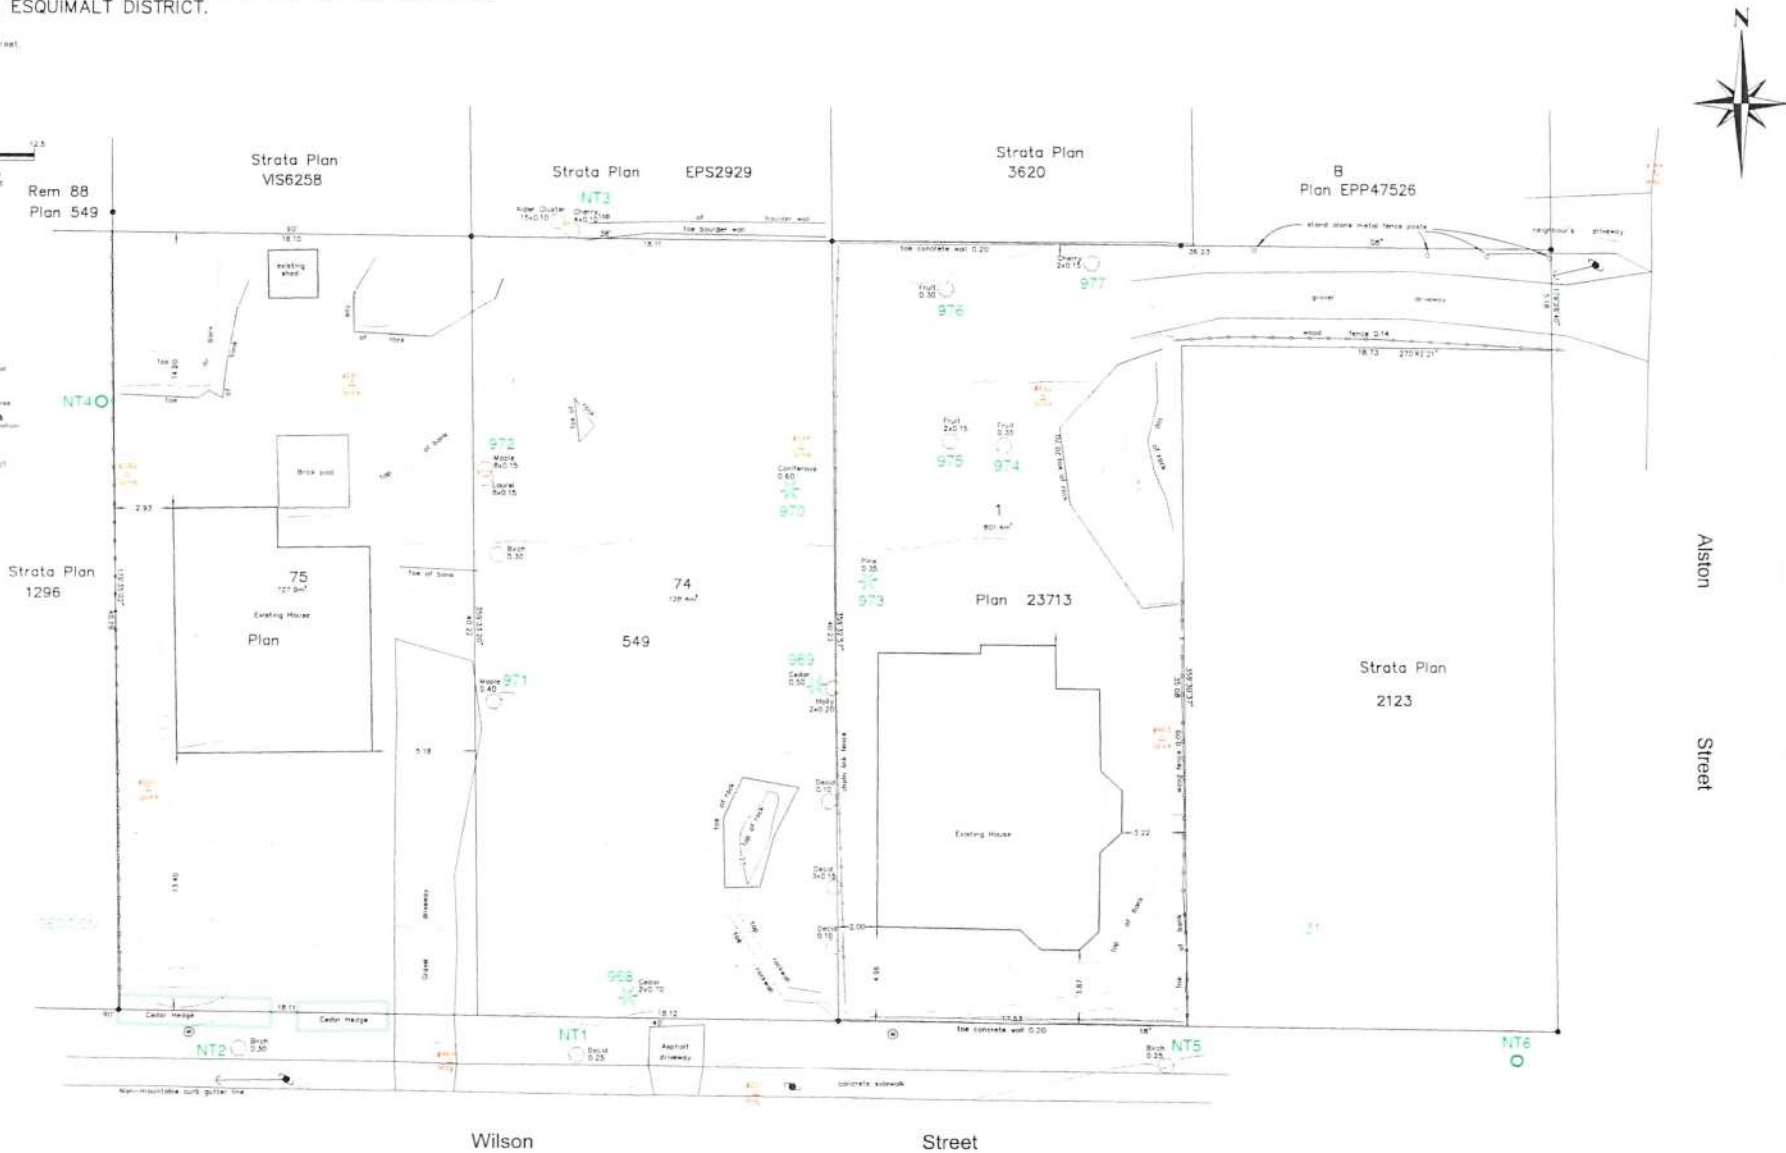
**Summary of Tree Resource:** Sixteen trees were in the inventory, including three by-law protected trees on the subject property. There are four municipal trees on the Wilson St frontage and two trees on neighbouring properties within 3m of the property boundary.

- **Trees #968-977** are located on the subject property within or immediately adjacent to the footprints of the proposed buildings or underground parkade.
- **Trees NT1-NT4** are located on the Wilson St boulevard and will require removal for construction of the new municipal sidewalk.

- **Cherry NT5** (11 stems, ~5-20cm DBH) is growing north of property boundary on a slope surrounded by stones from a partially collapsed stone retaining wall. The attached plans show the underground parkade will be constructed 3.5m from the north property line. If excavation can be limited to 2m outside the parkade footprint (or approximately 1.5m from the base of the tree), we do not anticipate any health impacts to the tree. We recommend the project arborist supervise any excavation within the CRZ of this tree (2.5m) and prune any roots encountered back to sound tissue. This tree's crown overhangs the subject property 3m. We do not anticipate crown pruning will be required as the closest patio is approximately 5m away.

- **Monterey Cypress NT6** (~40cm DBH) is growing near the fence line on the neighbouring property to the west. There is a retaining wall along the west property boundary that likely restricts root growth in the direction of the proposed building, which is approximately 3m away. Assuming excavation will occur 1m outside the building footprint, we do not anticipate the health of this tree will be significantly impacted. It has been topped and therefore, it will not pose a risk structurally, even if roots are encountered. We recommend the project arborist supervise any excavation within the CRZ of this tree (5m) in case roots are encountered growing underneath the retaining wall.

- **Arborist Supervision:** All excavation occurring within the critical root zones of protected trees should be completed under supervision by the project arborist. Any severed roots must be pruned back to sound tissue to reduce wound surface area and encourage rapid compartmentalization of the wound. In particular, the following activities should be completed under the direction of the project arborist:

- Excavation within the CRZs of neighbours' trees NT5 and NT6
- **Barrier fencing:** The areas surrounding the trees to be retained should be isolated from the construction activity by erecting protective barrier fencing. Where possible, the fencing should be erected at the perimeter of the critical root zones. The barrier fencing must be a minimum of 4 feet in height, of solid frame construction that is attached to wooden or metal posts. A solid board or rail must run between the posts at the top and the bottom of the fencing. This solid frame can then be covered with plywood, or flexible snow fencing. The fencing must be erected prior to the start of any construction activity on site (i.e. demolition, excavation, construction), and remain in place through completion of the project. Signs should be posted around the protection zone to declare it off limits to all construction related activity. The project arborist must be consulted before this fencing is removed or moved for any purpose.
