# 1811 Oak Bay Avenue, Victoria

## Tree Risk Assessment

91.0 cm DBH *Acer macrophyllum*

DATE OF ISSUANCE: April 15, 2019

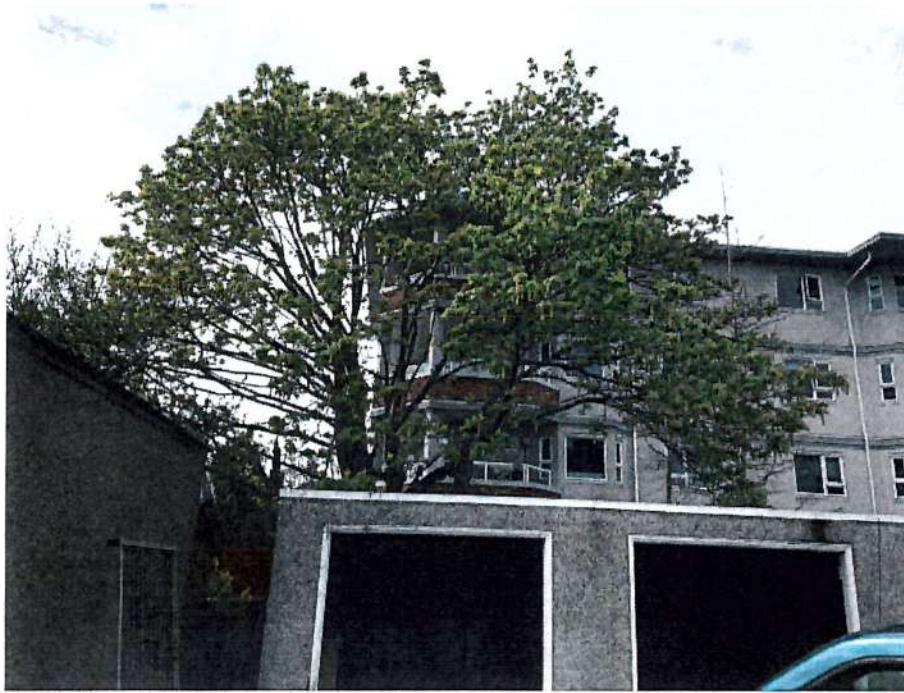
*Picture 1: Location of tree on property.*

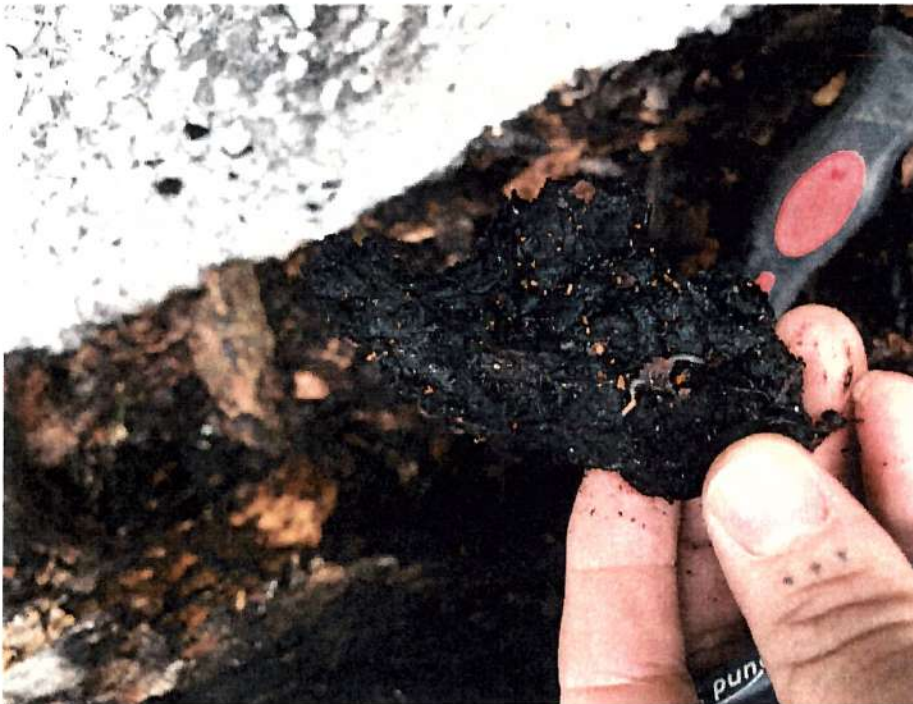
Resistograph readings taken at the base of the tree and at an angle into the root collar encountered significant drops on resistance, particularly in readings taken from the Southeast and Northeast sides of the tree. There is an open cavity with decayed tissue on the East side at the base of the tree that is difficult to access due to the existing garage, but the wood tissue that was able to be removed is deteriorated and consistent with the fungal infection.

This decay pathogen is known to cause whole tree failure due to the deterioration of the root system, or trunk shearing as a result of weakened brittle wood tissues. The tree is located where considerable property damage could occur should the tree fail, and it is our understanding that there will be demolition activity on the site to remove the existing buildings for the proposed new use of the property. Given the risk associated with the tree and the demolition activity that is going to occur, we recommend the tree be removed at the time of demolition to eliminate the risk associated with it.

*Picture 2: Kretzschmaria deusta fruiting body found during inventory.*

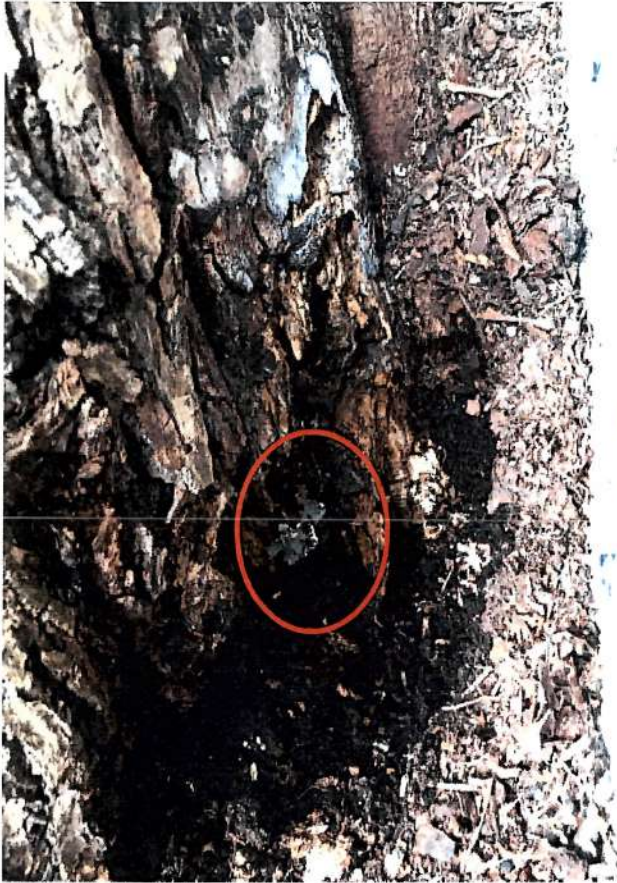
*Picture 3: Newly formed fruiting body found in follow up examination.*

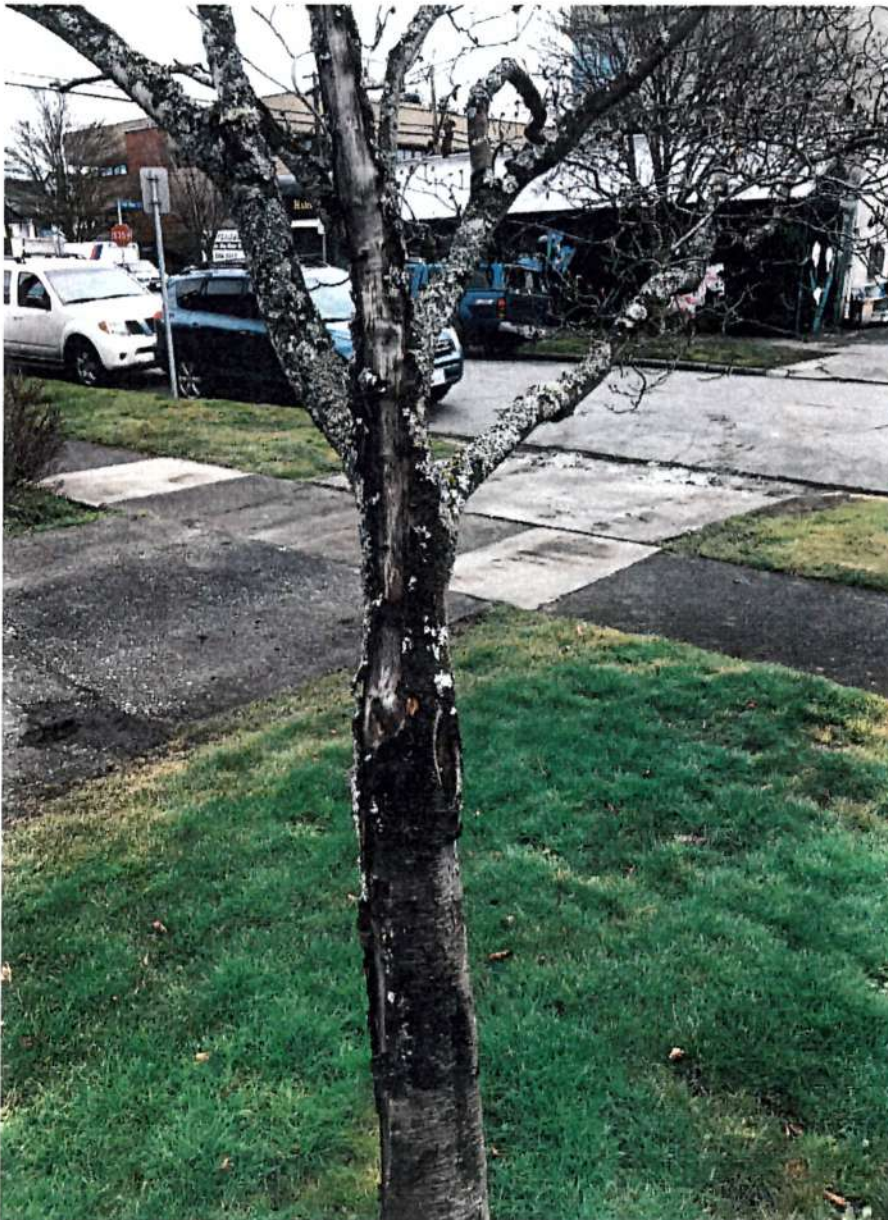
Dogwood #98- showing dead area of cambium.

| Tree ID | Common Name | Latin Name | DBH (cm)<br>~ approximate | Crown Spread (m) | CRZ (m) | Relative Tolerance | Health | Structure | Remarks and Recommendations | Protected by bylaw | Retention Status |
|---|---|---|---|---|---|---|---|---|---|---|---|
| 98 | Dogwood | <i>Cornus nuttallii</i> | 15.0 | 5.0 | 3.0 | Poor | Poor | Poor | ~50% of cambium on lower trunk dead. Within underground parking footprint. | Yes | X |

**Trees to be Removed:** Two bylaw protected trees, Big leaf maple #99 and Dogwood #98 will require removal due to construction related impacts both of which are either in poor health or structural condition due to existing health concerns. Additionally, non-bylaw protected Western Red cedar #100 and Lawson Cypress #97 will require removal. Based on the survey provided, both Big leaf maple #99 and Western Red cedar #100 have at least partial shared ownership with the neighbouring property to the West and we recommend that the neighbours be consulted prior to the trees removal.

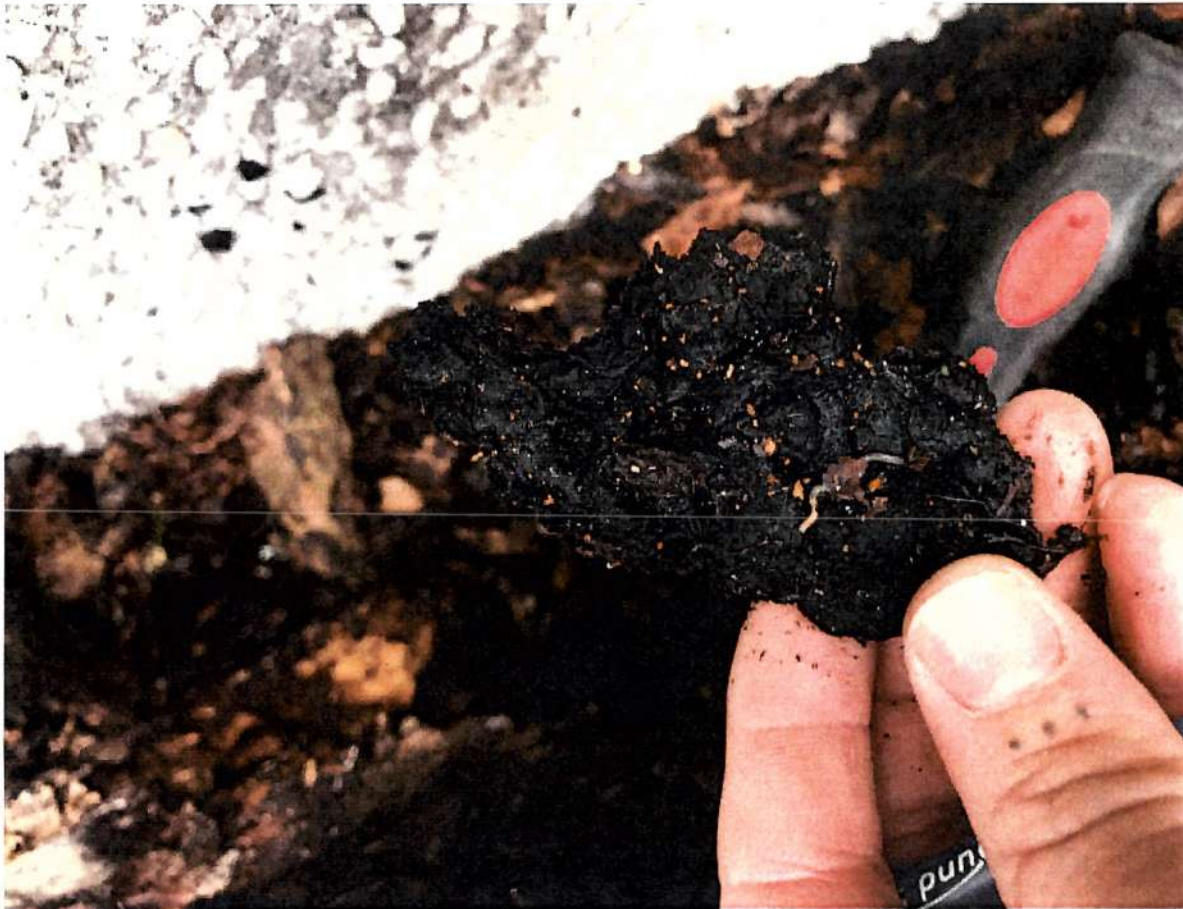
Big Leaf Maple #100 – showing fruiting body of *Kretzschmaria deusta* found at base.

| Tree ID | Common Name | Latin Name | DBH (cm)<br>~ approximate | Crown Spread (m) | CRZ (m) | Relative Tolerance | Health | Structure | Remarks and Recommendations | Protected by bylaw | Retention Status |
|---|---|---|---|---|---|---|---|---|---|---|---|
| 99 | Big Leaf Maple | <i>Acer macrophyllum</i> | 91.0 | 9.0 | 9.0 | Moderate | Fair | Fair/Poor | Decay evident on East side of lower trunk. <i>Kretzschmaria deusta</i> fruiting bodies found on lower trunk. Survey shows partial ownership with neighbour. | Yes | X |
