1139 Burdett Ave, Victoria

Construction Impact Assessment & Tree Preservation Plan

Talbot, Mackenzie & Associates

May 8, 2019

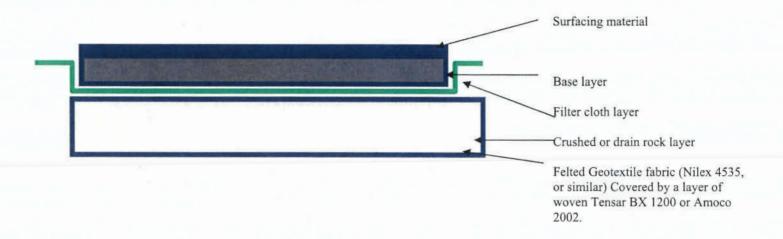
Diagram - Site Specific Floating Driveway, Parking and Walkway Areas

• Arbutus #33 (103cm DBH, 15.5m CRZ) is located at the southwest corner of the lot. The proposed parking area, driveway, and walkway to the bicycle storage area are all within 7m of the base of the tree. If excavation to bearing soil is required to construct these paved areas, large roots may be encountered, which, if severed, could significantly impact the health of the tree. The house addition also encroaches within the tree's CRZ, though we do not anticipate large, critical roots will be encountered during excavation. Based on discussions with the applicant, it is our understanding that a raised permeable driveway be constructed in the area where the proposed driveway, parking area, and walkway cross over the CRZ of the tree. The "floating driveway/parking area/walkway" specifications are attached.

The objective is to avoid root loss and to instead raise the driveway/parking area/walkway and their base layers above the roots. This may result in the grade of the "floating driveway/parking area/walkway" being raised above the existing grade (the amount depending on how close roots are to the surface and the depth of the driveway base layers). This may also result in soils which are high in organic content being left intact underneath. Based on discussions with the applicant, it is our understanding that the final grades of the driveway shown on the attached site plans are based on minimal excavation and the total thickness of the base layers and pavers to be approximately 30cm. Without an exploratory excavation, we cannot be certain of the depth at which roots will be encountered, so the final grades may vary slightly.

- Excavation for construction of the driveway/parking/walkway areas must remove the sod layer only, where they encroach on the root zones of the protected trees
- A layer of medium weight felted Geotextile fabric (Nilex 4535, or similar) is to be installed over the entire area of the critical root zone that is to be covered by the driveway. Cover this Geotextile fabric with a layer of woven Amoco 2002 or Tensar BX 1200. Each piece of fabric must overlap the adjoining piece by approximately 30-cm.
- 3. A 10cm layer of torpedo rock, or 20-mm clean crushed drain rock, is to be used to cover the Geotextile fabric.
- 4. A layer of felted filter fabric is to be installed over the crushed rock layer to prevent fine particles of sand and soil from infiltrating this layer.
- 5. The bedding or base layer and permeable surfacing can be installed directly on top of the Geotextile fabric.
