1139 Burdett Avenue

Heritage Restoration Plan

Stuart Stark, Heritage Consultant, July 2019 www.HeritageConsultants.ca

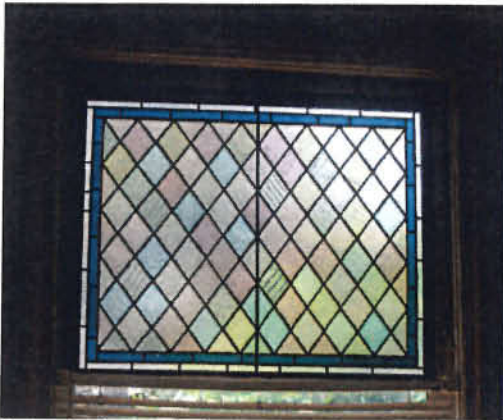
Stained-glass windows at 1139 Burdett Avenue; and windows in the staircase/hall windows from Tiarks' own house on Gorge Road (archival photo. Heritage consultant's collection)

- Repair & restore original wood double-hung windows on North, East and West elevations. Work will include paint stripping, removal and replacement of dried out/damaged glazing putty, replacement of broken or missing sash cords and sash locks, and replacement of missing multi-pane top sash lights in the west gable of the second floor of North (front) elevation; and second floor of West Elevation.
- Remove and replace historically incorrect aluminum windows on South (rear) elevation of West Gable with period-correct wood windows.
- Replace non-original textured glass in original stairway window on east side of the house with stained glass to match the rest of the original stained glass windows. (based on stair windows from other Tiarks designs)

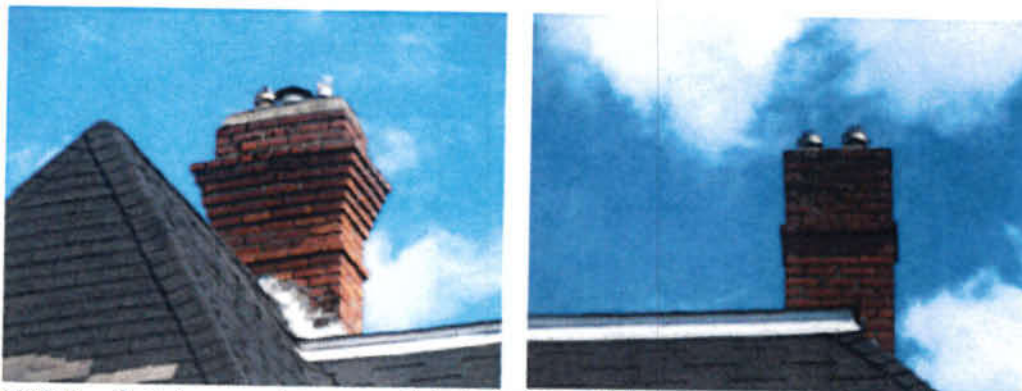
Repoint/rebuild two chimneys from roof line up, including new concrete chimney caps and metal flue liners for gas fireplaces. The larger of the two chimneys retains its original corbel design, the other one has been rebuilt straight over the years. The intention is to rebuild both to match Tiarks' original design. Research shows these chimneys match the chimney design on the Tiarks house at 508 Dallas Road. (See photos below)
Replace metal flashing & remove improper tar job.

*1139 Burdett Avenue chimneys: Original design left; to be rebuilt, right.
Both chimneys will be taken down to roof and rebuilt to original design.*

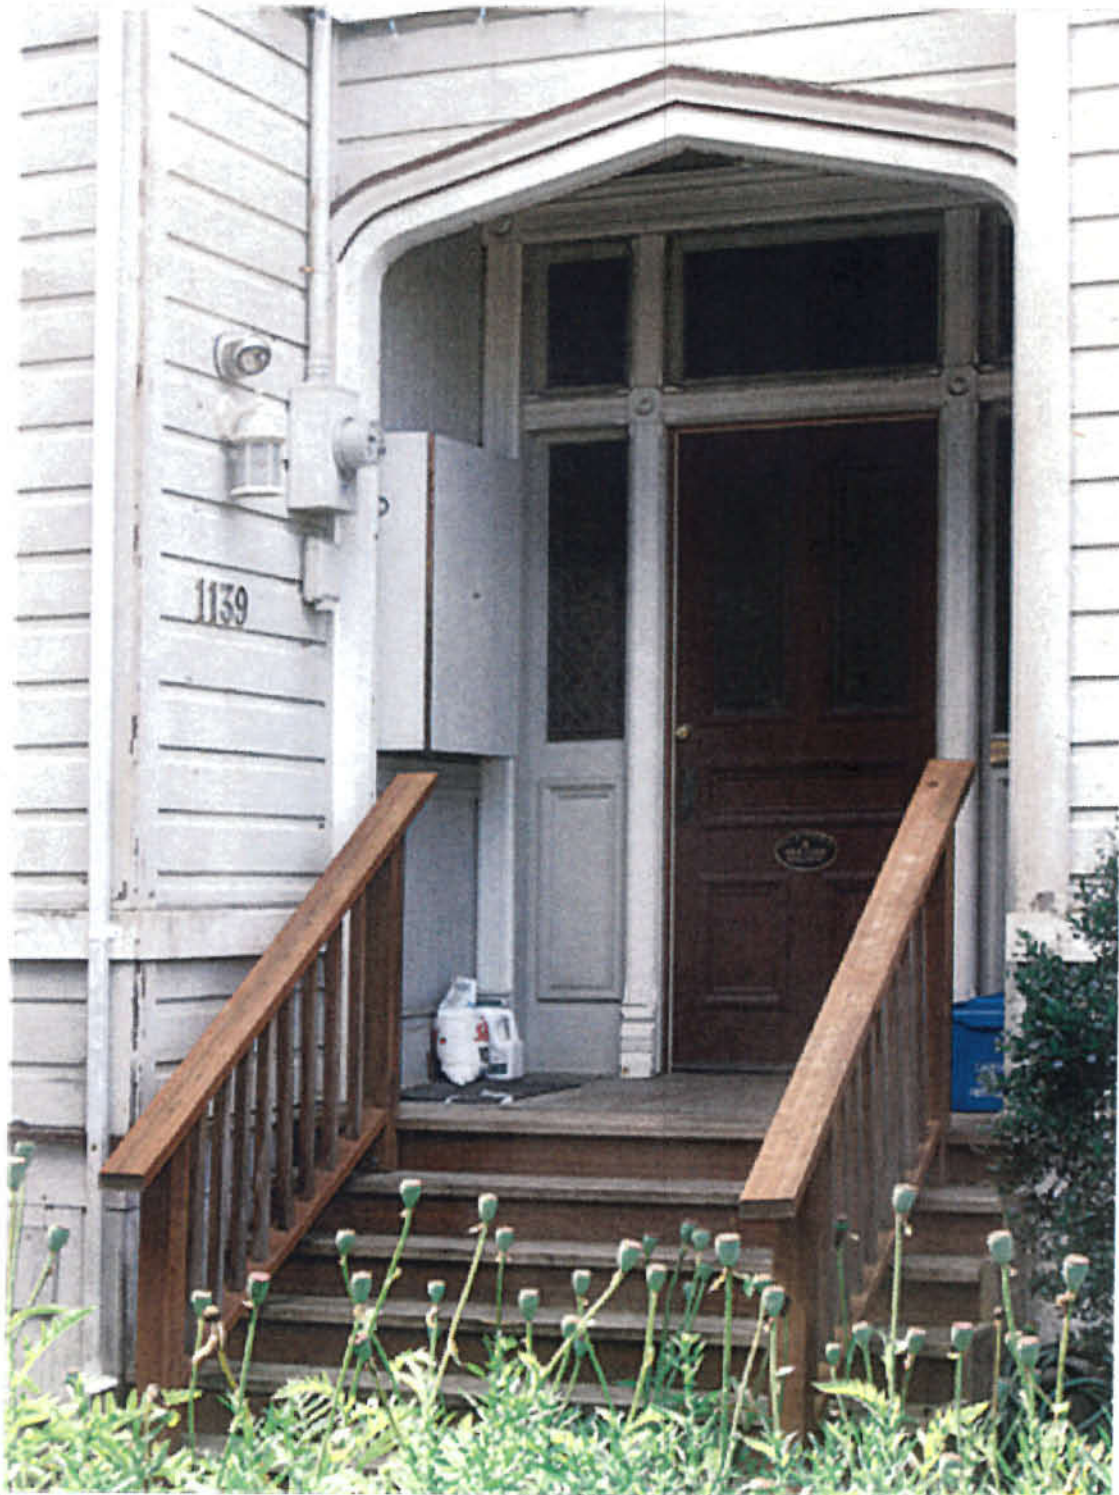
Remove current electrical mast, meter and breaker panel box as well as 'Home Depot special' lights from front porch. New electrical mast will be on east side of house and new meters will be in electrical room at rear of the house.

Stairs were replaced (probably in the 1990s). They are not in keeping with the heritage design of the house. It is intended to rebuild them in an appropriate style by using other Tiarks-designed stairs as precedents for the restoration. See next page.

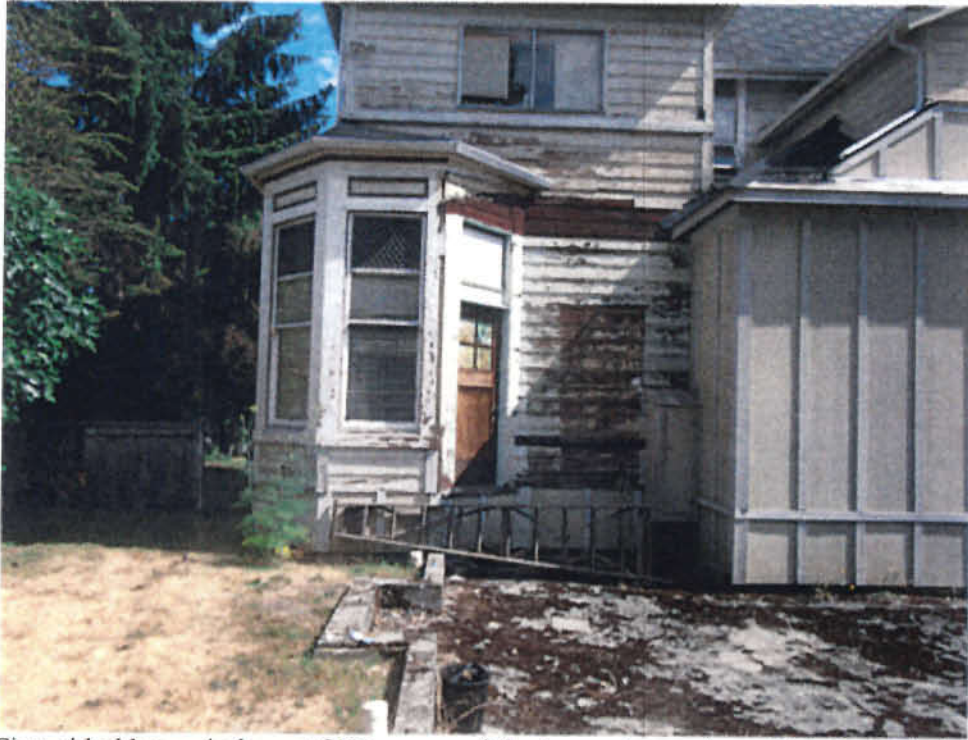
Five-sided bay window at SW corner of the house (rear view). This bay window contains original upper stained glass panels in each window. [Aluminum-framed window above will be replaced with wood sash]

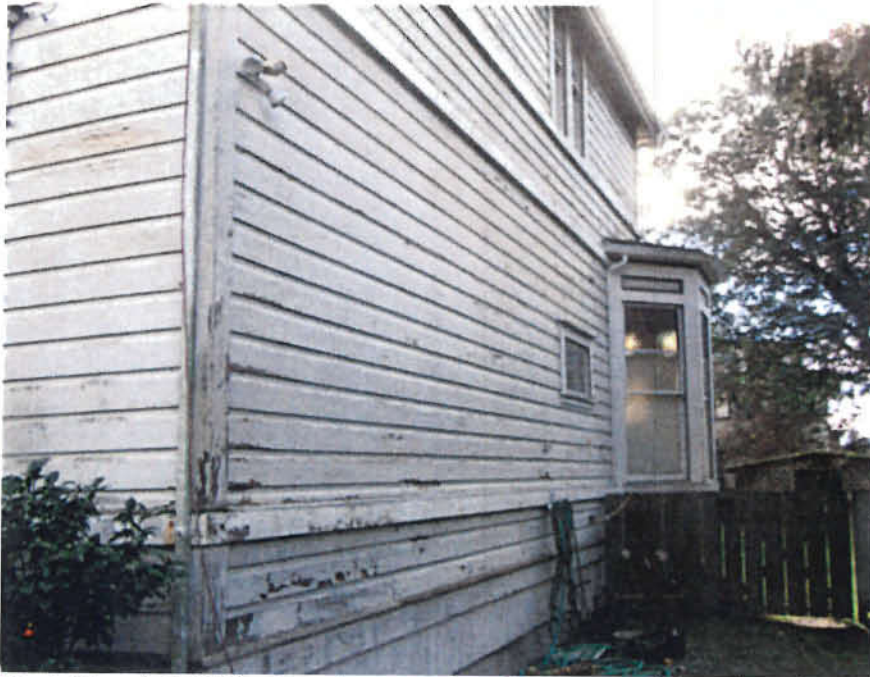
West side of 1139 Burdett Avenue, showing proposed location of new pair of double-hung windows, replacing current (probably later) piano window. The re-installed pair of double-hung windows would vertically line up with the pair of windows above on the second floor.

Prior to the 1903 map, there had to have been a window in the SW main floor room. (bottom left on plan) Based on other windows in the house, it was likely a joined pair of double-hung windows facing west, over the side yard garden, in the location of the later bay window. [It is proposed to re-install a pair of wood, double-hung windows in this location]. See submitted architect's plans.
