September 14, 2016

Re: Safety and Security Audit – 844 Johnson Street (Formerly the Central Care Home)

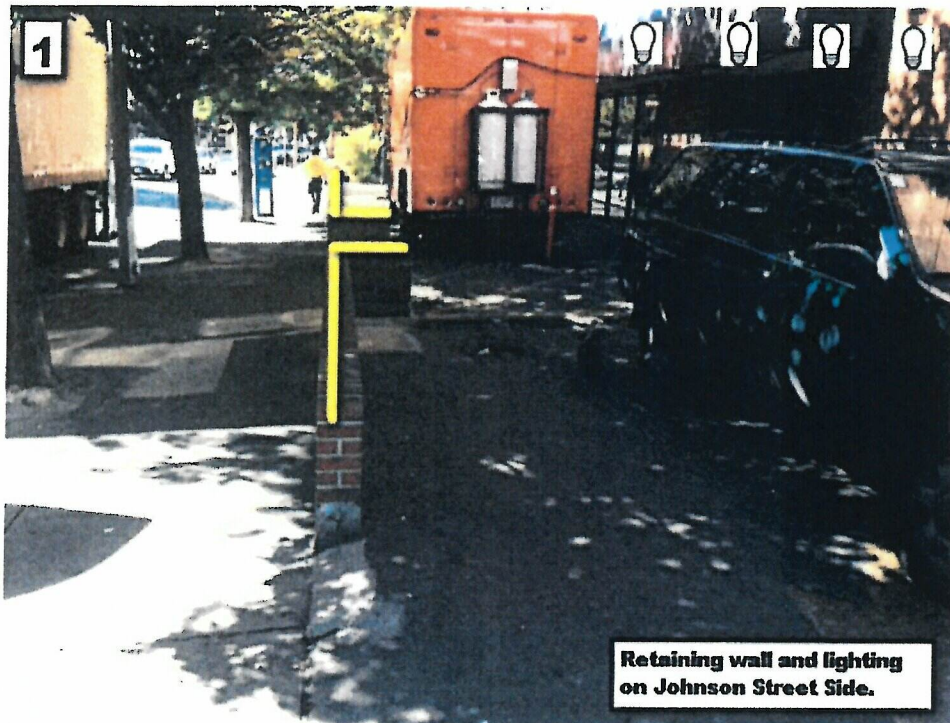
- Improve exterior lighting along the front of the building (Johnson Street side). Install fixtures that would light up the area between the building entrance and the sidewalk. Remove awning if necessary (it may block light). *Refer to photograph #1.*
- Improve lighting on the front west side of the building (Johnson Street side). *Refer to photograph #2.*
- Move fencing on the west side of the building (Johnson Street side) up to meet the southwest corner of the building. *Refer to photograph #2.*
- Landscaping the empty garden beds on the front west side of the building (Johnson Street). Plant low shrubs or ground cover that won't obscure the view to the building. *Refer to photograph #2.*
- Significant pruning of trees that line the sidewalk on Johnson Street; these trees currently block the light to the sidewalk from the lone streetlight. If lighting is still

- Remove the low brick retaining wall in front of the Johnson Street entrance and replace with low, wrought iron fencing or small shrubbery. *Refer to photograph #1.*

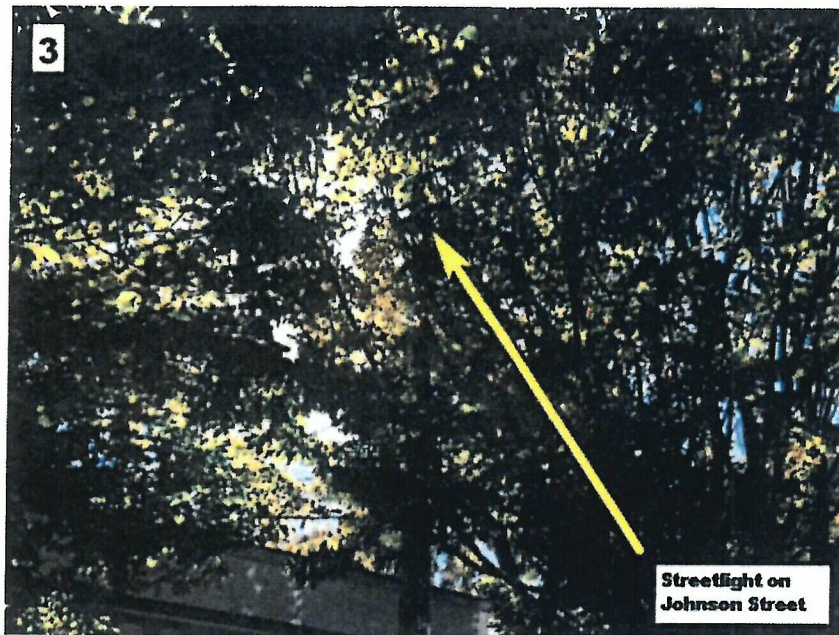
inadequate with pruning and the addition of exterior building lighting then consider alternatives to the streetlight. *Refer to photograph #3.*

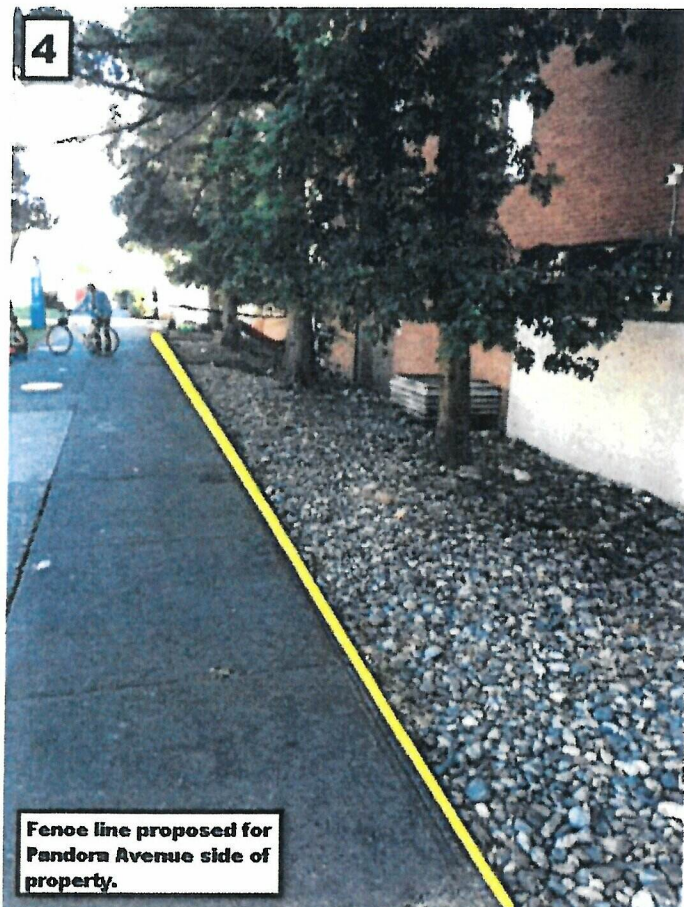
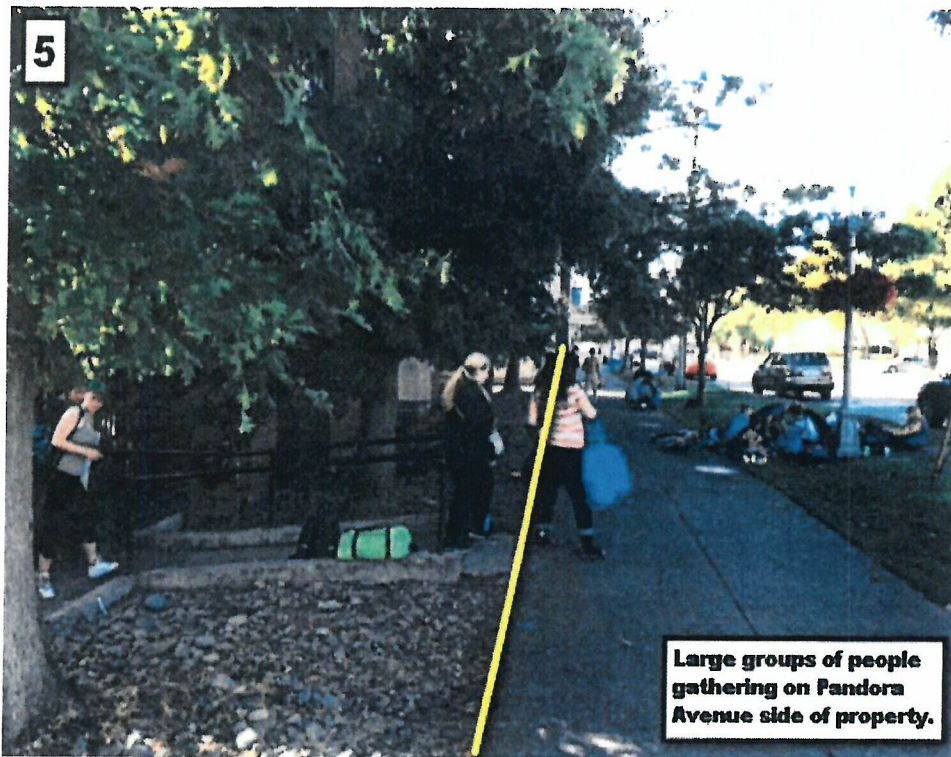
- Install plexi-glass along the fencing on the east side of the building which borders the parking lot of 850 Johnson Street.
- Install high wrought iron fencing (similar to existing fencing) up to the sidewalk at the rear (Pandora Street) of the building (the length of the building) that cannot be easily climbed. *Refer to photograph #4 and #5.*

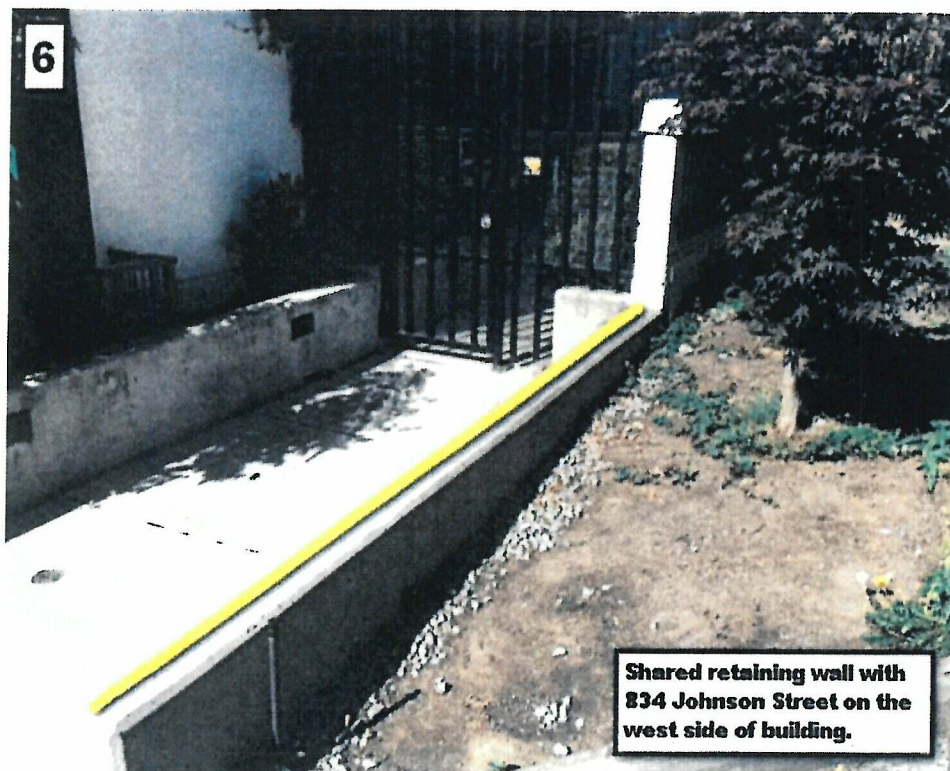
- Install low, wrought iron fencing along the top of the low concrete wall bordering the walkway next to 834 Johnson Street (west side). *Refer to photograph #6.*

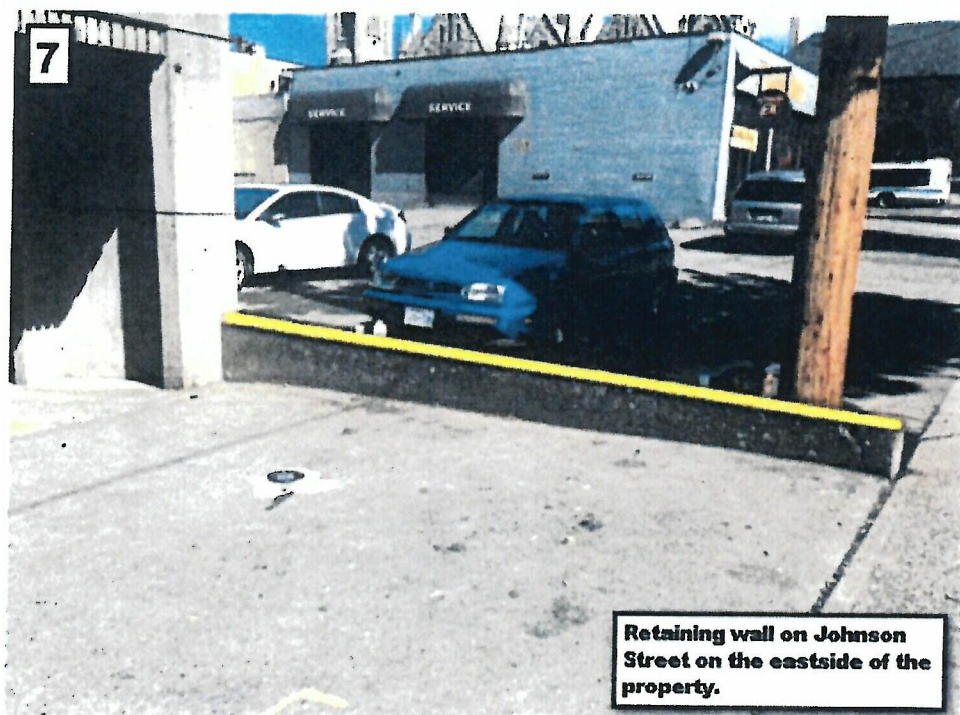
- Install low, wrought iron fencing along the top of the low concrete retaining wall bordering the driveway (Johnson Street side). *Refer to photograph #7.*
