PARKWAY APARTMENTS

1050 PANDORA AVENUE, VICTORIA, BC

CONSERVATION PLAN

JULY 2019

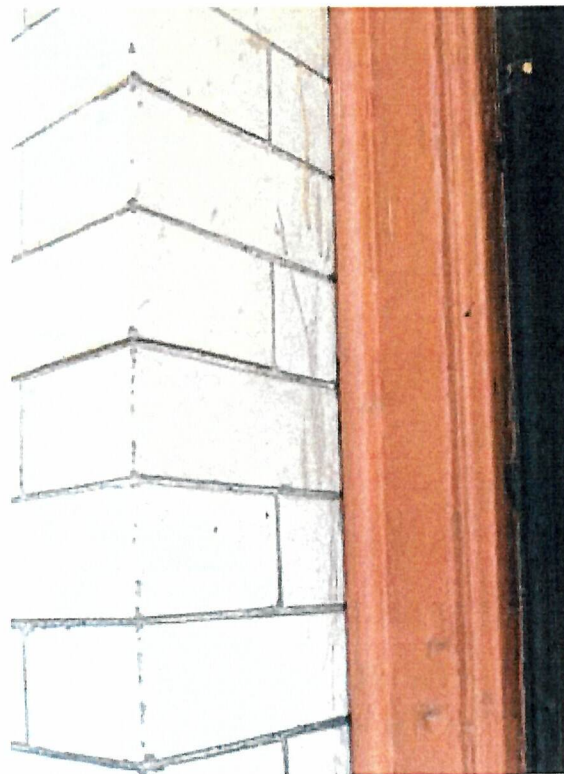
Visual inspection of the brick from the ground was conducted. Overall, the glazed brick of the Pandora Avenue and Cook Street façades is in good condition. Deterioration that is present appears in the form of chips to the glazing (typically at the arises of bricks and outside corners of the building), mortar loss, localized areas of staining of mortar, organic deposits in some areas, and over painting on to the brick. Redundant fixtures and anchors are also present on both "street" façades which should be removed and any resulting holes repaired.

Above: Typical brick damage of chips and paint on brick face from painting adjacent wood elements, present on both "street" façades.

- Overall, preserve the brick of retained façades and replace in-kind brickwork that is too deteriorated to retain.
- Undertake complete condition survey of all brick surfaces.
- Retain sound exterior masonry or deteriorated exterior masonry that can be repaired.
- All masonry cleaning, repair, and repointing specifications to be reviewed by Heritage Consultant.
- All redundant metal inserts/anchors should be removed and, where possible, services mounted on the exterior walls removed or reconfigured.
- Any holes in the brick should be filled, if possible, or replace damaged brick with new

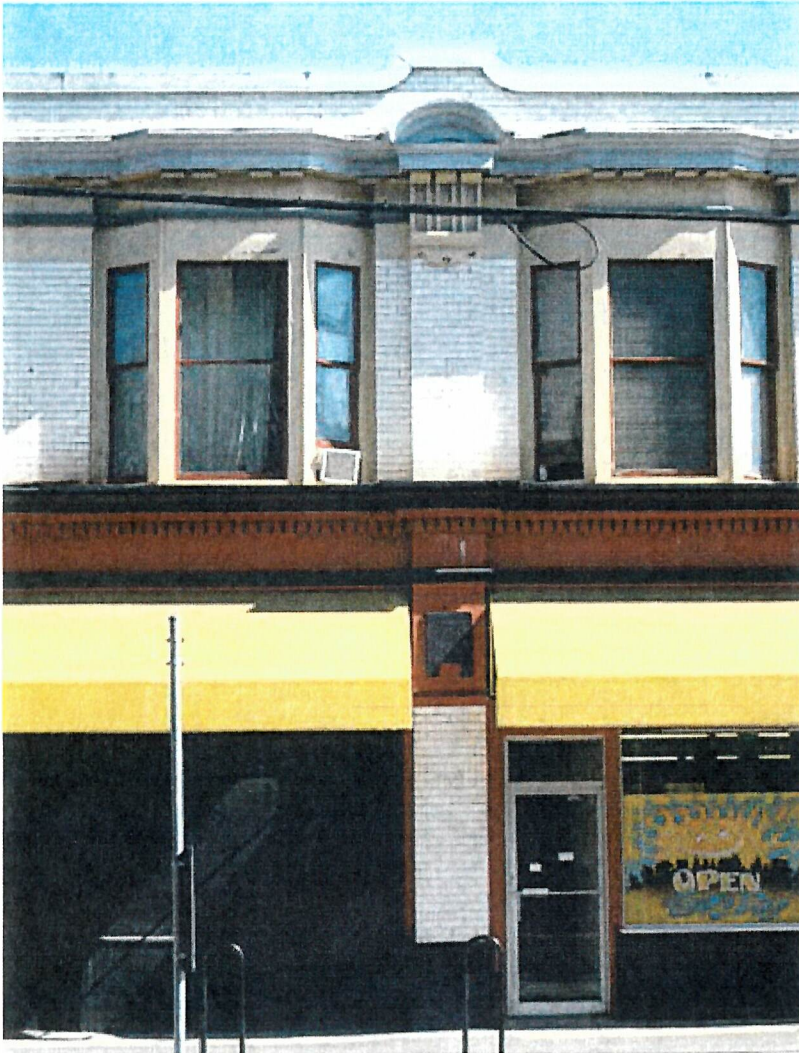
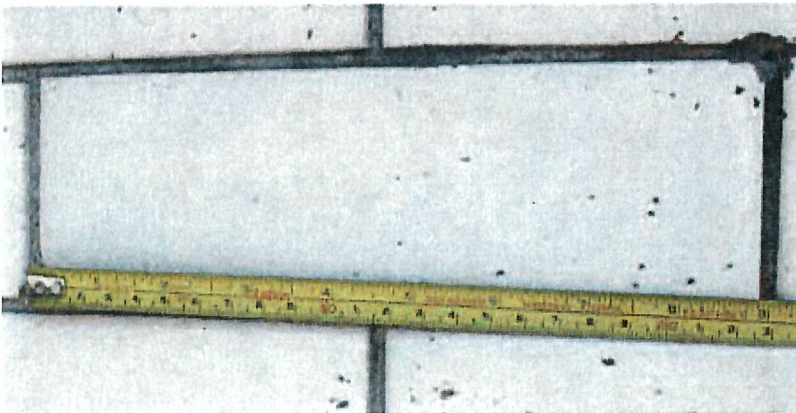
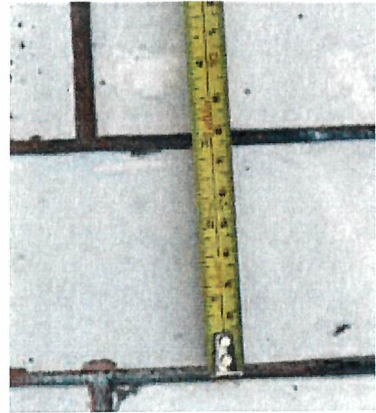
Left: Exterior of “street” façades with brick laid in running bond with white mortar. Brick present on pilasters separating storefront bays, second floor walls, and parapet. Overall in good condition with local areas of deterioration.

Below Left and Right: Existing brick of “street” façades showing mortar joints

- Repoint brickwork by raking out loose mortar material to a uniform depth. Take care that the rises of the brick are not damaged. Work should only be undertaken by skilled masons. Do not use power tools to cut or grind joints. Repoint mortar joints with new mortar that matches existing in consistency, composition, strength, colour and pointing profile; note the finely tooled profile of the original mortar joints.

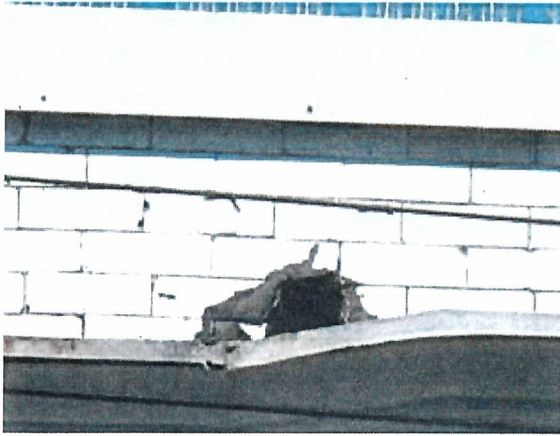
Above: Later installed scupper above roof cornice on Cook Street façade. Weather proofing material applied onto the face of the parapet.

Alterations to the “street” façades include the addition of a thru-wall scupper installed above the rooftop cornice on the Cook Street façade. The waterproofing of the scupper has been spread onto the adjacent brick. Consideration should be given to ensuring the roof drains in a manner that permits the deletion of this later added scupper. Additional alterations include: the base of the glazed brick pilasters being parged; increase height and parging of the original glazed brick storefront bulkhead; removal of the pairs of cylindrical ‘chimney-like’ elements positioned at the top of the pilasters at the parapet level.

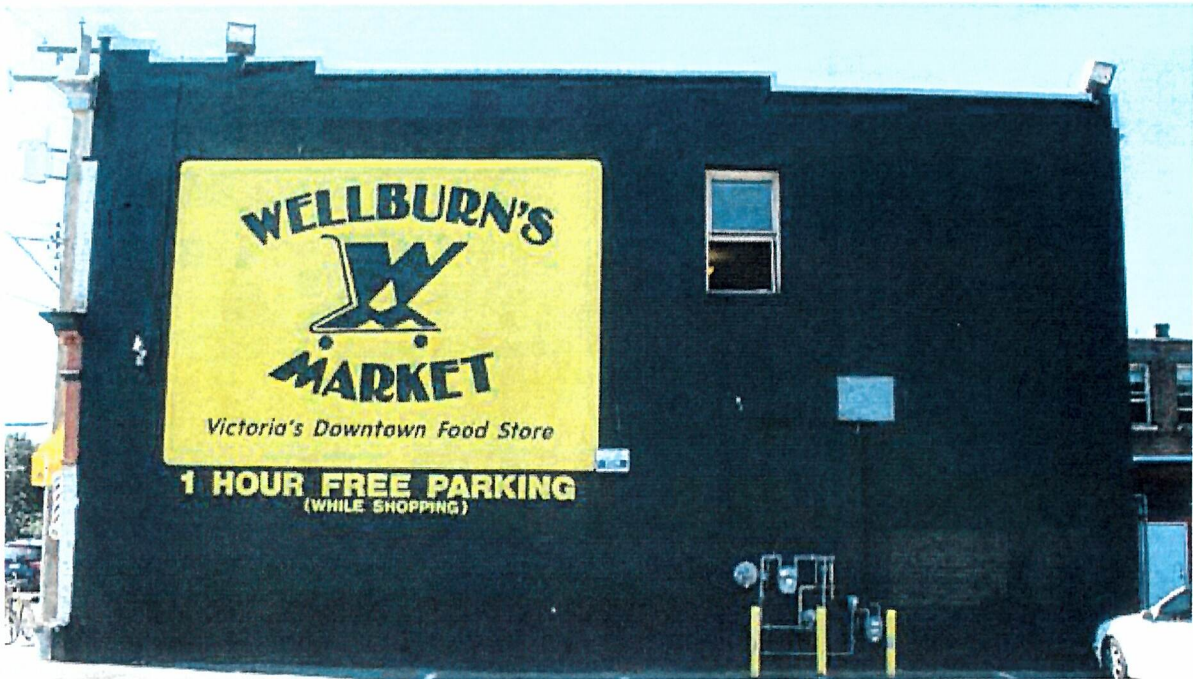
The “non-street” façades consist of red brick with cream mortar laid in common bond. Overall, the brick is in fair condition with localized areas of deterioration noted. Portions of the brick walls have been painted. The paint prevents the examination and assessment of the underlying brick. Paint can trap moisture behind the surface in the brick causing it to deteriorate. The paint may also contain lead and necessary precautions must be taken in dealing with such hazardous materials.

Above: Painted brick of the north façade. Paint is a later intervention and limits assessment of underlying brick. Surface damage to some brick and mortar loss present in areas at base of wall at approximate height of car mufflers and bumpers.

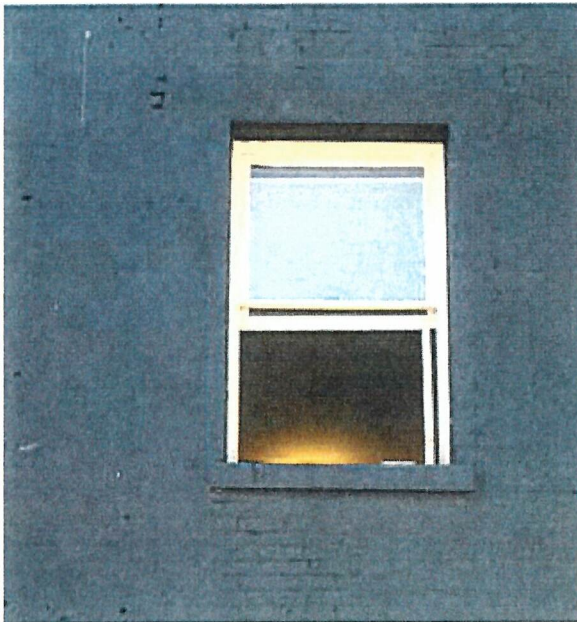
Above: Typical example of mortar loss and unpatched past penetrations in brick wall on "non-street" façade.

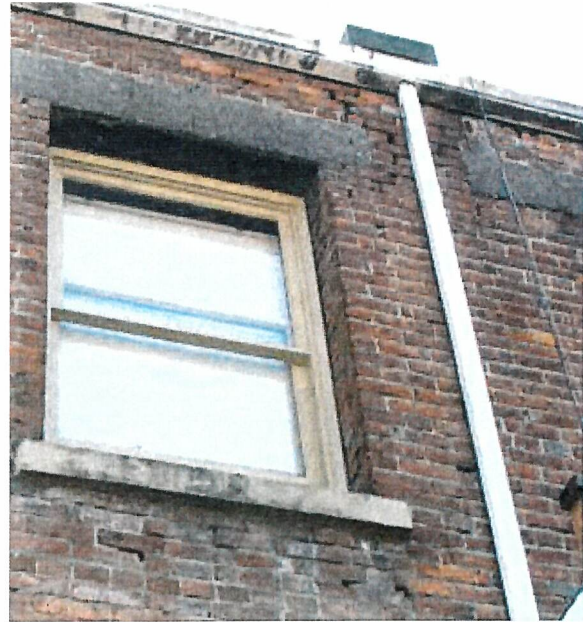
Above: Mortar loss, distortion of brick, and staining on rear of building likely caused by overflowing gutters and undersized downspout.

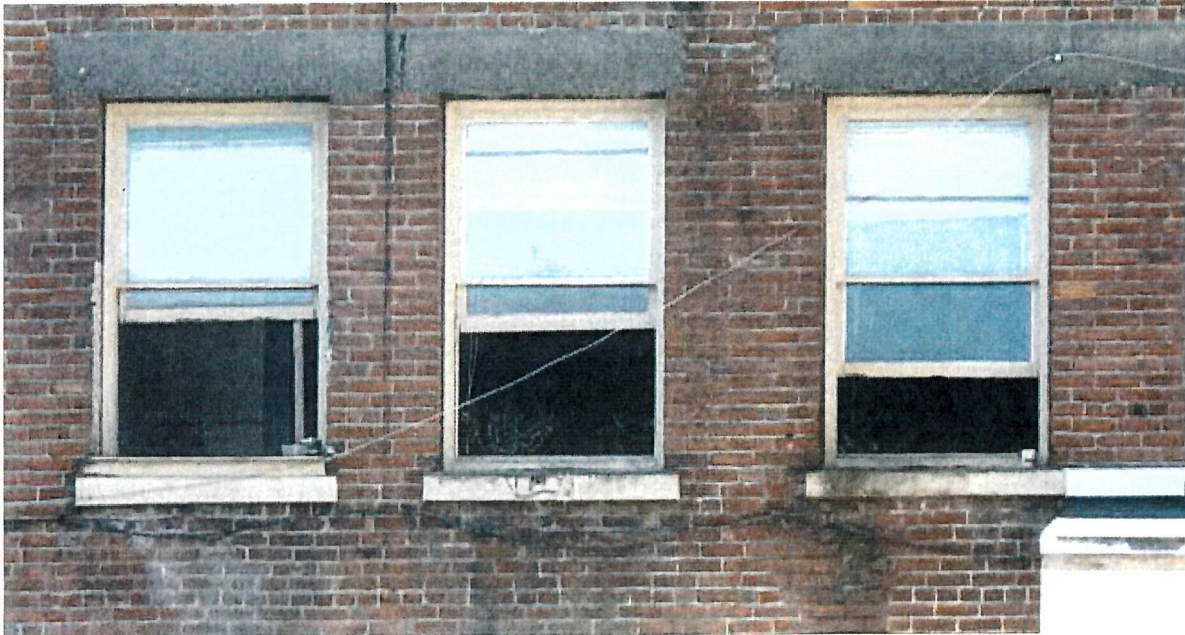
Above: Typical deterioration of masonry on rear of building including staining, cracked bricks, mortar loss, efflorescence and past unsympathetic repairs.

evident on the brick below second floor window sills and below the roof's gutter. The latter is likely the result of leaking or poorly maintained gutters that have permitted moisture to saturate the brick below the gutter. Mortar loss, past unsympathetic repointing, cracked bricks, eroded bricks, stepped cracks, roofing tar spills, and holes from past penetrations are evident at multiple locations on the "non-public" façades of the building.

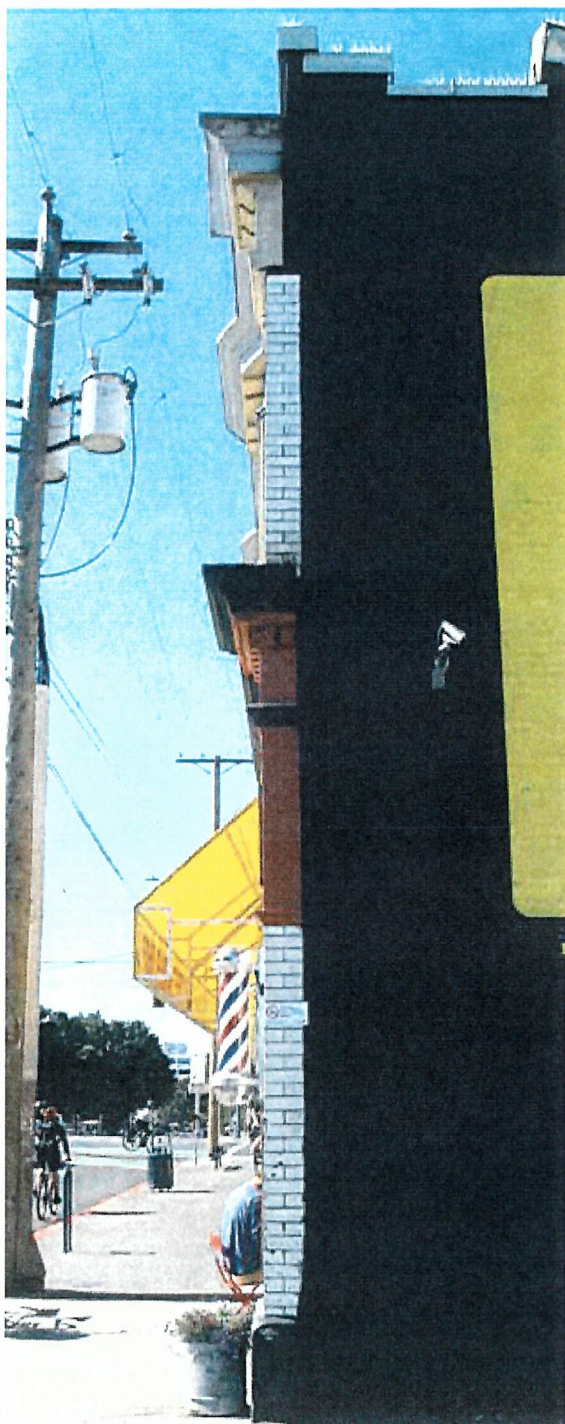
Overall the storefront cornice is in fair condition with the visual inspection from ground level identifying areas of deterioration of varying degrees. The storefront cornice appears to be well anchored to the building with no gaps from the face of the building noted. The nature of the anchoring and its adequacy was not determined, and requires further

Above: Profile of storefront and roof level cornices that are present on Pandora Avenue and Cook Street façades.

investigation. A number of dentils of the storefront cornice are damaged on both the Pandora Avenue and Cook Street sides of the building. The roof level cornice, located above the second floor windows of the Pandora Avenue and Cook Street façades, is more substantial and ornate in design than the storefront cornice. Metalwork components of the oriole windows on the second floor include metalwork detailing as part of the window surround as well as the top of the brick pilasters. This metalwork is in fair condition with localized damage and paint failure.

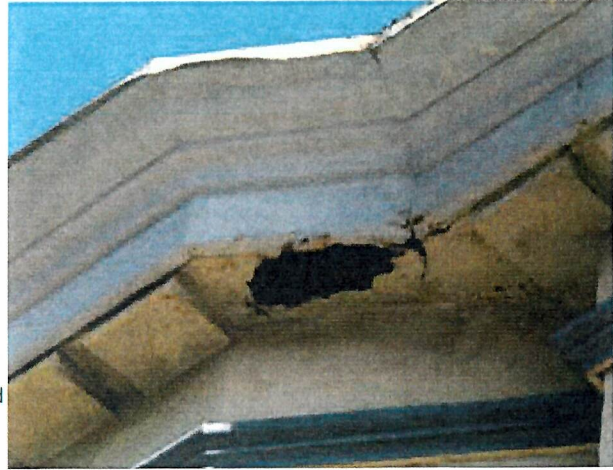
Right: Heavily corroded under side of roof level cornice and corrosion of modillions. Typical paint failure also shown.

determines they are too deteriorated to repair, remove and replace those deteriorated elements, or the entire cornice with one that matches the historic in original dimensions, design, materials, and finish.

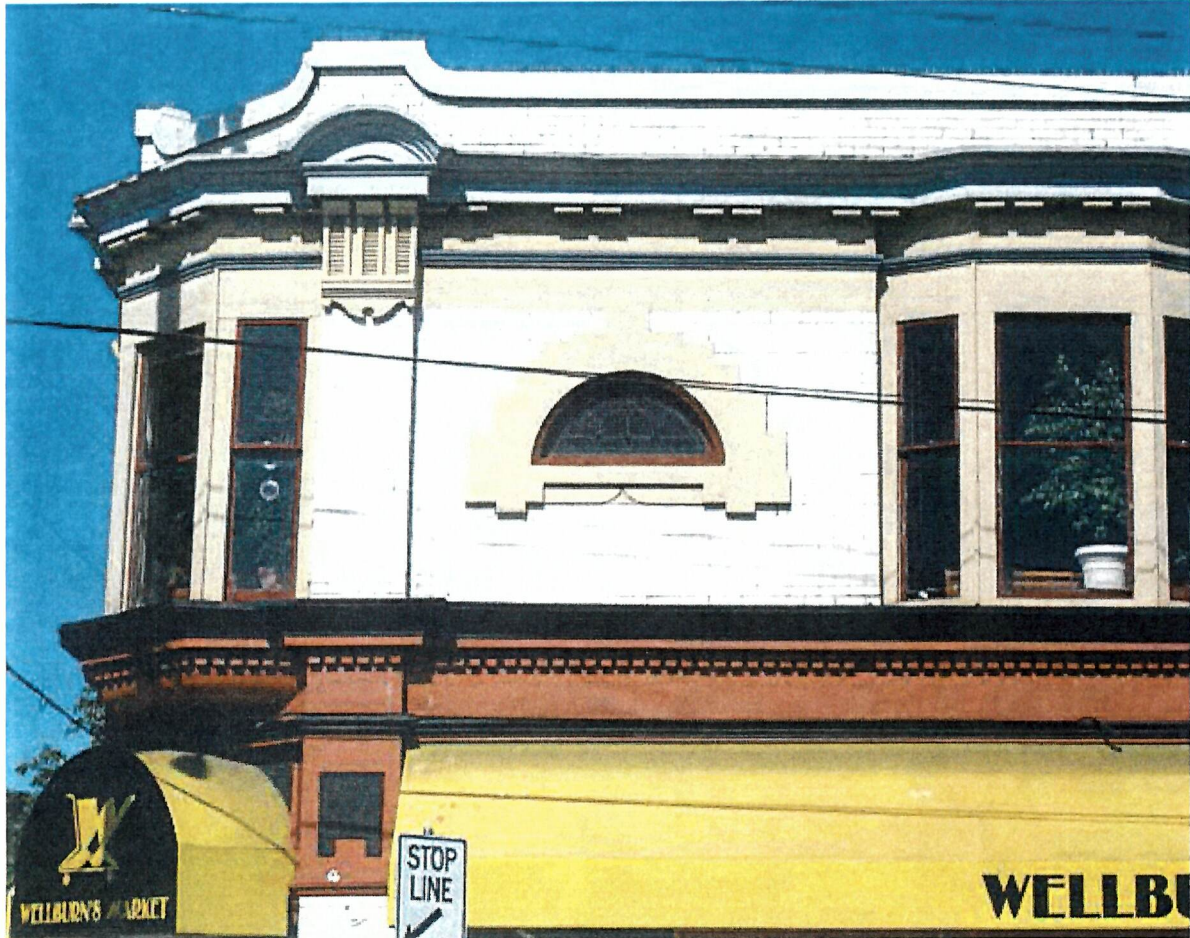
Above: Architectural metalwork of the storefront cornice, brick piers, oriole windows, roof level cornice and parapet cap.

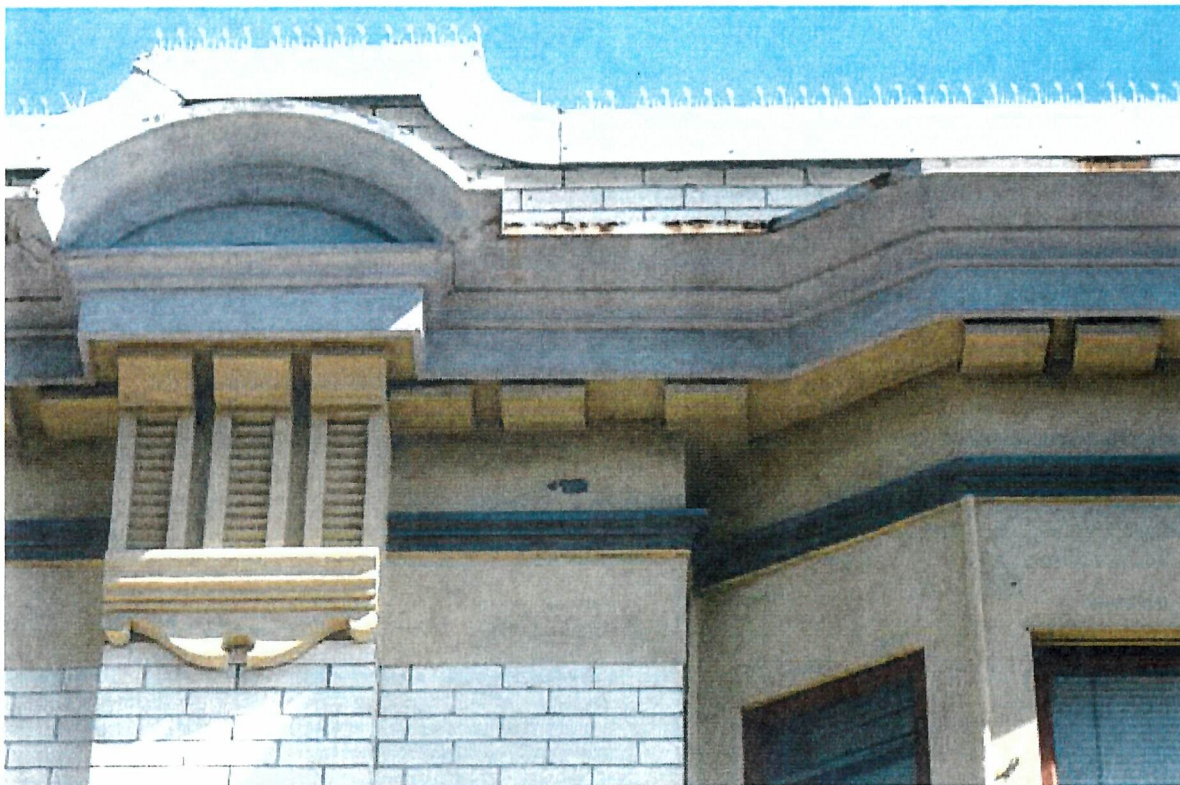
Above: Metal work of oriole windows, roof level cornice, top of brick pilasters, and parapet cap flashing. Paint failure evident and corrosion of drip edge on cap of cornice evident. Gap between parapet cap flashing and wall face noted. Bird spikes on parapet later addition.

- Evaluate the overall condition of the parapet cap flashing to determine whether more than protection, maintenance and limited repair or

- Remove corrosion that may be discovered upon close inspection, patch and repair, caulk joints as required and apply appropriate primer for galvanized surface.
- Repair or replace deteriorated flashing, as required. Repairs should be physically and visually compatible.
- Restoration of missing chimney elements that were associated with the pairs of conical element on raised portions of parapet.
- If new flashings are installed, ensure that the colour is compatible with the overall colour scheme of the historic resource.
- Consider alternative pest (bird) deterrent option that is less visible on the “public” façades.

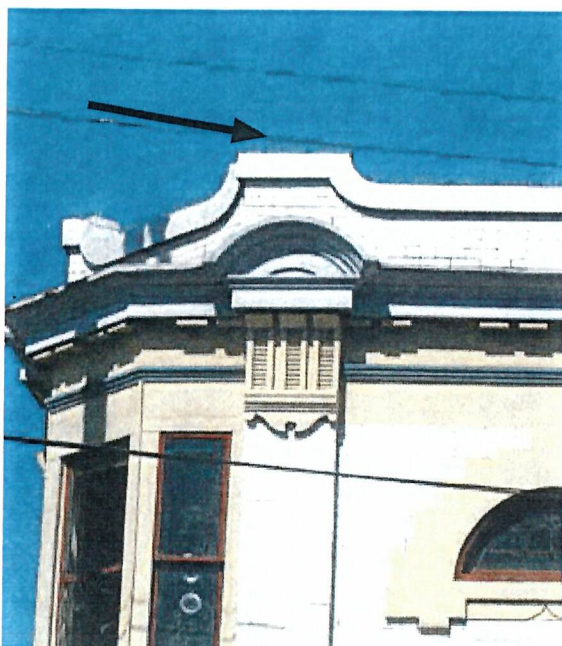
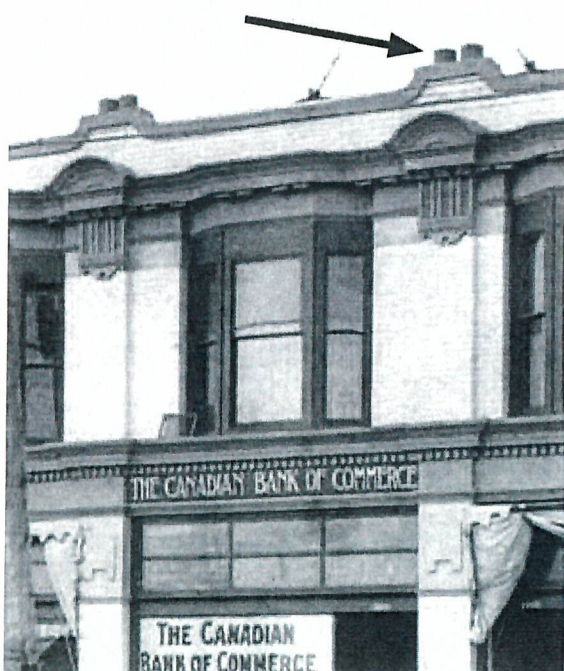
Above and Below: Pairs of cylindrical elements that were once present on top of each raised section of the parapet along the Pandora Avenue and Cook Street façades. These were removed post-1960, perhaps at the time the cap flashing was replaced and/or bird spikes installed.

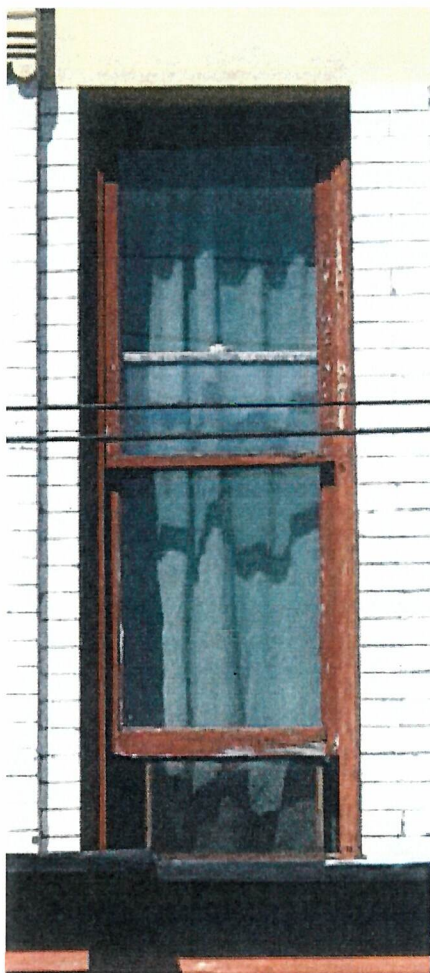
Above Left: Typical second floor wood sash and frame hung window. Typical example of condition of wooden elements and finish of windows on upper floor.

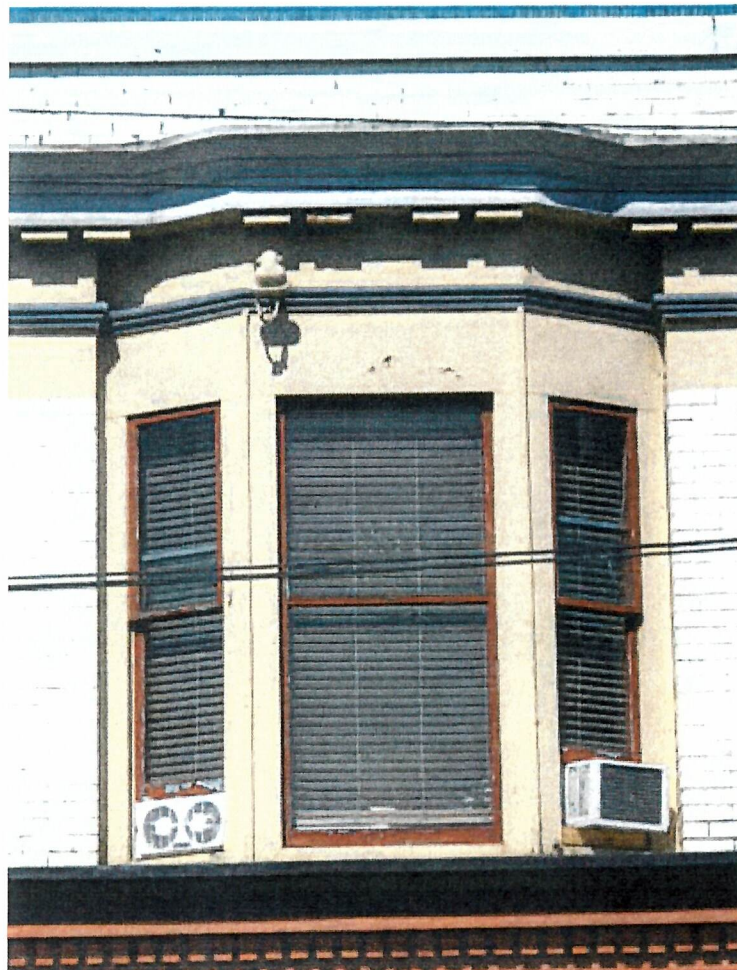
Above Right: Oriole bay window with wood sash and frame hung windows on either side of a fixed wood sash and frame window. Metal window surround present on all oriole windows. Shown condition of wood and metal typical of all oriole windows.

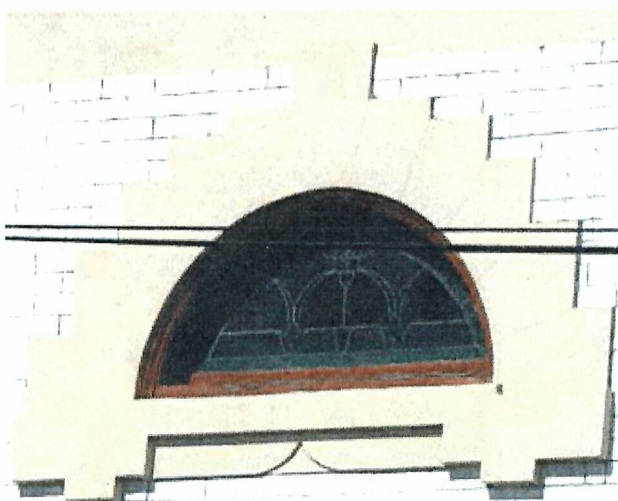
Left: Half-moon wood frame and sash window with leaded glass panel and decorative window surround. Leaded glass panel with rough rolled coloured glass in good condition no missing or broken glass noted. Painted finish on wood elements deteriorate. Cracks in window surround noted.

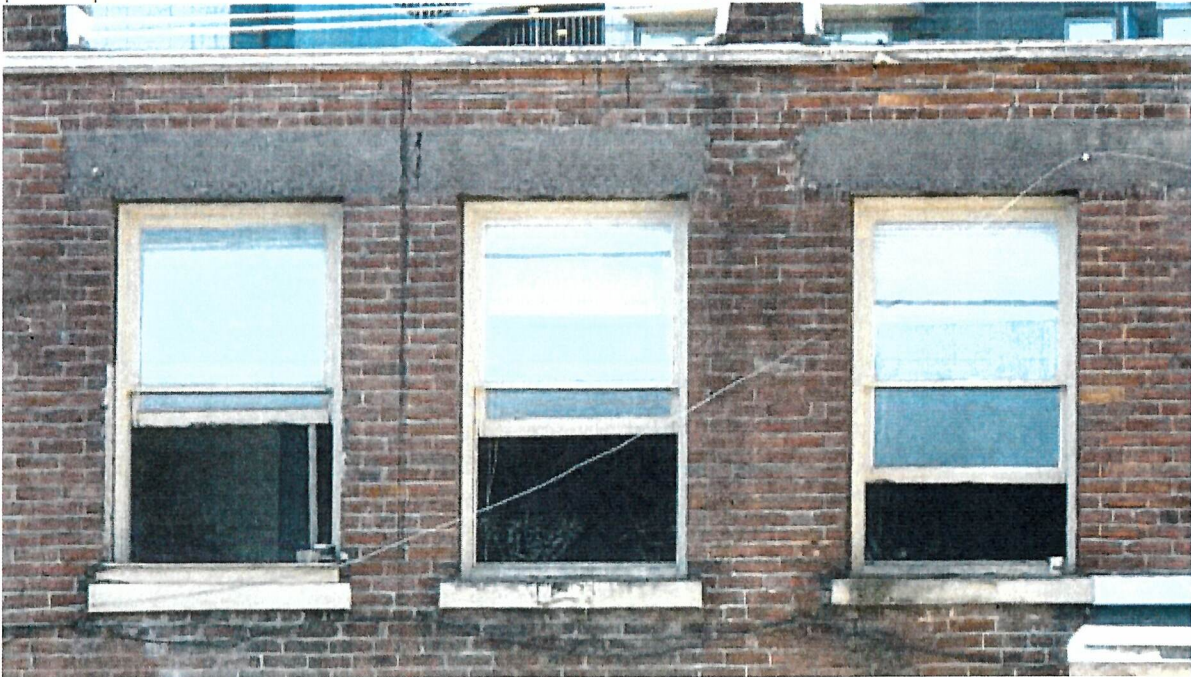
Based on a visual inspection from the ground the lower sections of the stiles, bottom rail of the lower sashes, and sills show signs of deterioration. This

Above: 1-over-1 hung wood sash and frame windows on rear of building. Most windows appear to still have an operable lower-sash, unknown if upper-sash can be lowered. Concrete lintels span one to two window openings. Deterioration evident on sills lower jambs, bottom rail. Localized areas of paint failure present. Staining on and around brick sills.

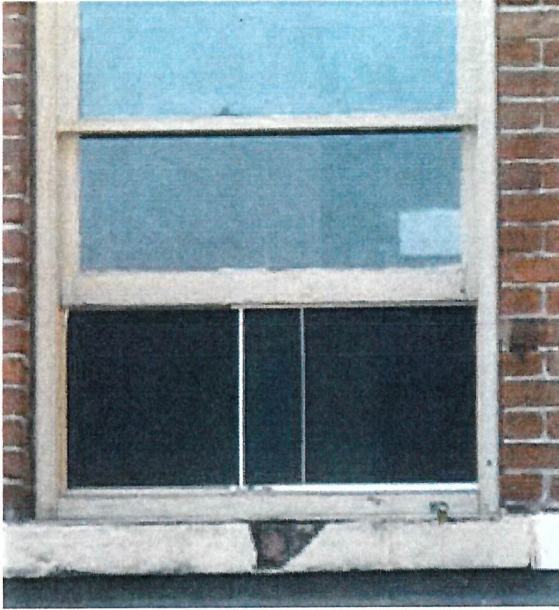
Above: Parge brick sill of rear façade window showing deteriorated parging.

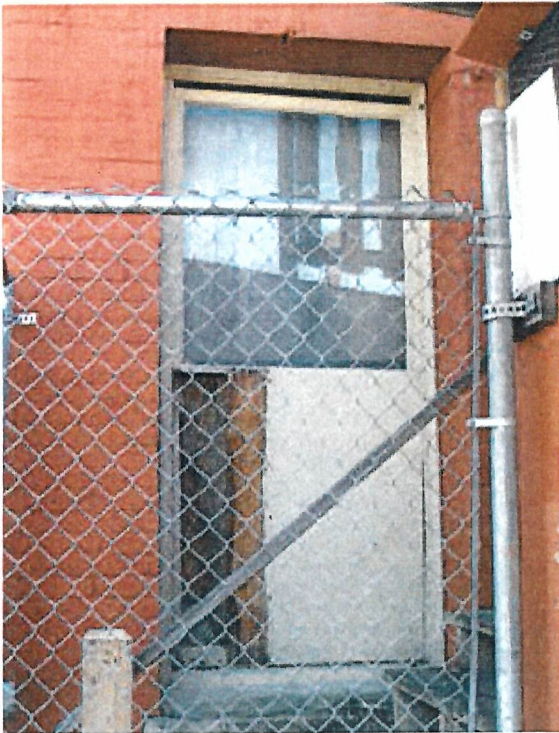
Below: Window on ground floor of rear façade with missing glass and loose upper sash.

deterioration is most evident on the second floor windows. Some glazing has been replaced. Those first floor windows that are visible possess either broken or missing glass with wood installed in its absence. The painted finish of all windows has deteriorated with peeling paint present.

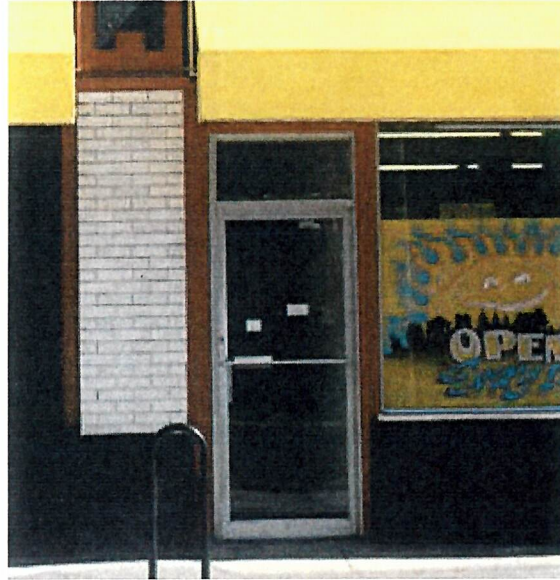
Above: Original door opening on Pandora Avenue façade providing access to second floor. Floor in entry retains penny-tiles mosaic. Door assembly has been replaced with modern materials.

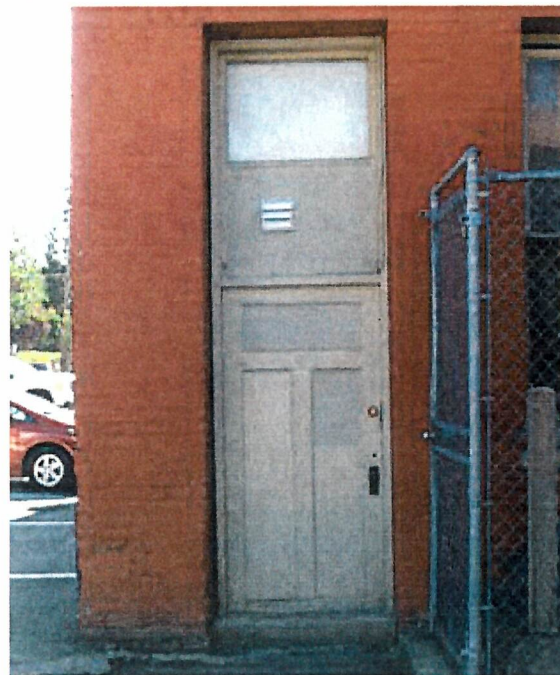
Below: Wood door, frame, and transom on rear façade ground floor intact. Transom glass removed and/or boarded over. Brass hardware of door intact. Lower extent of door and sill shows signs of deterioration.

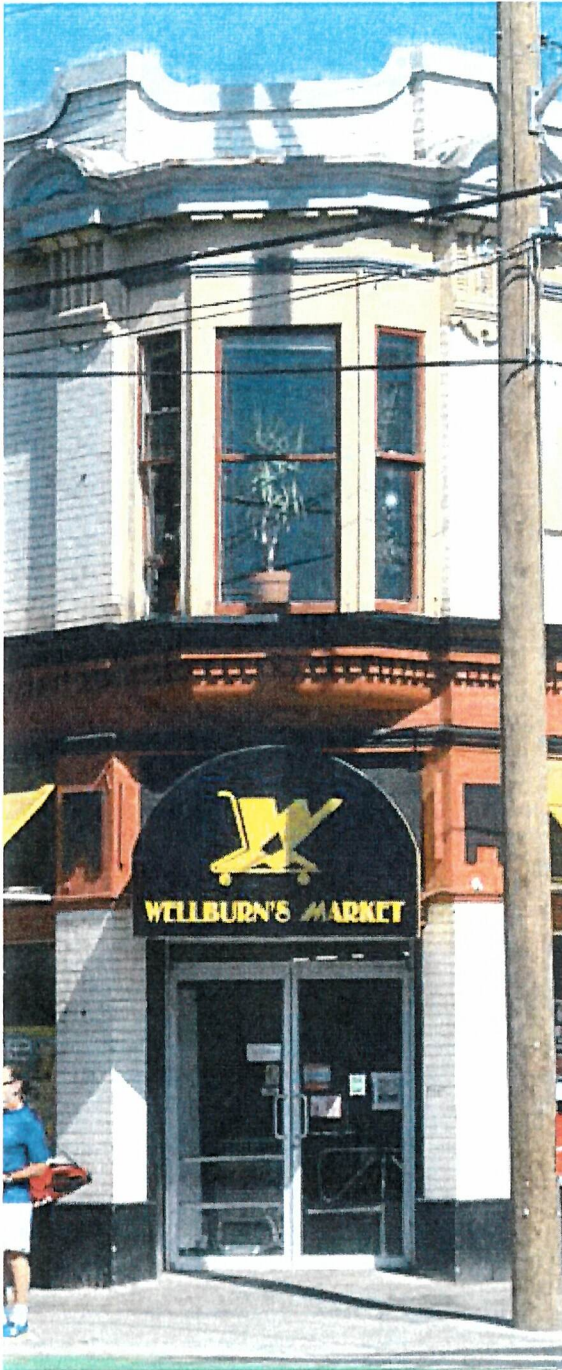
Above: Chamfered entry on ground floor with double doors and transom. Historic assembly has been replaced with aluminum assembly, including transom.

The location and configuration of the chamfered corner entry remains intact; however, the transom and double doors have been replaced with aluminum assemblies. New awnings have also been added on both street façades. Further investigation is required to determine the extent, if any, of original materials that remain obscured by later interventions.

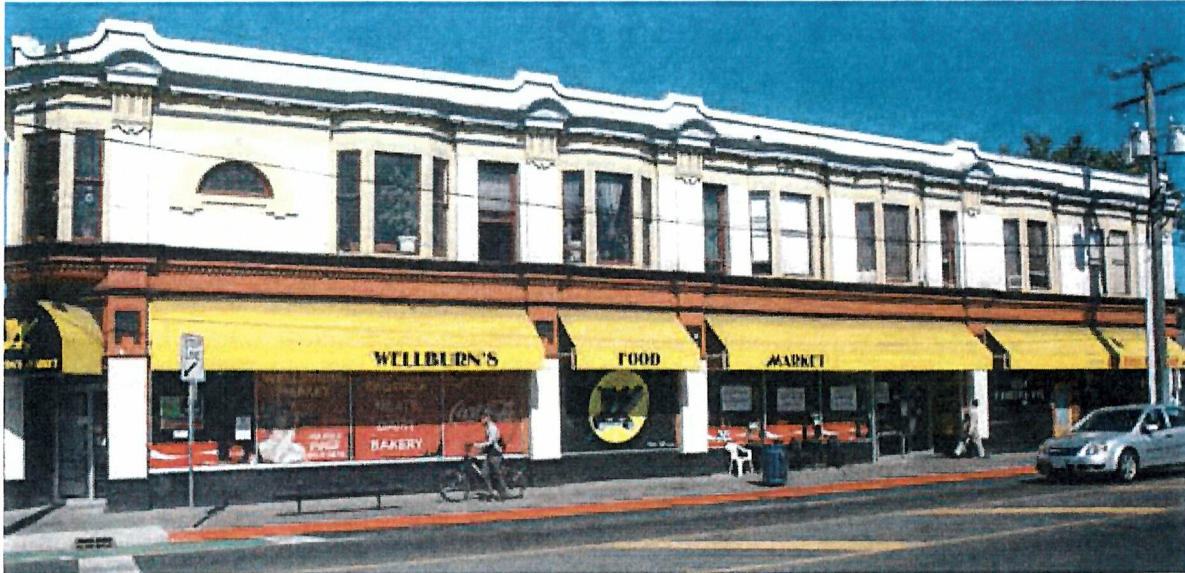
Above: Ground floor storefronts of Cook Street with original storefront design and assemblies altered and/or removed.

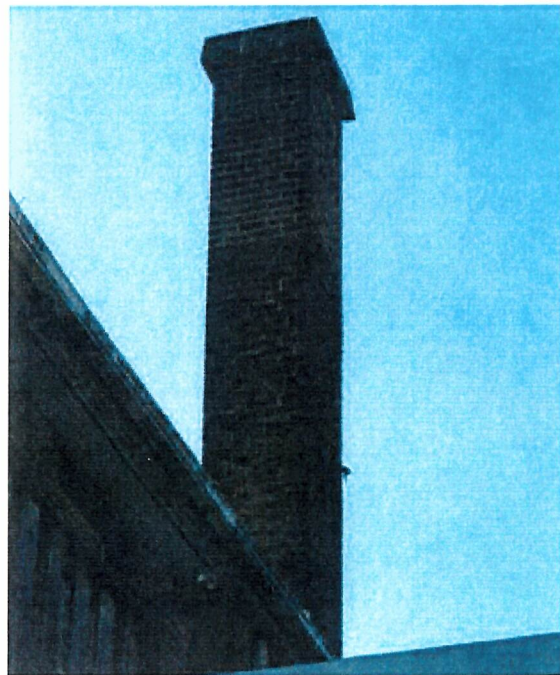
Above: Brick chimney with concrete cap. With proposed demolition of building, chimney brick could be salvaged for reuse.
