Art Gallery of Greater Victoria

Renewal Project

Construction Impact Assessment & Tree Preservation Plan

Jobsite Property: 1040 Moss St, Victoria, BC
Date of Site Visits: February 5 - March 8, 2019
Site Conditions: No ongoing construction activity. Recent road repair and root loss observed adjacent to Sequoia #261. Exposed rock outcrops visible and surface roots from Garry Oaks; limited soil volumes likely in areas.

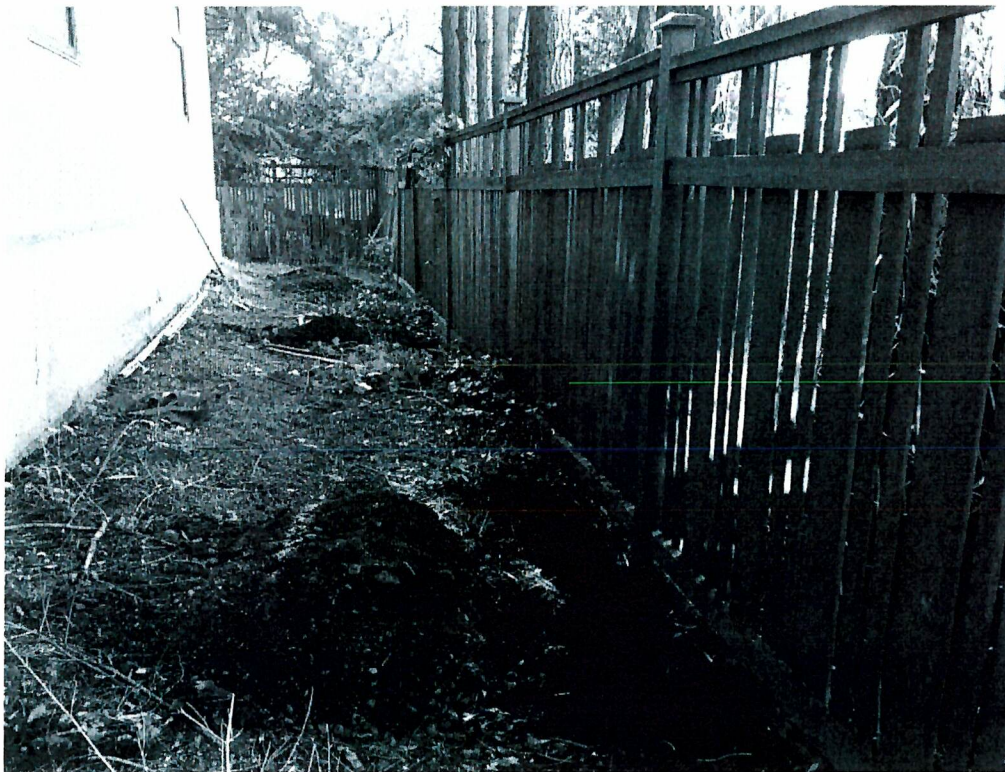
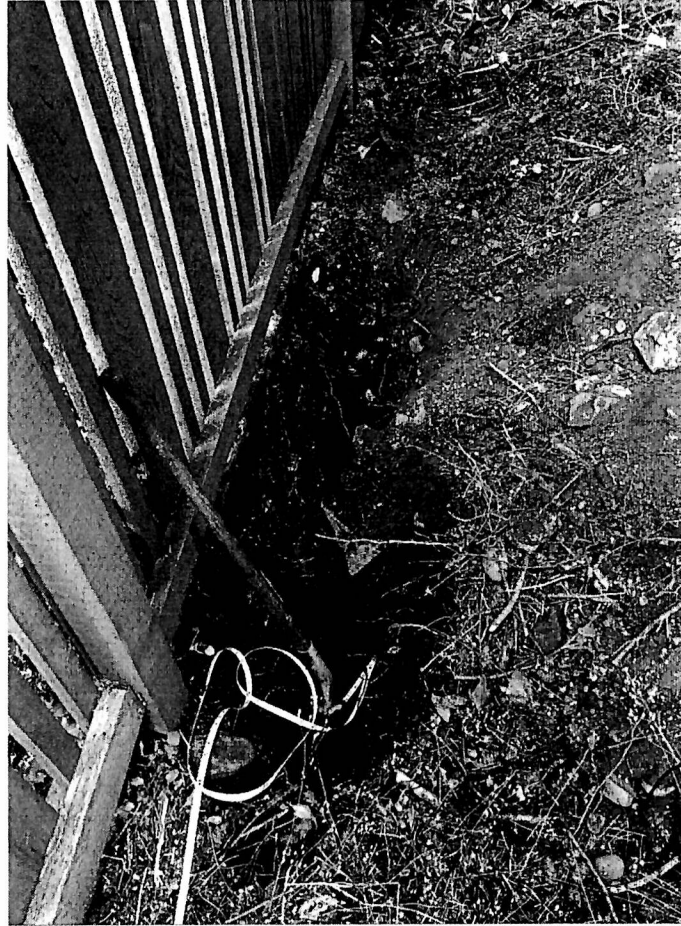
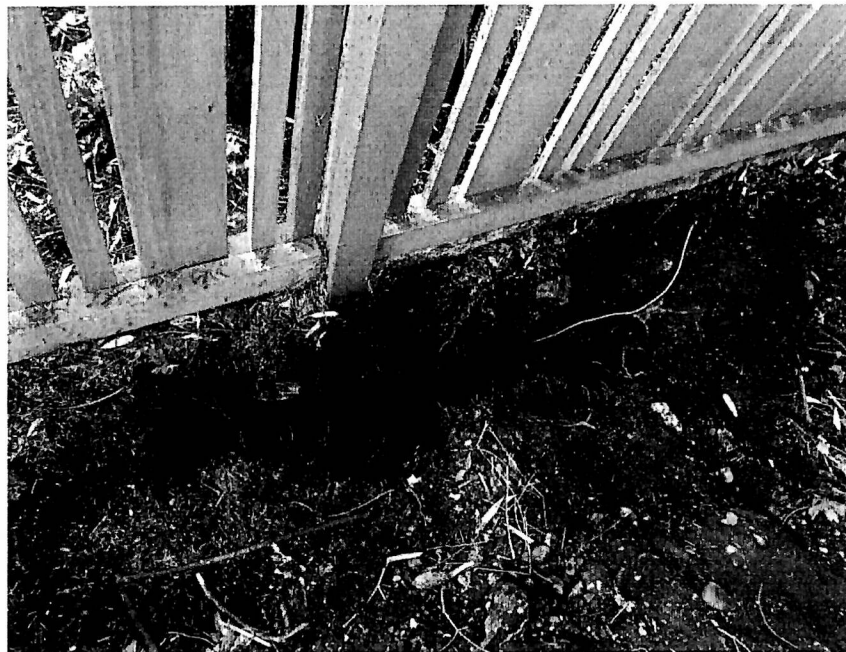
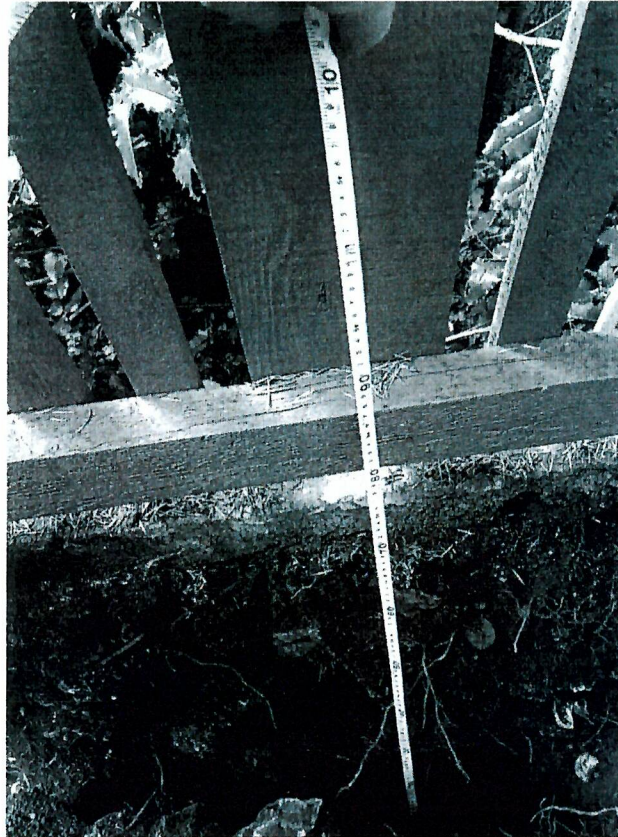
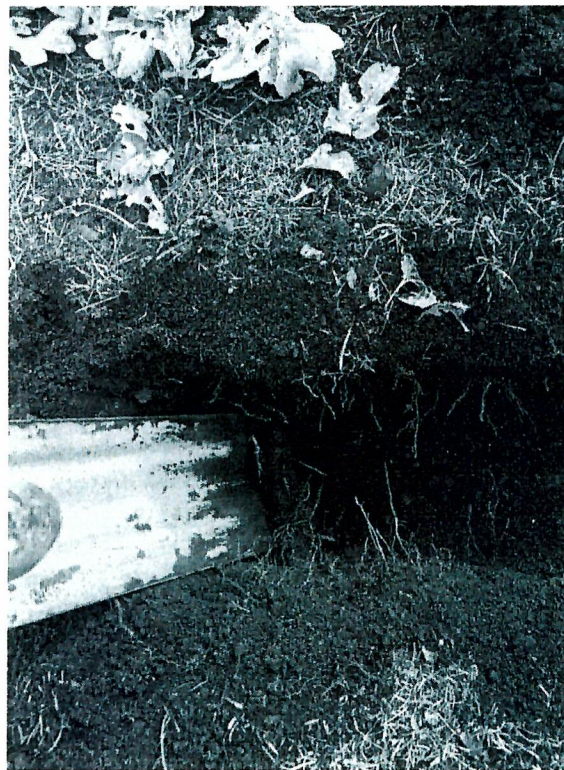
Exploratory Excavation Photos

* Exploratory excavations were conducted beside the retaining wall to determine if roots had grown underneath the wall and if the trees could be significantly impacted by the proposed excavation for the storm drain (if replacement is required), underground hydro and foundation excavation. Photos are attached to this report.

* Three trenches were hand-dug directly beside the wall in front of the largest firs in the row with trenches located roughly at the south, middle and north end of the row. The trenches were approximately 1.5m in length and reached an average of 75cm in depth. Rocks were encountered throughout which made excavation not possible in certain areas. Only two 1cm Douglas-fir roots were observed and a low density of small fibrous roots that may have been from the firs and grew through small cracks in the wall. It is possible that roots have grown below the exposed trenches or between the trenches in the areas not excavated, but based on the observations of the areas exposed, we anticipate the wall and rocks have deflected most root growth away from the art gallery property and that these trees can be retained. We recommend an arborist supervise the excavation and the new retaining wall avoid root loss as per the recommendations below.

A new retaining wall will likely be required as the grade of the walkway in this area will be raised above the existing wall. If these trees are retained, excavation for the new retaining wall should avoid root damage. Either of the following design options will accomplish this:

2-3cm diameter root encountered close to the surface from oak #277.

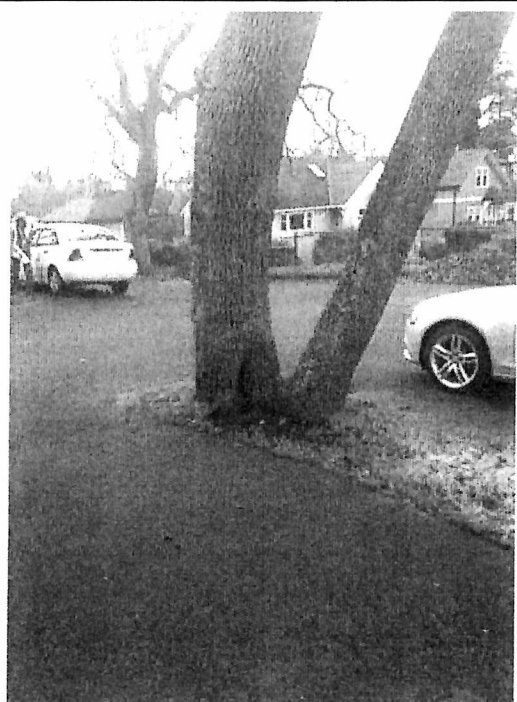
Garry oak #0299

We have recommended that the paving of the parking lot allow for proper future buttress root expansion, especially for trees #300, 297 and 294. The paving west of #300 has been shifted away from the trunk by 60cm. However, space limitations to accommodate onsite parking stalls prevented more space around the trunks of trees being given. We have recommended protection be installed around the lower trunks of #299 and 300 in order to prevent further vehicle damage.

Protective hoarding (3-4m in height) should be installed around the trunks of #278 and 288 and be clearly visible to machine operators in order to avoid potential trunk damage. Similarly, the trunks of #299 or 300 should be protected if machinery is expected in this area.
