***SouthShore Forest Consultants***

**Arborist Report**

Site  
1015 Cook Street– Victoria BC  
Residential Demolition and Development

## **RE: Proposed Demolition & Development Tree Assessment & Tree Protection Plan (TPP)**

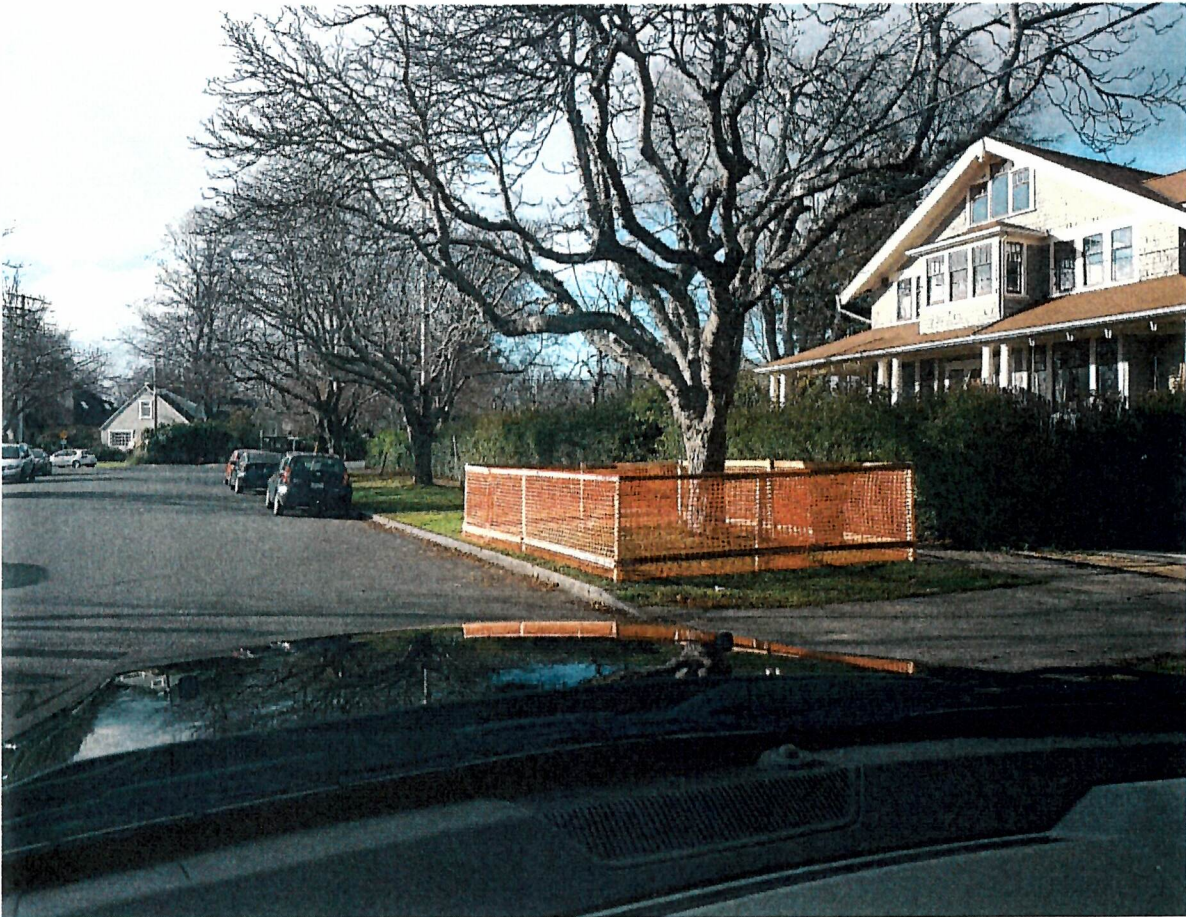
Photo #1 – Tree Protection Fencing Construction

In this photo you can observed a typical Tree Protection Fence. This type of construction is square with right angles.

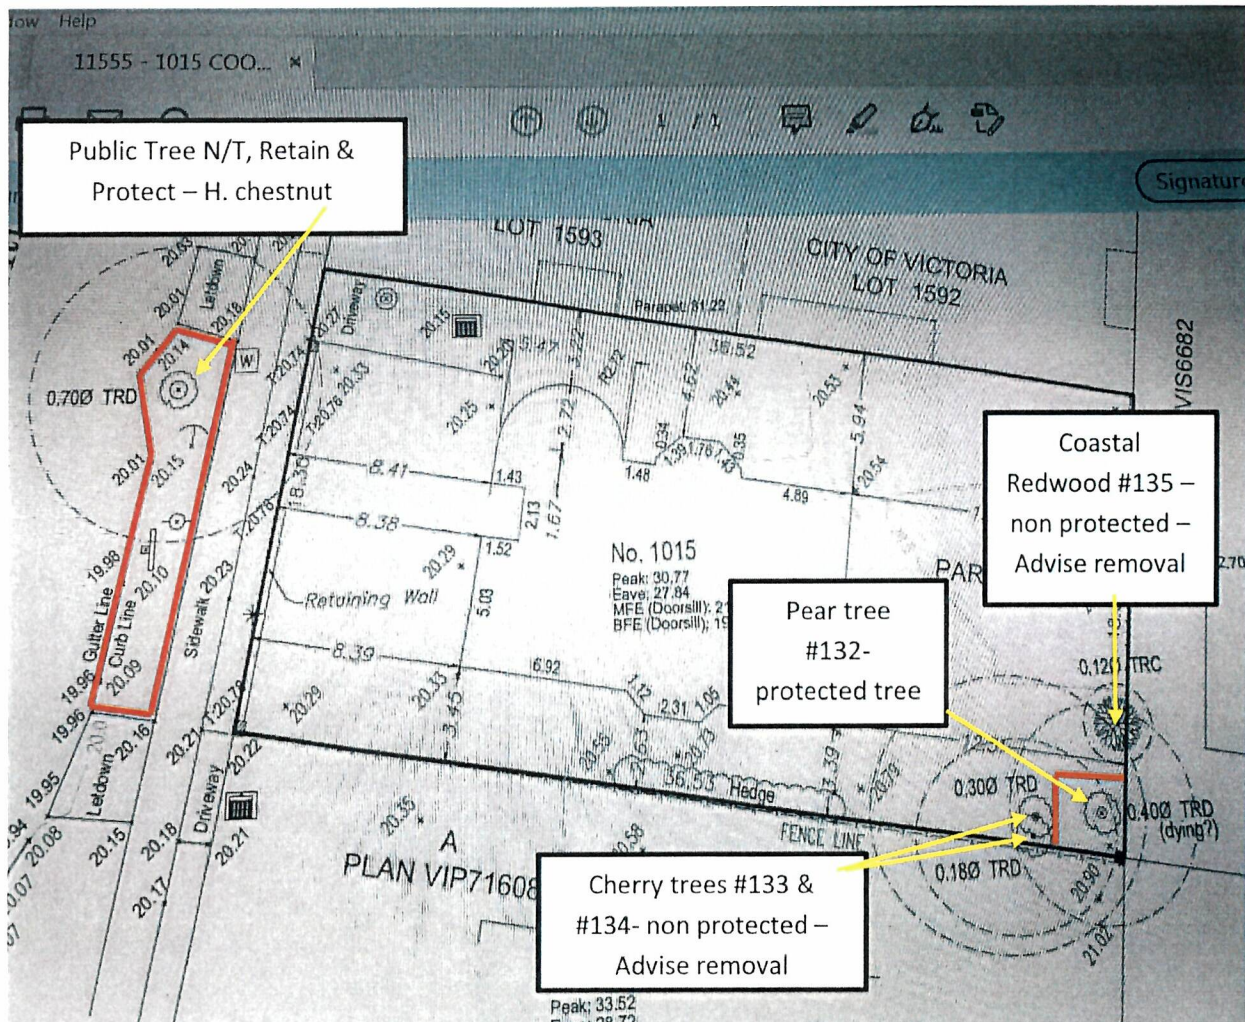
Photo #2- Tree Site Map – 1015 Cook Street

In this photo you can see the approximate positioning of the Tree Protection Fencing (TPF) indicated in red. Our observations indicate that pear tree #132 can be preserved and retained. A 5.1m setback for the proposed new structure is expected to impact a moderate portion of the trees Critical Root Zone (CRZ).

- Provide Tree Protection Fencing (TPF) for two specific locations at the site.
- (1) – N/T horse chestnut located in the Municipal Right-of Way. Erect TPF to represent similar positioning as indicated in Tree Site Map - Appendix “B” photo #2.

- (2) – pear tree #132 located in the S/E corner of the lot. Erect TPF to represent similar positioning as indicated in Tree Site Map – Appendix “B” photo #2. Provide fencing at a distance of 3.75m off of each fence/property line. This distance can be adjusted back to 4m once the excavation and foundation construction is completed. (Upon Project Arborist verification)

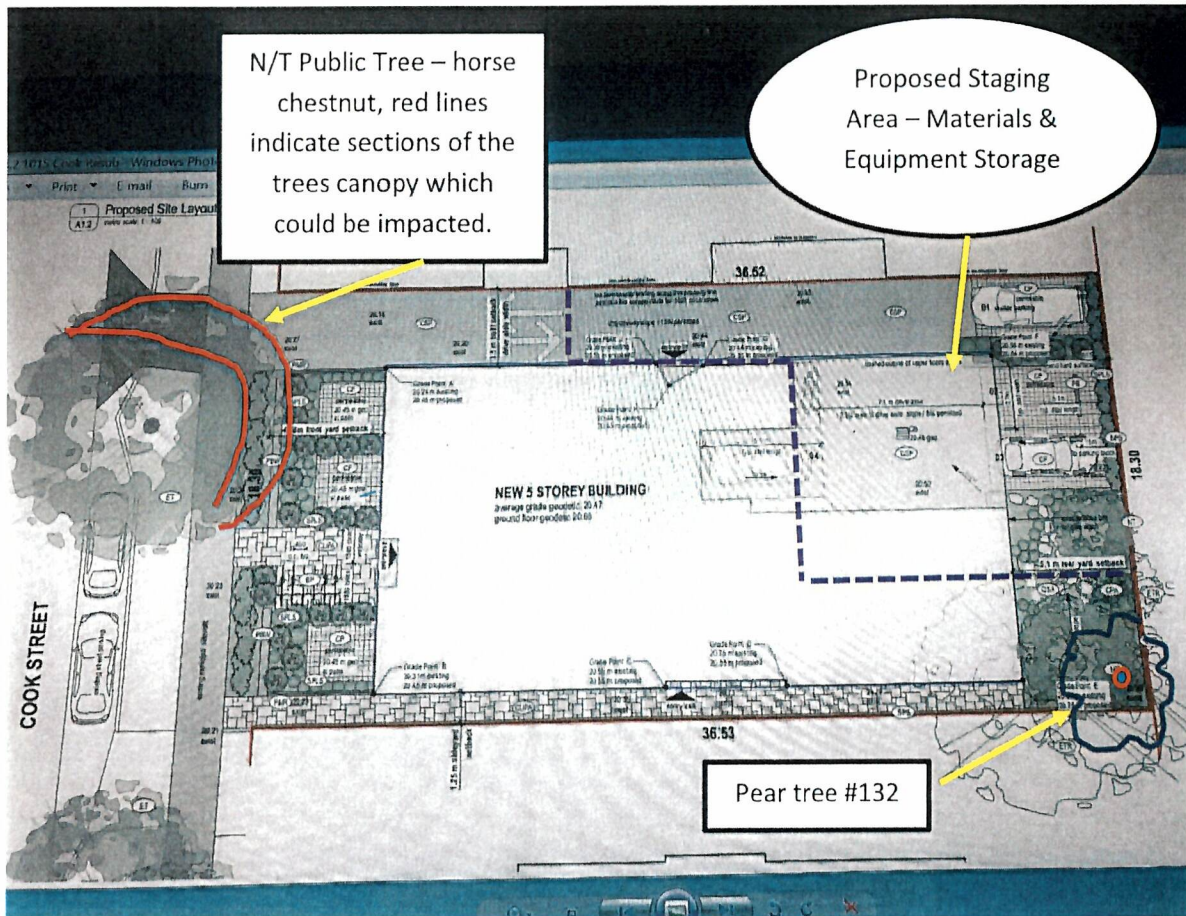
Photo # 3 – Proposed Development Layout

In this photo you can see the positioning of the proposed building within the lot. The chestnut tree will require elevation and branch reduction pruning to provide sufficient construction clearances. Pear tree #132 can be retained and may require branch reduction and elevation pruning to provide sufficient equipment clearances. Materials staging should be positioned in the N/E corner of the site (indicated by the hatched purple lines).

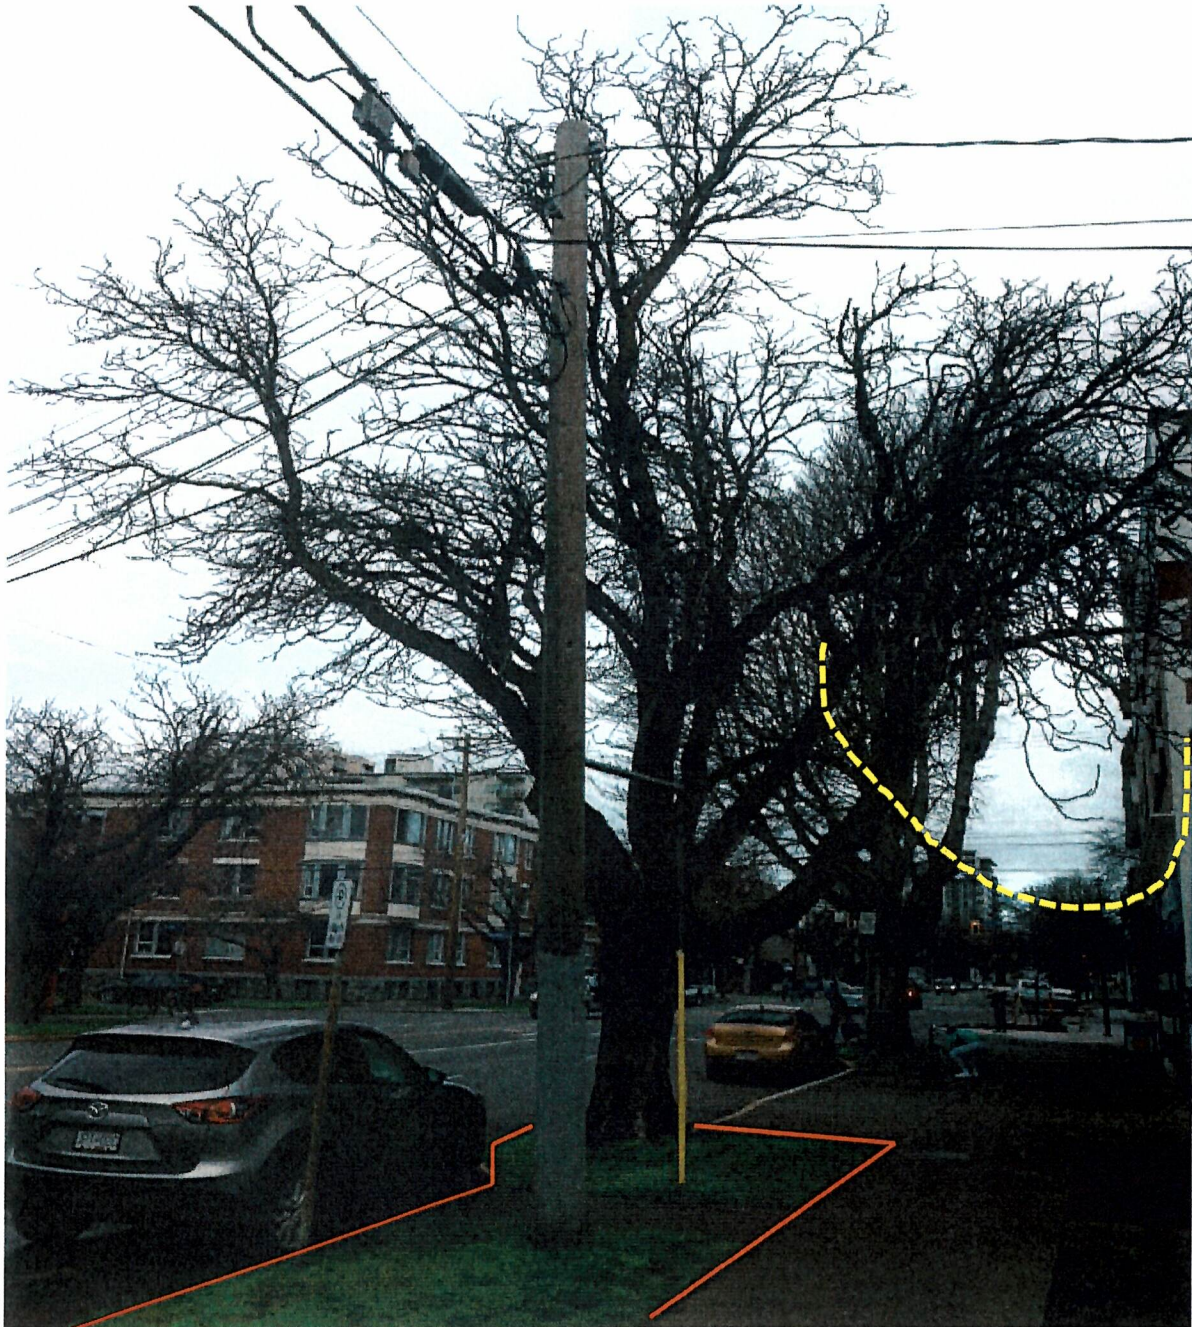
Photo # 4 – N/T Horse Chestnut – Public Tree

In this photo you can see the chestnut tree positioned in the Municipal Boulevard. The boulevard must be protected during the entire length of the project (red lines). Low branching will require pruning to allow for vehicle and materials egress, (yellow hatched line).

- Provide tree pruning to reduce, elevate and provide sufficient clearances for egress into and out of the site. This may require directional pruning to be performed on the Public chestnut tree above the sidewalk and driveway entrance off Cook Street.

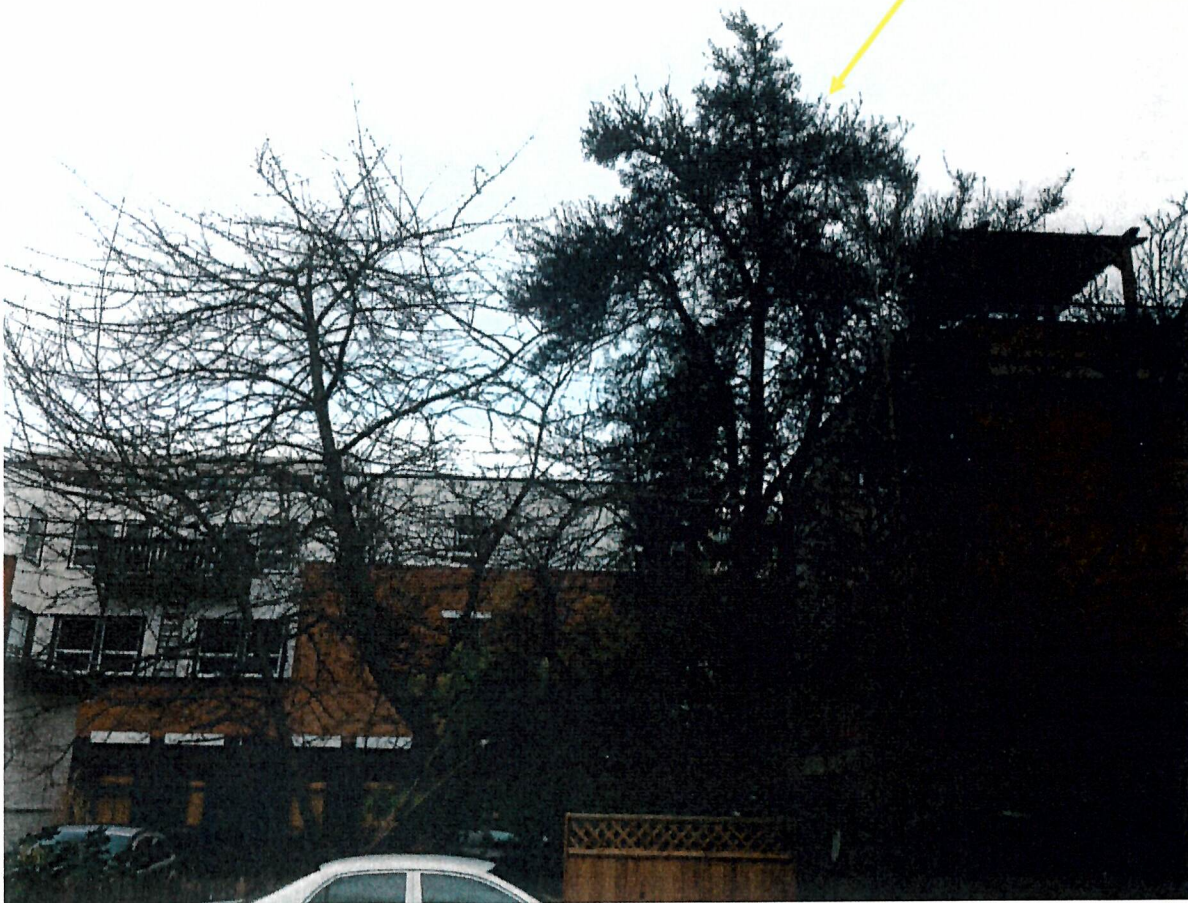
Photo #5 – Pear tree #132

Our observations indicate that pear tree #132 positioned in the rear of the property is of protected size. Measuring 41cm in diameter, the tree is protected under the current City of Victoria Tree Preservation Bylaw. Our observations indicates that the tree can be retained under the current proposal. The proposed building setback is approximately 5m back from the base of the tree. Our observation indicates that a minimum of a 4m Tree Protection Zone can be establish, maintained and utilized during the demolition and construction phase of the project. Our observations indicate that over excavation will be required during the project. The utilization of the Project Arborist to assess excavation and landscape modifications will reduce impacts to the pear tree.

In this photo you can see the pear tree #132 positioned in the S/E corner of the site. Our observations indicate that the tree can be protected and preserved. A Protected Tree, the trees diameter measures 41cm at 1.4 m above grade.

- Provide tree pruning for pear tree #132. This may require pruning to allow for branch removal to provide sufficient clearances for the proposed building setback and the maneuvering of constructive equipment. All Pruning MUST be performed by a Certified Arborist and licenced company in good standing with the City of Victoria’s Park Department.

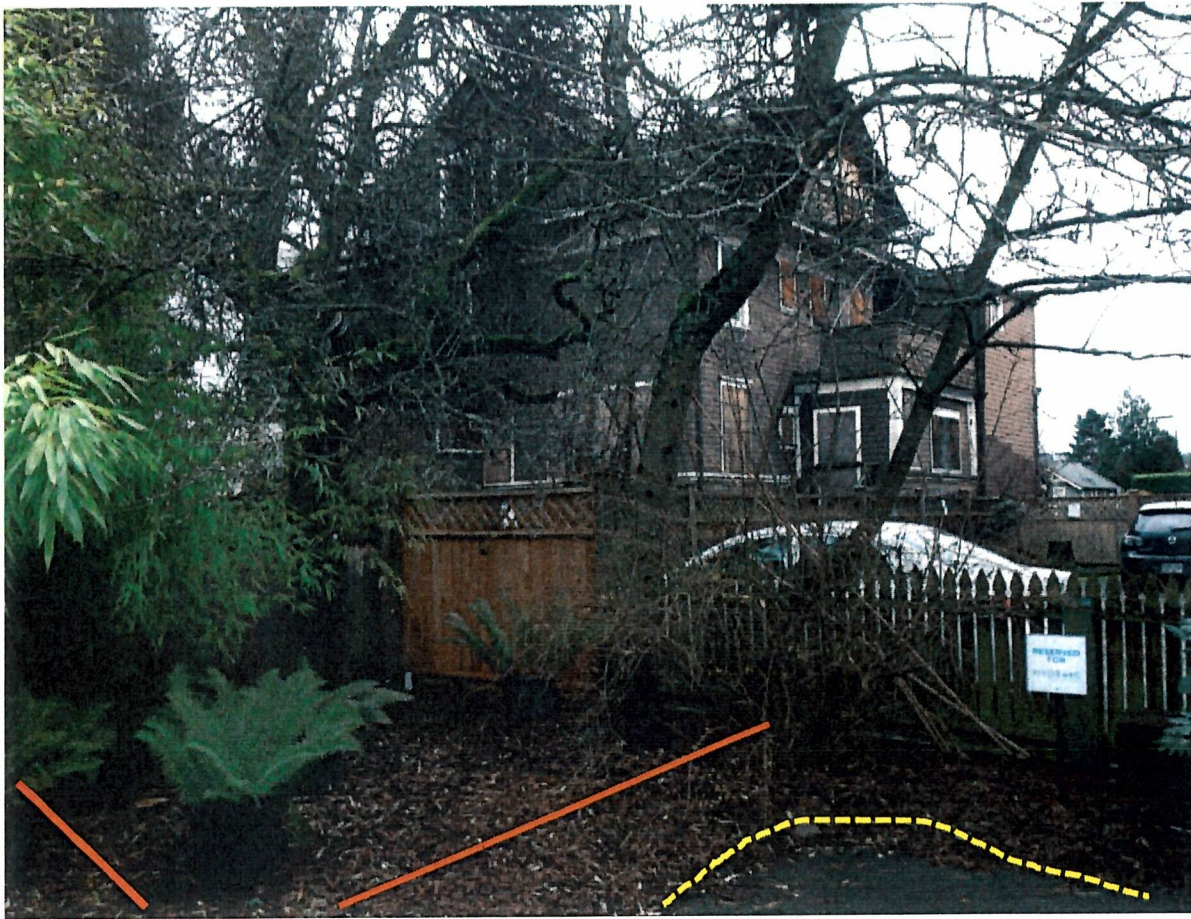
Photo #5 – Rear Yard, S/E Corner

Our observations indicate that three (3) trees located in the rear (S/E) corner of the property are of non-protected size. Each of the three trees, #133, #134 & #135 can be removed by the client. No municipal permitting is required.

In this photo you can see an existing driveway pad (yellow outline) and three trees. Pear tree #132 is in the corner of the lot. The red lines indicate the approximate positioning for the installation of the TPP.
