FRASER WAREHOUSE

1316-18 WHARF STREET, VICTORIA, BC

CONSERVATION PLAN

MAY 2019

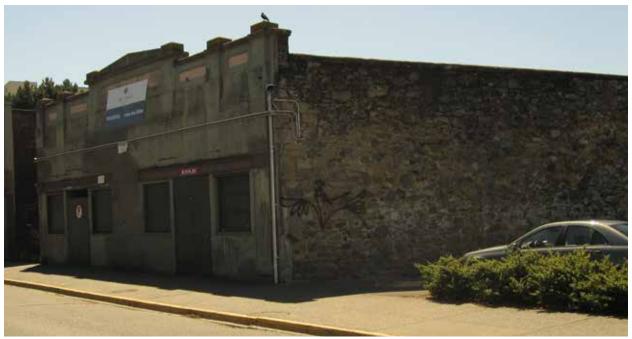
Current front elevation with late applied stucco of the Fraser Warehouse.

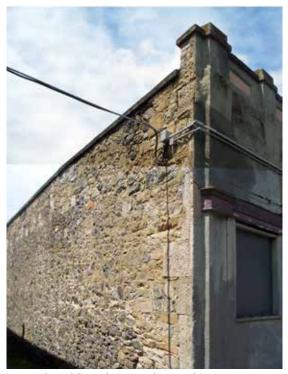
Current side and front elevations showing the stone construction with quioning on the corner Fraser Warehouse

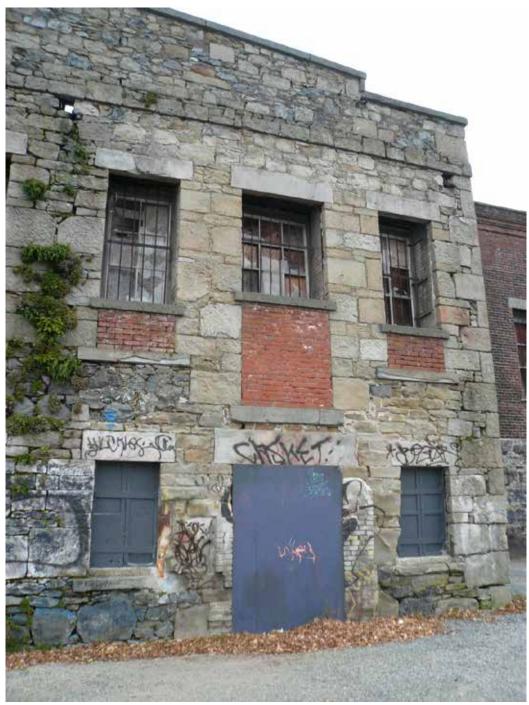
Rear elevation of the Fraser Warehouse showing openings altered using brick, changes to window assemblies, and general condition of masonry.

The existing window openings on the rear façade show be preserved and the later added brick removed. Archival photographs of the façade can be used as guides for the replacement windows. For the front façade, the infills and other alterations made will need to be investigated and later stucco removed to clarify what the original design was. Contextual photographs of comparable buildings and façades should be used to develop a sympathetic and reasonable front façade that would be in keeping with the historic aesthetic of the building.

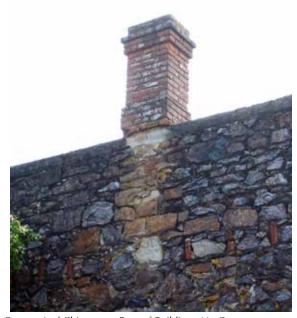
The cap flashings on the Fraser Warehouse are limited in there coverage. Absence of flashing to shed water and protect the masonry façade or interface with the roof assembly has contributed to deterioration, organic buildups, mortar loss, and staining. Locations where flashings are absent, new

Parapet And Chimney at Rear of Building - No Cap Flashing Noted

- Evaluate the overall condition of any intact parapet cap flashing to determine whether more protection is required, or replacement in kind is required.
- Repair or replace deteriorated flashing, as required. Repairs should be physically and visually compatible.
- If new flashings are installed, ensure that their design and colour is compatible with the historic masonry façades.
