# Arboricultural Inventory and Report

Crosstown Properties (Wharf Street) Ltd.

1314 & 1318 Wharf Street

Date: October 17<sup>th</sup>, 2019

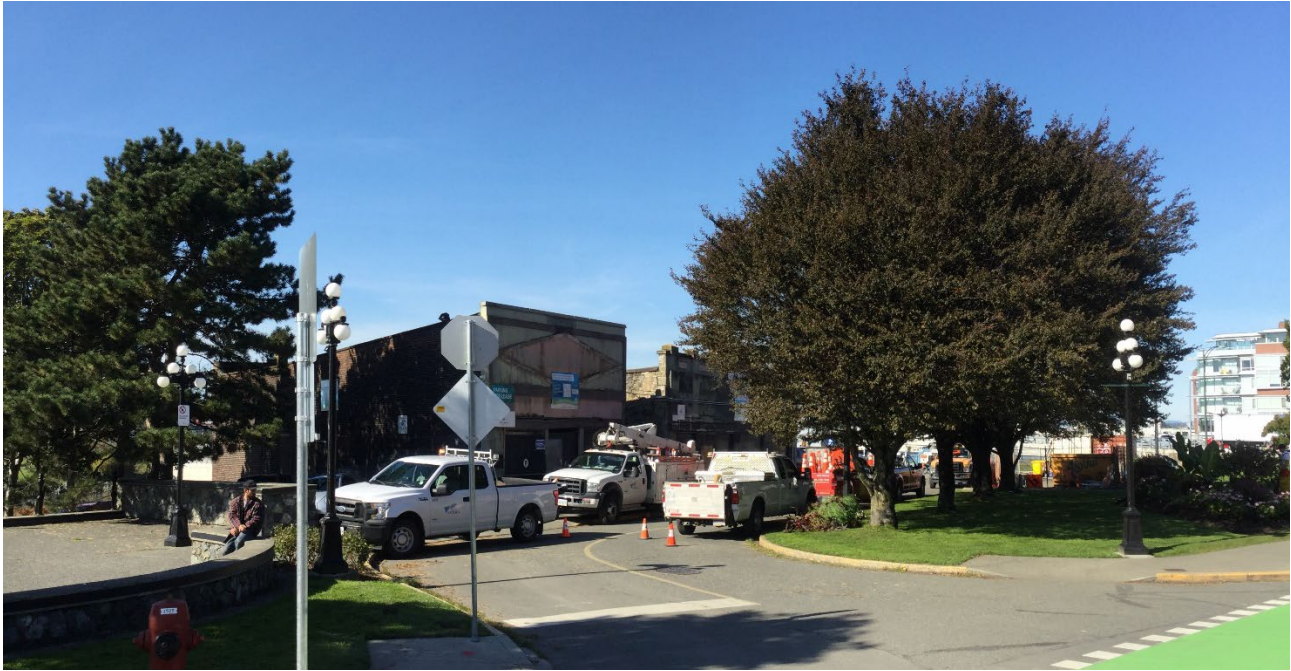
Four City-owned purple European beeches were growing in a row approximately 2.5 m the east of the Wharf Street Connection curb (Photos 1 and 7). No major root collar or trunk defects were observed, however the branching of this cultivar is dense and moderately upright from acute branch unions with included bark. These unions currently appear to be stable. The crowns have been raised to 2 m and are generally rounded and symmetrical. All four beech trees were assessed to have *moderate* health and structure ratings because of their abundant acute branch unions, but retention value was assessed to be *high* on account of their good overall health, form, and prominent position in the surrounding landscape.

Photo 1. The subject site viewed from Wharf Street.

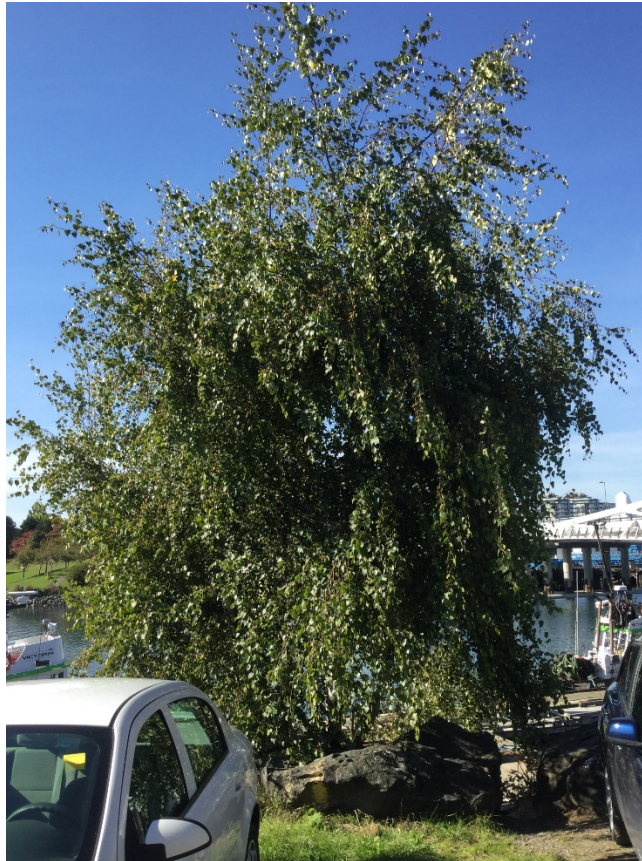
Only one on-site tree was identified in the inventory. It is a small multi-stemmed silver birch growing from a decayed stump among rocks at the harbor edge. We assessed this tree to have a *poor* health and rating and *low* retention value (Photo 2).

| Tag # | Location | Species Common Name | Botanical Name | DBH (cm) | Height (m) | LCR | Dripline Radius (m) | Health and Structure Rating | Comments | Retention Value Rating | Retain/Remove | Retention/TPZ Comments | *TPZ (m) |
|---|---|---|---|---|---|---|---|---|---|---|---|---|---|
| 887 | On-Site | Silver Birch | Betula pendula | 30 | 5 | 60-79% | 3 | Poor | Unsurveyed tree. Growing at top of steep bank among large boulders. Naturally regenerated. Three 10 cm DBH stems from broken decayed stump. | Low | Remove | Tree health and structure is unsuitable for long-term retention and will conflict with proposed deck. | 3.6 |

Photo 2. Tree 886 growing from boulders in the harbor wall.

The one on-site birch tree (number 887, Photo 2) is proposed for removal on account of its poor health and structure and conflicts with a proposed deck. Similarly, the one privately-owned off-site birch tree (number 886, Photo 3) is also proposed for removal. This tree currently grows among boulders in a steep bank approximately 3 m from the on-site building. We expect that any excavation work around the on-site building foundation will conflict with and potentially destabilise this tree. In addition, there will be moderate crown conflicts with the proposed deck. Removal of this tree will require written permission from the off-site property owner.

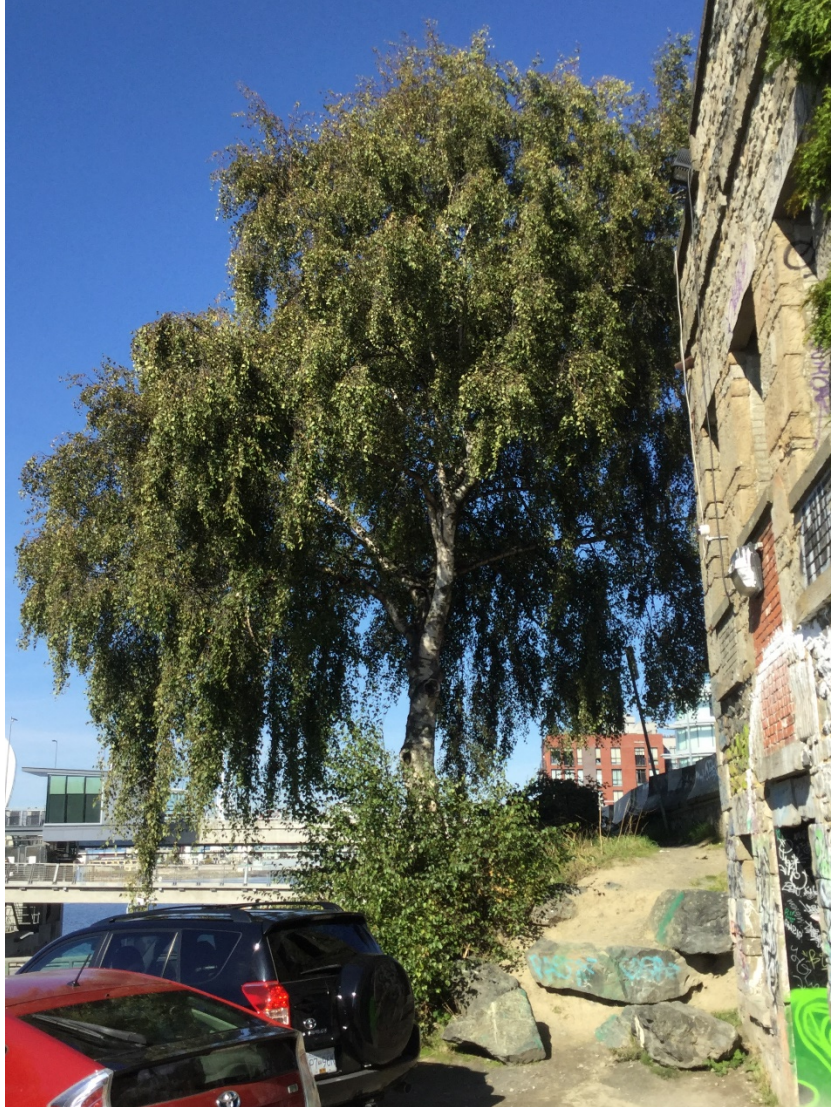
| Tag # | Location | Species Common Name | Botanical Name | DBH (cm) | Height (m) | LCR | Dripline Radius (m) | Health and Structure Rating | Comments | Retention Value Rating | Retain/Remove | Retention/TPZ Comments | *TPZ (m) |
|---|---|---|---|---|---|---|---|---|---|---|---|---|---|
| 886 | Off-Site | Silver Birch | Betula pendula | 42 | 12 | 60-79% | 6.3 | Poor | Growing at top of steep bank among large boulders. Likely naturally regenerated. 3 m from building corner. Multiple medium-sized pruning wounds in trunk with decay cavities developing. Structural unions are good. Over-extended branch to north. Crown full and healthy. Drip line 6.3 m N, 5.6 m E, 4.7 m S, 5 m W. | Low | Remove | Tree is likely to be destabilised by expected excavation around existing building envelope and crown will conflict with proposed deck. Owner's permission required for removal. | 5 |

Photo 3. Tree 886 growing from among boulders at the top of the harbor wall at the north west corner of an on-site building.

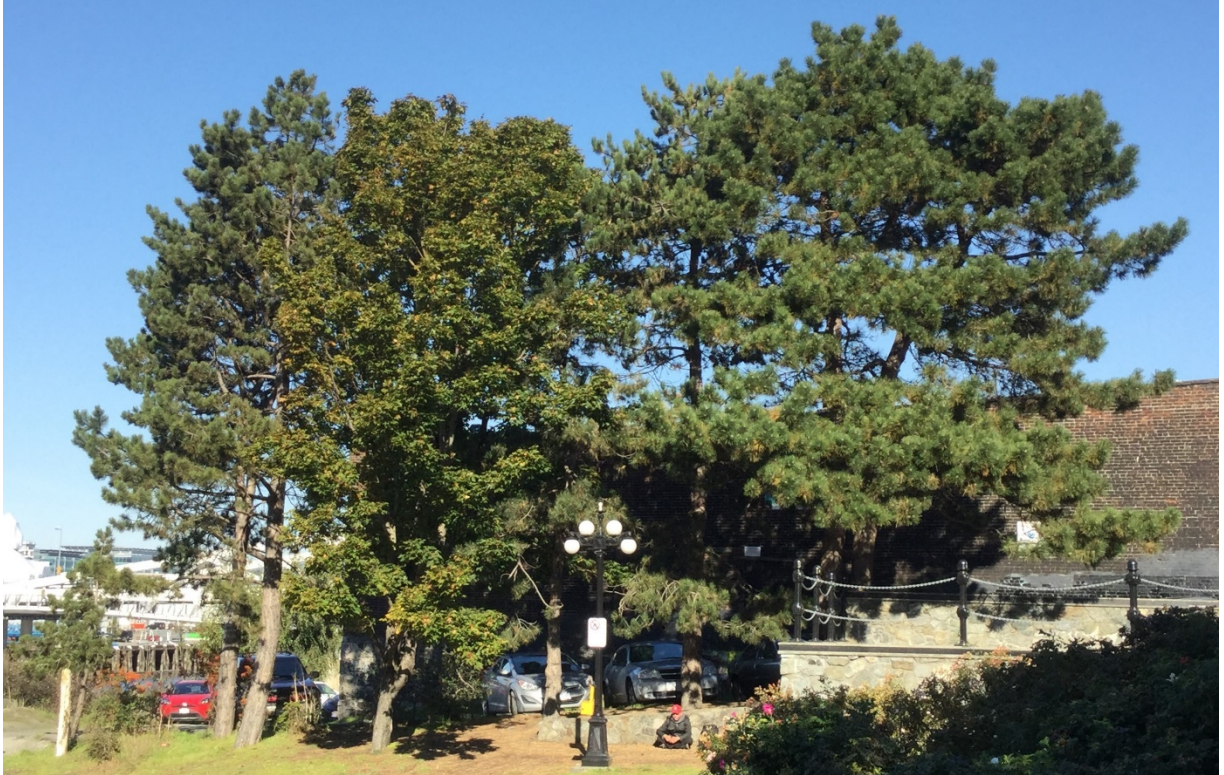
The eight trees in Reeson Park were free from obvious major defects, but their crowns had been raised and some broken branch stubs remain. Abundant small-diameter dead wood was present in the black pine crowns. All eight trees have asymmetrical crown development because of their growth in a group. Shoot extension growth of the black pines appears to be slowing and the larger trees have lost their apical dominance. It is likely that growth and vigor of these trees is becoming prematurely limited by the poor rooting environment.

Photo 4. Trees 874 to 881 (left to right) in Reeson Park adjacent to the subject site property line.

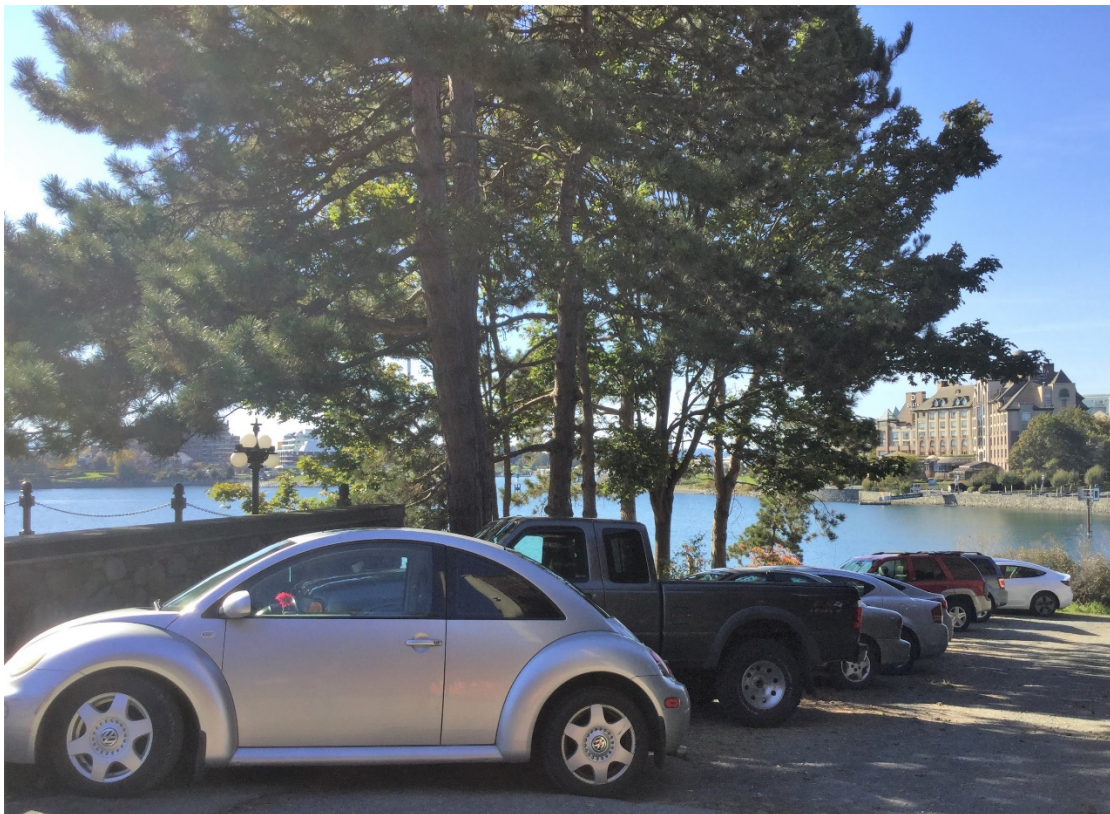
Photo 5. Trees in Reeson Park adjacent to the subject site property line viewed from the subject site.

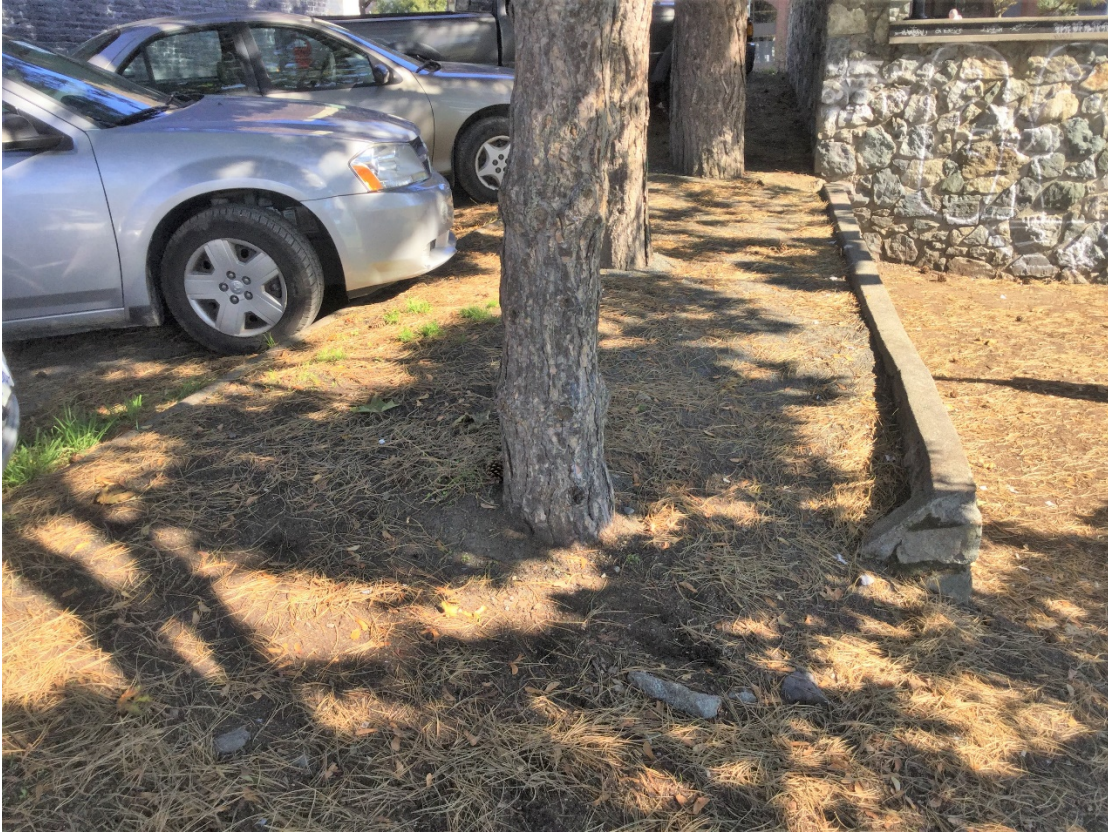
| Tag # | Location | Species Common Name | Botanical Name | DBH (cm) | Height (m) | LCR | Dripline Radius (m) | Health and Structure Rating | Comments | Retention Value Rating | Retain/Remove | Retention/TPZ Comments | *TPZ (m) |
|---|---|---|---|---|---|---|---|---|---|---|---|---|---|
| 879 | City | Black Pine | Pinus nigra | 26 | 12 | 60-79% | 4.1 | Poor | Suppressed in clump. 1.3 m from asphalt curb to north. 0.9 m to low retaining wall to south. Root collar appears slightly buried. Single upright stem, no obvious defects. Crown raised to 3 m. One broken branch stub and minor dead wood in crown. Branch structure is straggly and asymmetrical to south, one branch 4.1 m north. Foliage density is poor, but appears healthy. Drip line 4.1 m N, 2.4 m E, 3.6 m S, 1.2 m W. Retain only in group. | Low | Remove | Tree conflicts excessively proposed on-site plans. See Section 4.2 of the DHC Arboricultural Report dated October 17th, 2019 for further details. | 3.1 |

| Tag # | Location | Species Common Name | Botanical Name | DBH (cm) | Height (m) | LCR | Dripline Radius (m) | Health and Structure Rating | Comments | Retention Value Rating | Retain/Remove | Retention/TPZ Comments | *TPZ (m) |
|---|---|---|---|---|---|---|---|---|---|---|---|---|---|
| 880 | City | Black Pine | Pinus nigra | 37 | 13 | 60-79% | 5.7 | Moderate | Codominant in clump. 0.65 m from asphalt curb to north. 1.05 m to low retaining wall to south. Root collar appears slightly buried. Single upright stem, no obvious defects, top third is sinuous. Crown raised to 2.5 m. Minor dead wood in crown. Branch structure is asymmetrical to north. Foliage density is moderate, appears healthy. Drip line 2.7 m from building envelope. Drip line 5.7 m N, 2.8 m E, 4.2 m S, 2.4 m W. Retain only in group. | Medium | Remove | Tree conflicts excessively proposed on-site plans. See Section 4.2 of the DHC Arboricultural Report dated October 17th, 2019 for further details. | 4.4 |

Photo 6. The restricted root zones of trees 879 (closest), 880 and 881 (furthest).

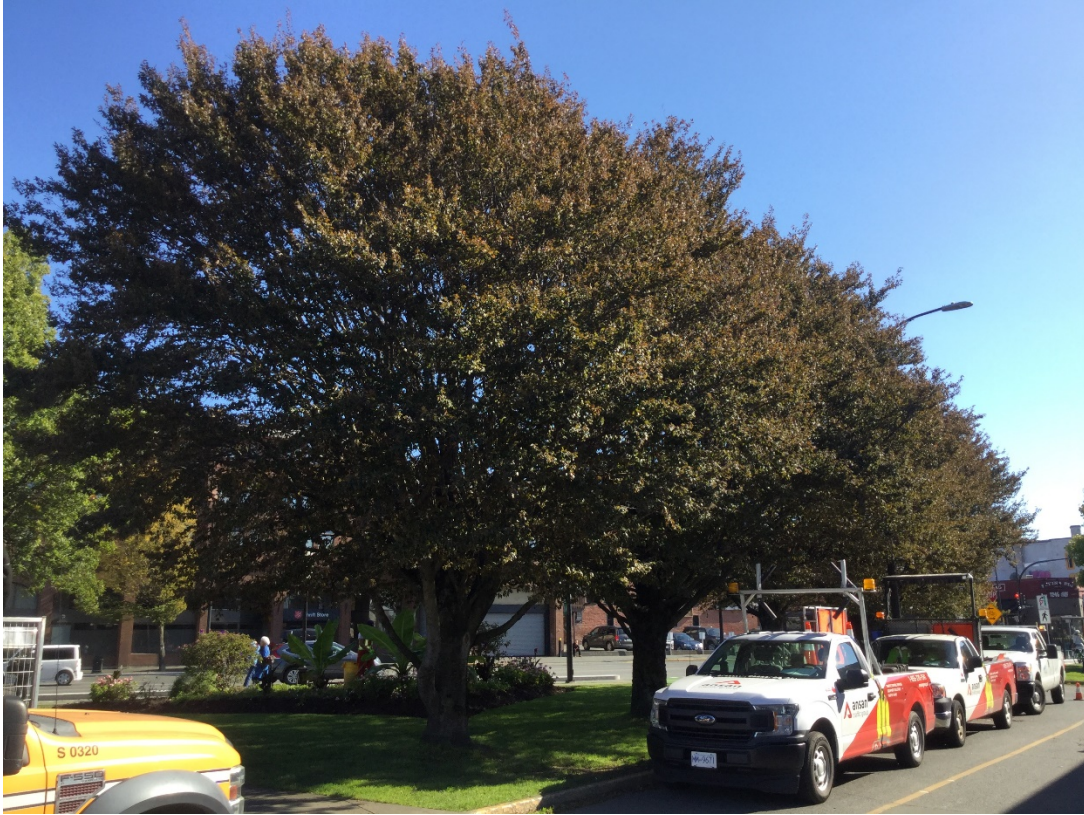
Photo 7. Trees 885 (left) to 882 (right) viewed from the north west.
