Talbot Mackenzie & Associates

Construction Impact Assessment & Tree Preservation Plan

Date of Issuance: October 18, 2019 (TPP#1)

Jobsite Property: 2003 Shakespeare St, Victoria, BC

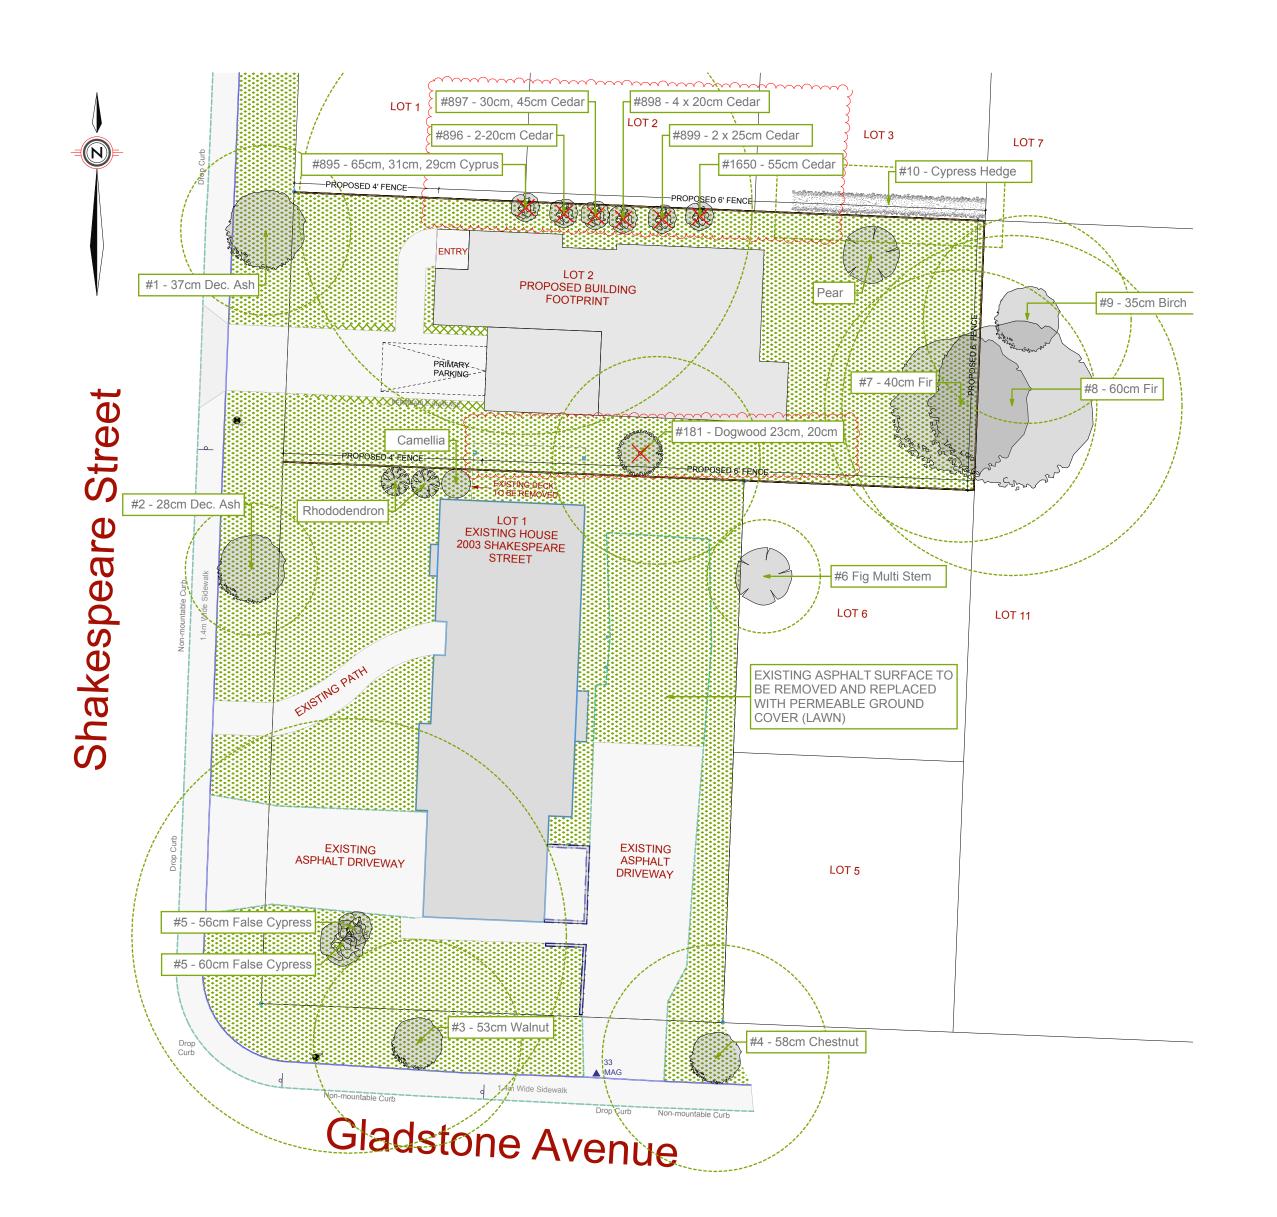
PROPOSED LANDSCAPE PLAN
SCALE = 1 : 200

*NT#1 Flowering Ash (37cm) – The proposed driveway edge will be 5m from the centre of this tree. We do not anticipate the health or stability of the tree will be impacted by the excavation for the driveway or services. We recommend the excavation be completed under the direction of the project arborist.

*Rear Fence – The concrete fence pilings within the CRZs of trees #7, 8 and 9 should be hand-dug under the project arborist's direction to avoid damaging significant roots.

- *Arborist Supervision: All excavation occurring within the critical root zones of protected trees should be completed under the direction or supervision of the project arborist. This includes (but is not limited to) the following activities within CRZs:
 - Excavation of the new driveway adjacent to NT #1 Ash
 - Excavation for the fence post pilings within the CRZs of #7-9
