# **202 Raynor Ave, Victoria**

## **Construction Impact Assessment & Tree Preservation Plan**

Date of Issuance: February 28, 2020

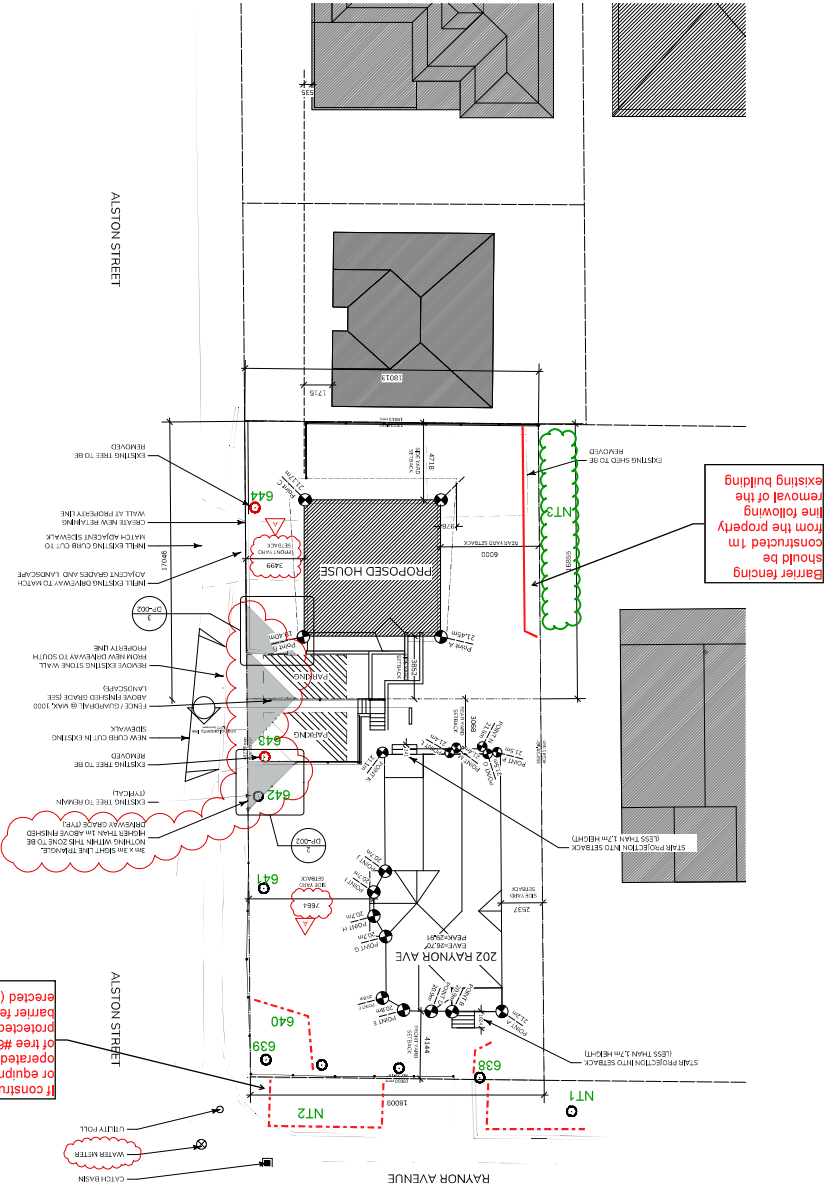
1 Site Plan  
Scale: 1:150

If construction materials protected, additional barrier fencing must be erected (dashed lines)
