Attachment A - Photographs

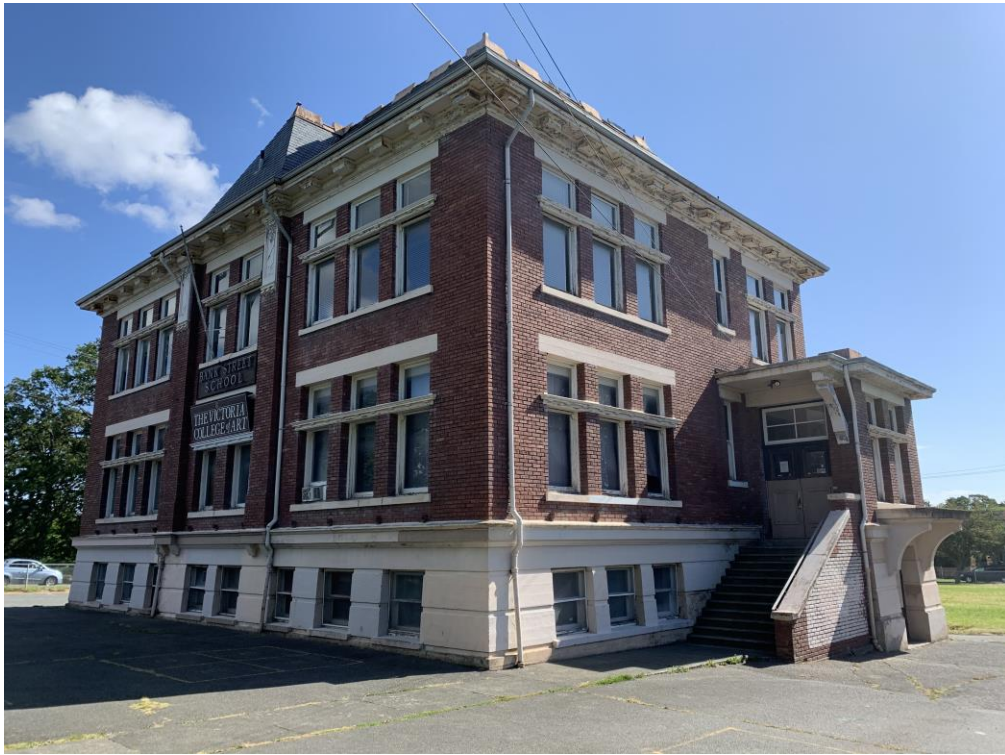
Front (West) and Rear (south) Elevation

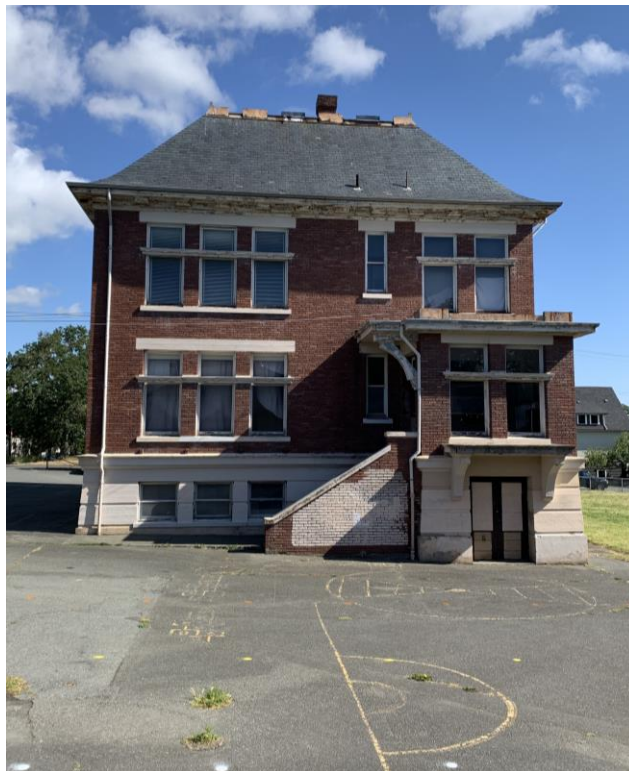
Rear (south) elevation

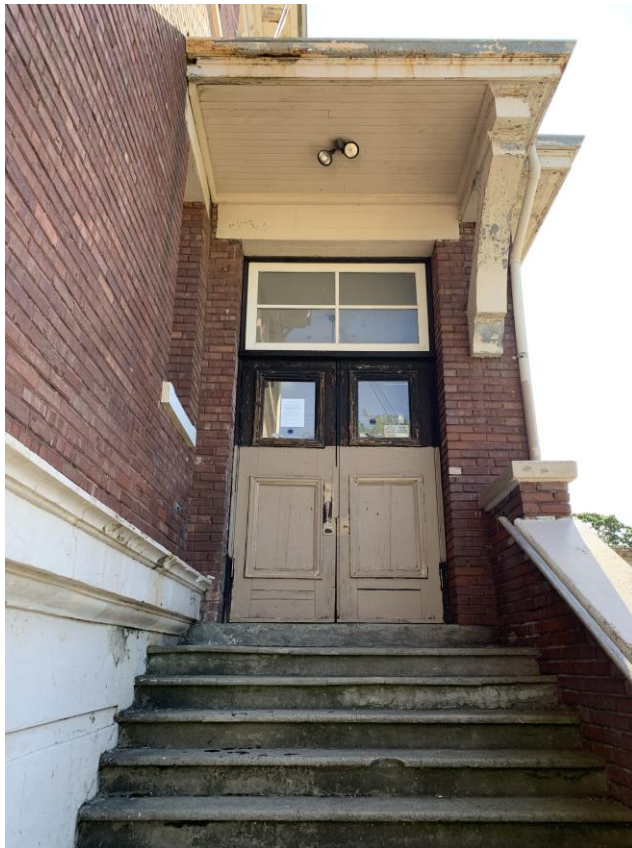
South Entrance

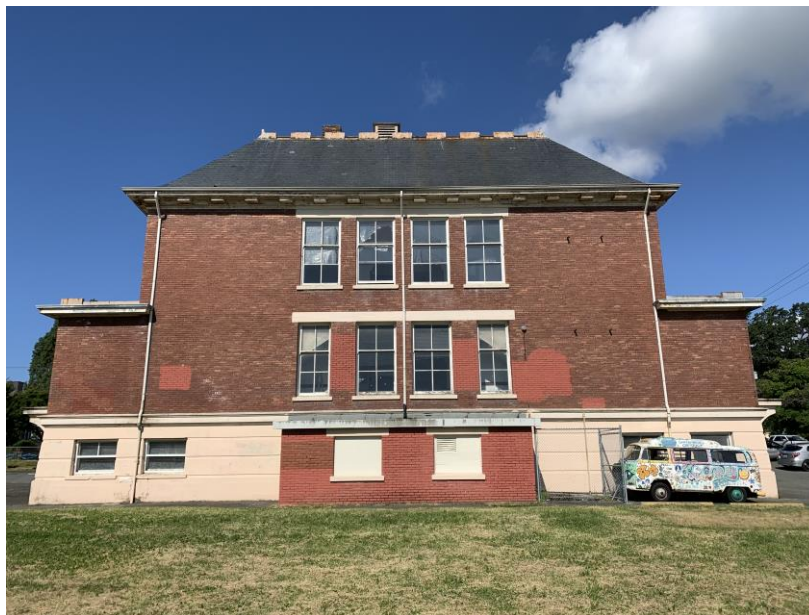
Rear (East) Elevation

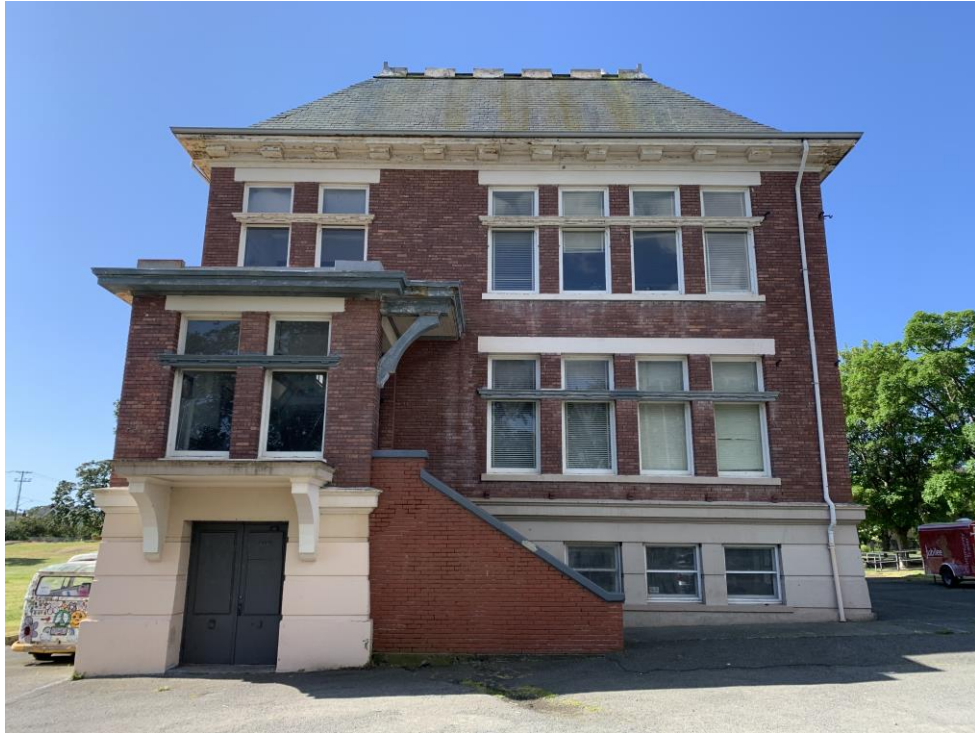
Side (north) elevation

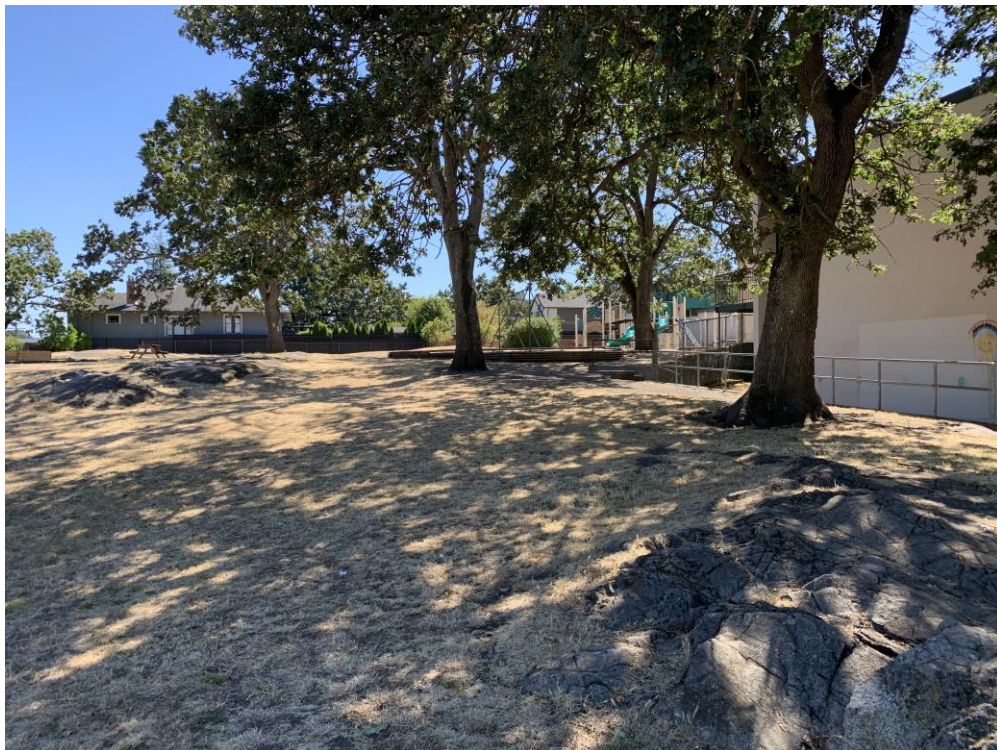
Garry Oak

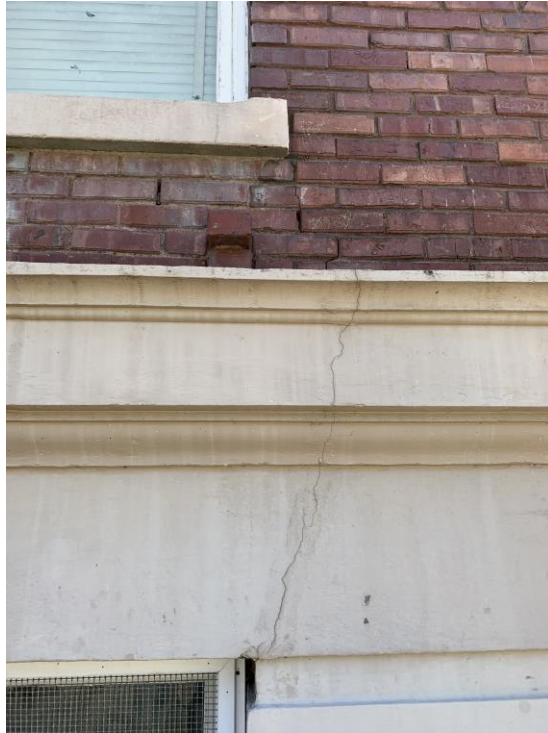
Crack in Brickwork

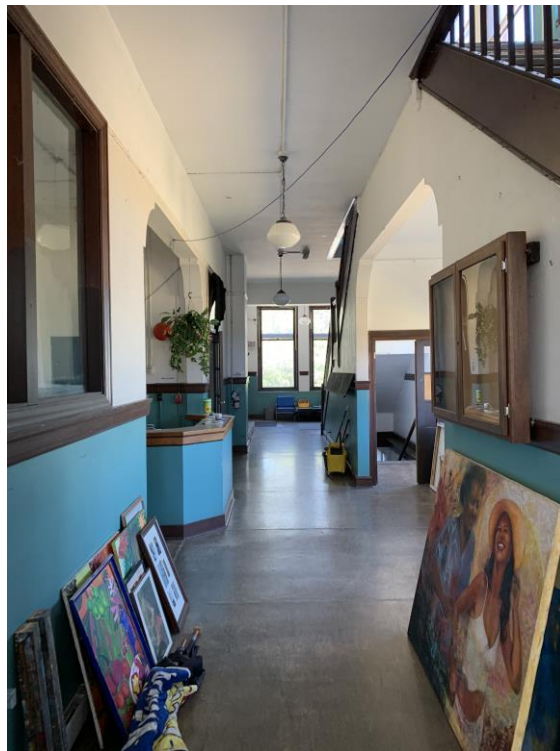
Second Storey Hallway

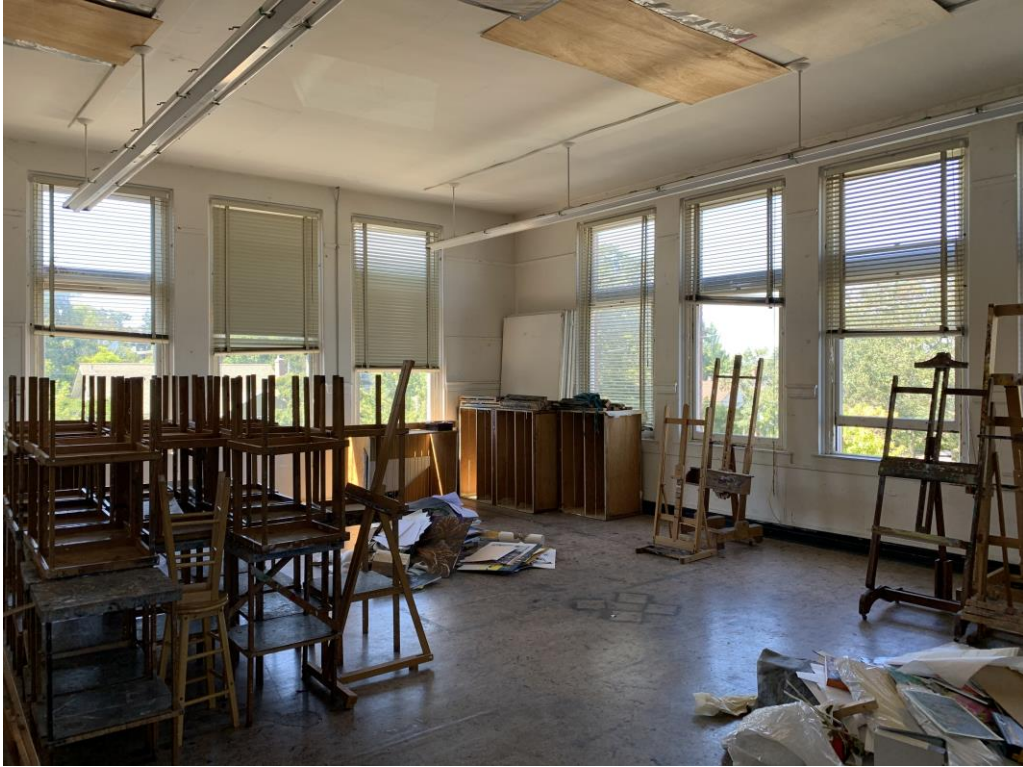
Classroom on Upper Storey

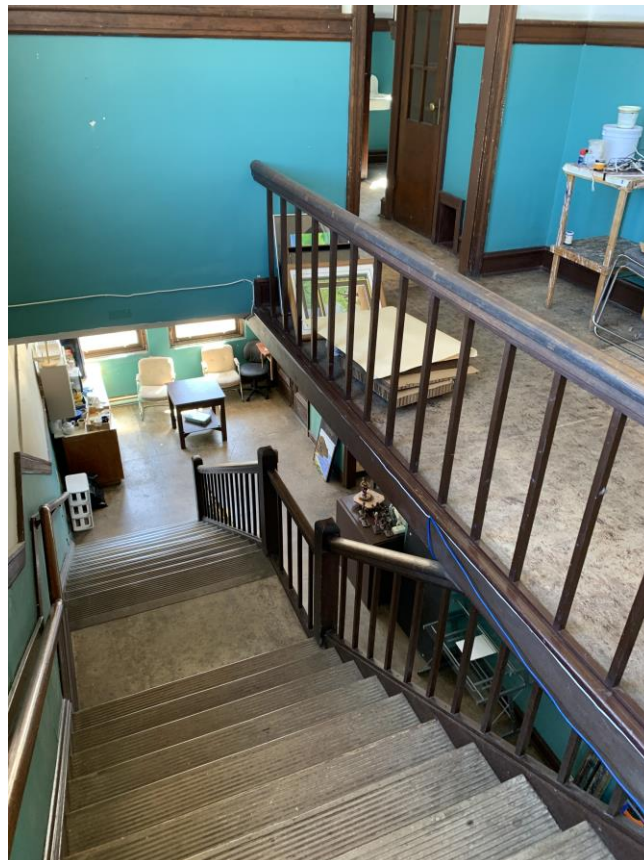
South Staircase from Upper Storey to Main Storey

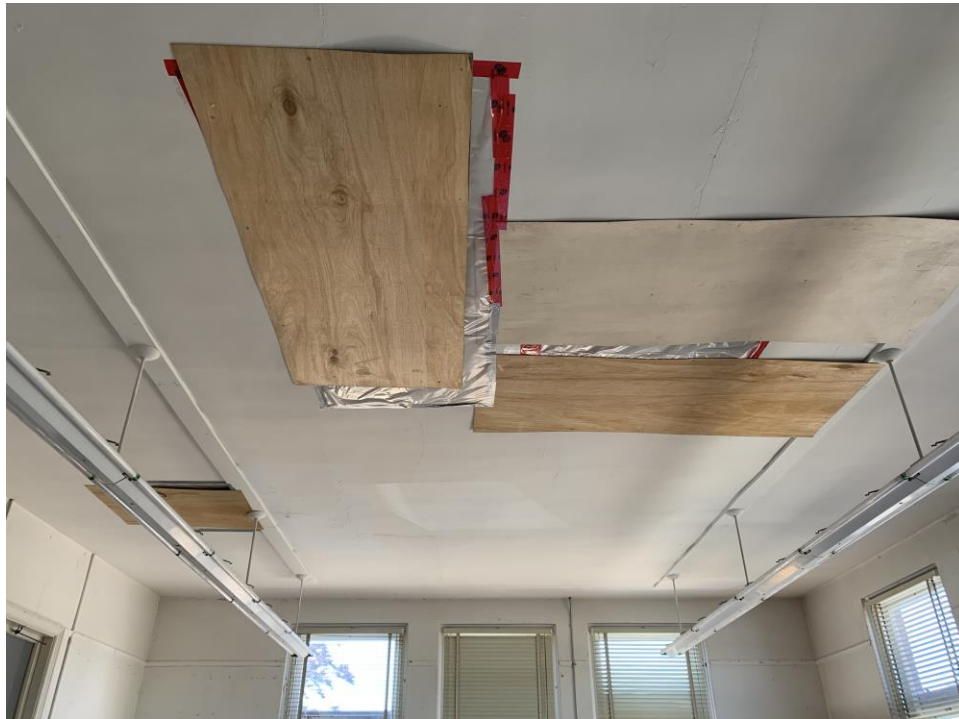
Ceiling patches

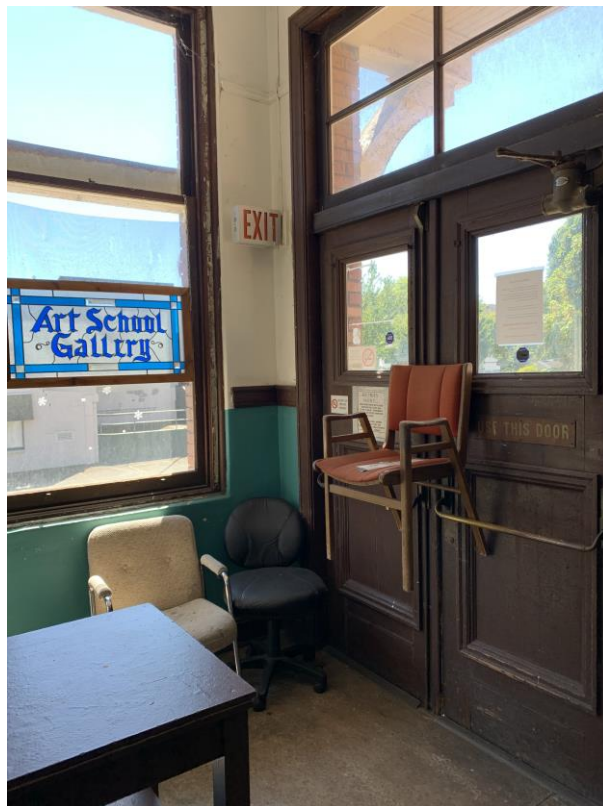
Main Entrance

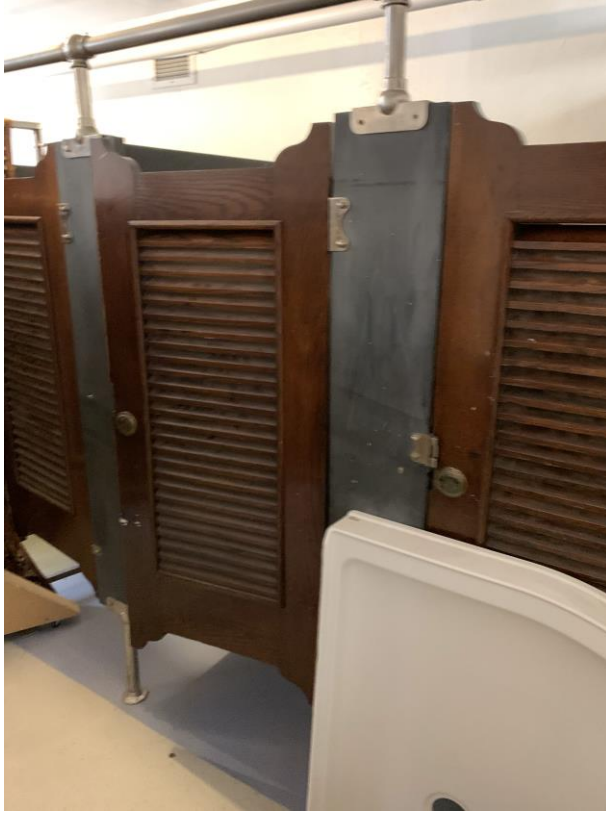
Washrooms with Slate Dividers at Ground Level

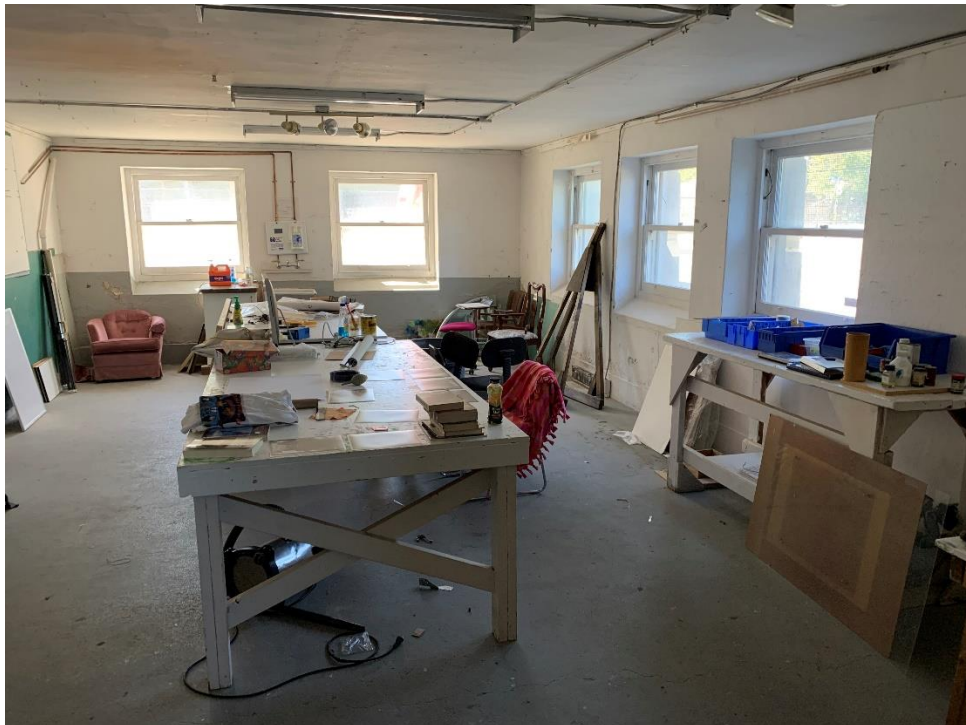
Basement Workshop Area
