Committee of the Whole Report

Subject: **Report on the Potential Heritage Designation of 1623-1625 Bank Street**

BANK STREET SCHOOL CONDITION ASSESSMENT REPORT

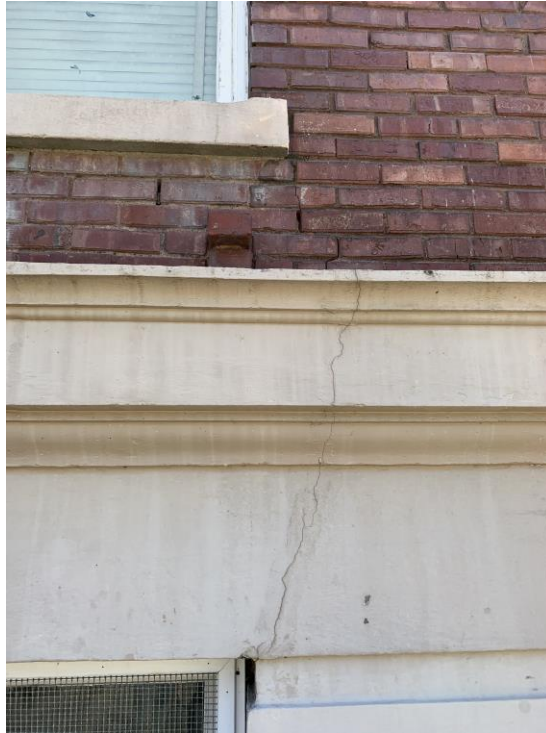
- Settlement and fractures are present in the concrete foundation around the perimeter of the building.
 - Settlement of the foundation is causing minor spider cracking in mortar joints of the masonry walls.

Crack in Brickwork

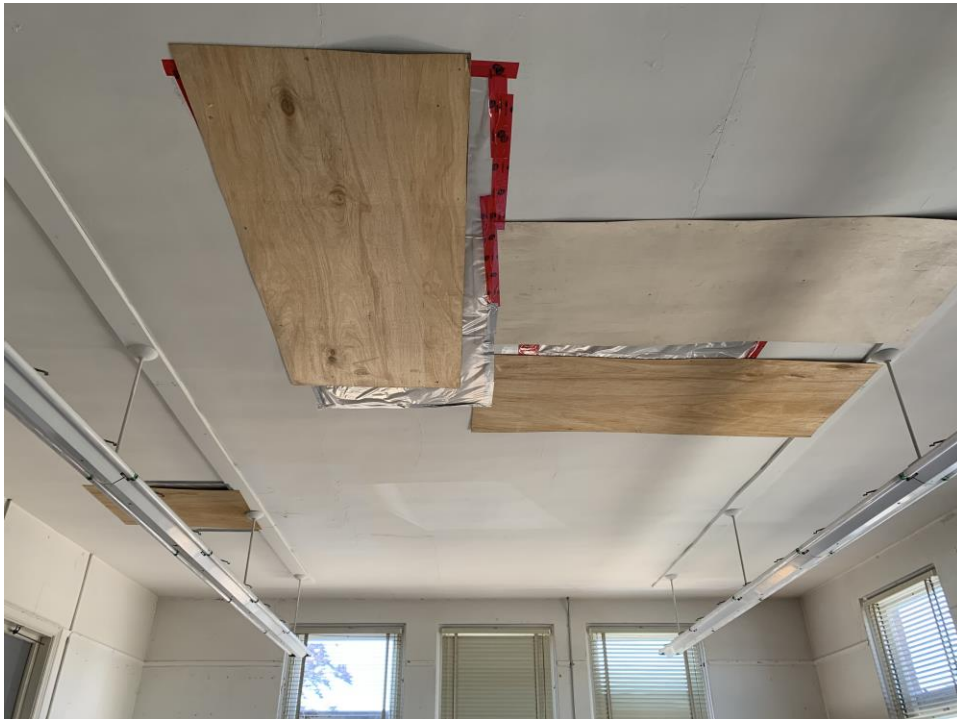
Ceiling patches

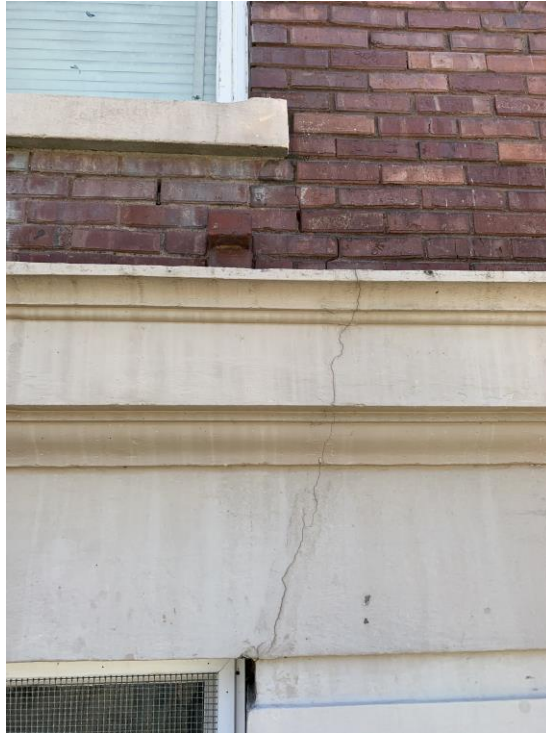
Crack in Brickwork

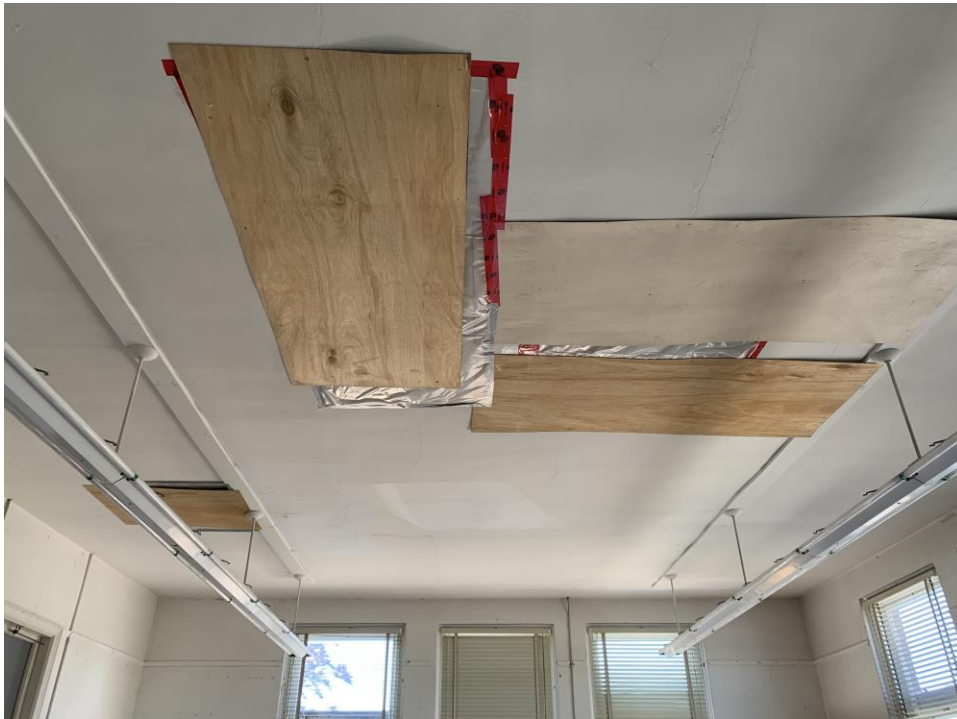
Ceiling patches
