Talbot Mackenzie & Associates
Consulting Arborists

August 15, 2020

Re: 1114 Rockland Avenue - Addendum for November 01, 2019 Tree Protection report

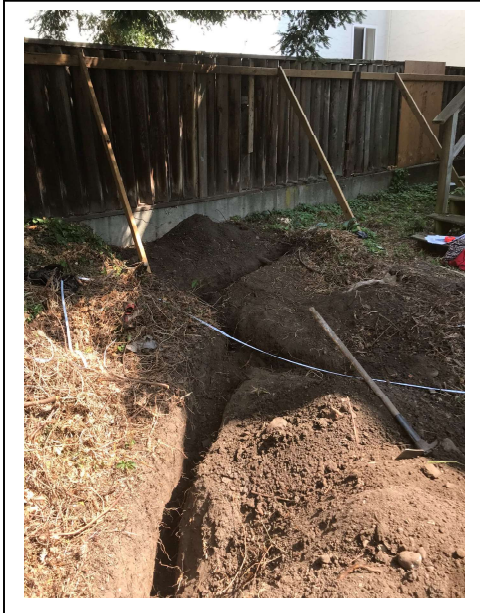
- The excavation was to a depth of 60 cm below the existing grade. A permeable topsoil layer comprised this upper layer of soil. At 60 cm in depth, a hard clay layer was encountered that made hand excavation difficult. This layer should be sufficient to provide bearing beneath the parking slab and may be suitable for bearing beneath the strip footing (suitability to be determined by a geotechnical engineer).

Excavation viewed from north west

- The excavation for the strip footing that extends from the stairwell is limited to a depth of 60 cm below the existing grade and 1-metre outside the footing location.

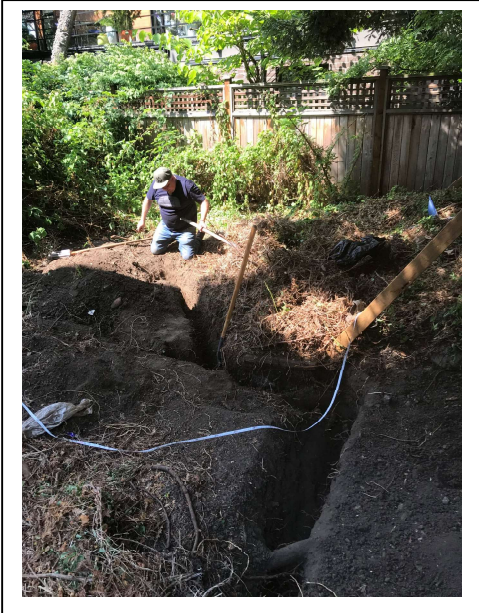
- Our excavation was 1.3 metres from the east fence line and 5.0 metres from the north fence line at the north east building corner. It extended several metres to the south and extended along the north side of the building, up to the stairwell structure. The excavation was offset 1.0 metre outside the strip footing and stairwell structure wall.

Excavation viewed from south east

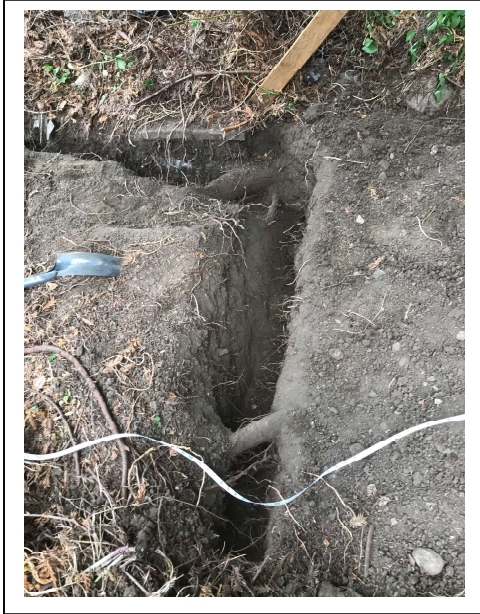
- There were few Sequoia (Redwood) roots encountered in the upper soil layers; 1 x thirteen 13 cm diameter root was encountered 20 cm below grade at the north east corner of the excavation , 2.8 metres from the subject tree and one 1 x six 6 cm diameter surface root was encountered along the east side of the excavation 3.5 metres from the subject tree. There were no other roots over 1 cm diameter encountered in the upper soil layer. Small root growth was visible within the upper surface of the clay layer that was encountered at the 60 cm depth, but we did not excavate deeper into this layer until it is known whether it is a suitable bearing layer for the strip footing and parking grade.

Roots encountered at north east corner
