## **Talbot Mackenzie & Associates**

Re: 1114 Rockland Avenue - Addendum for November 01, 2019 Tree Protection report

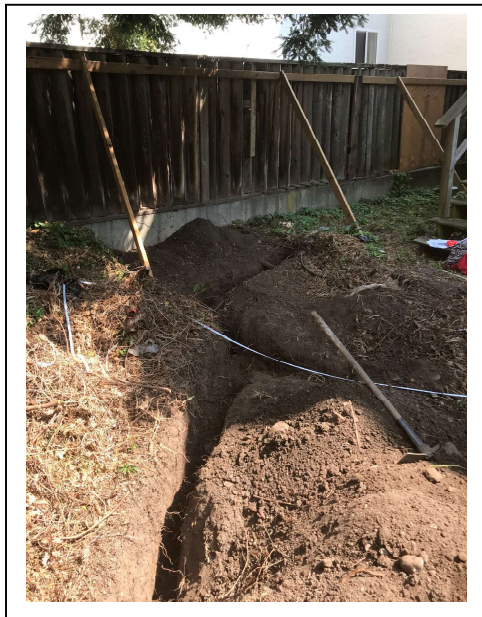
- Our excavation was 1.3 metres from the east fence line and 5.0 metres from the north fence line at the north east building corner. It extended several metres to the south and extended along the north side of the building, up to the stairwell structure. The excavation was offset 1.0 metre outside the strip footing and stairwell structure wall.

- The excavation was to a depth of 60 cm below the existing grade. A permeable topsoil layer comprised this upper layer of soil. At 60 cm in depth, a hard clay layer was encountered that made hand excavation difficult. This layer should be sufficient to provide bearing beneath the parking slab and may be suitable for bearing beneath the strip footing (suitability to be determined by a geotechnical engineer).

Excavation viewed from north west

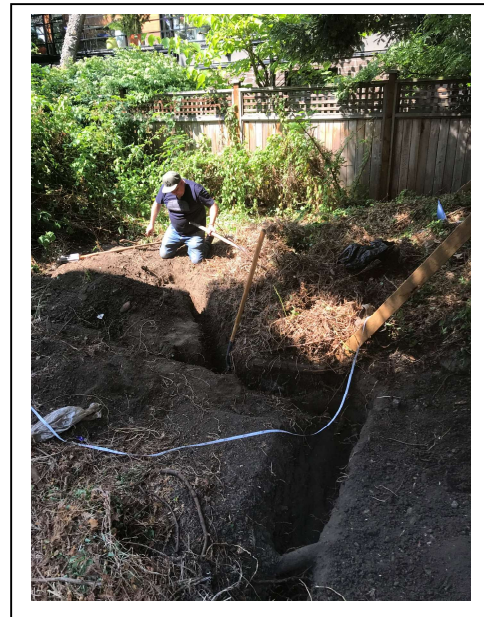
Excavation viewed from south east

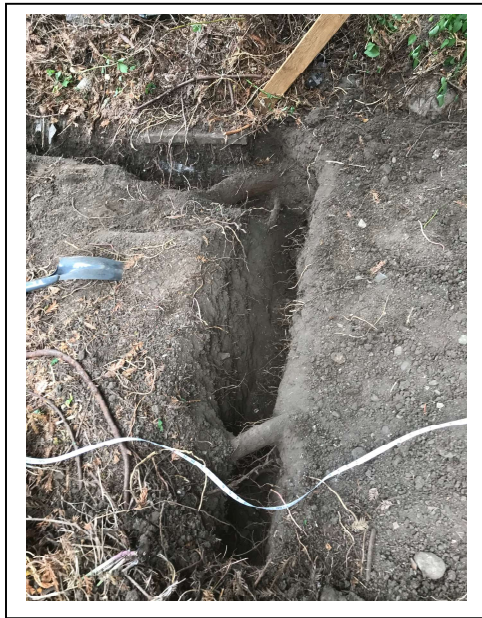
- There were few Sequoia (Redwood) roots encountered in the upper soil layers; 1 x thirteen 13 cm diameter root was encountered 20 cm below grade at the north east corner of the excavation, 2.8 metres from the subject tree and one 1 x six 6 cm diameter surface root was encountered along the east side of the excavation 3.5 metres from the subject tree. There were no other roots over 1 cm diameter encountered in the upper soil layer. Small root growth was visible within the upper surface of the clay layer that was encountered at the 60 cm depth, but we did not excavate deeper into this layer until it is known whether it is a suitable bearing layer for the strip footing and parking grade.

Roots encountered at north east corner
