DUNSTER & ASSOCIATES

September 29, 2020

As requested I have visited the site and reviewed the trees on site. Figure 1 is a survey plan of the trees. Table 1 provides details about each tree.

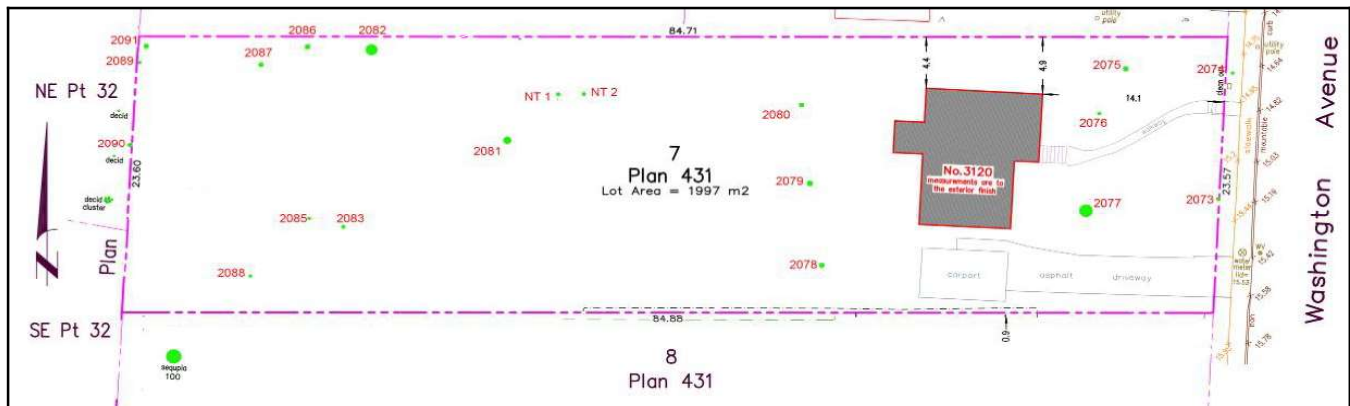
Figure 1. Location of trees on site.

There are 11 bylaw sized trees on site. One tree (# 2074) is on City property. There is also a bylaw sized sequoia tree on the adjacent property in the south west corner. Two trees straddle the property line. One of those (# 2073) is between the site and City land. The other (# 2090) is at the west end of the site. The proposed works will require removal of all but four of the trees on site. That means removal of 16 trees, of which 8 are not protected trees, and 8 are protected trees. The four trees to be retained are one Garry Oak (# 2082), and 3 hawthorns ((#2089, #2090, #2091).

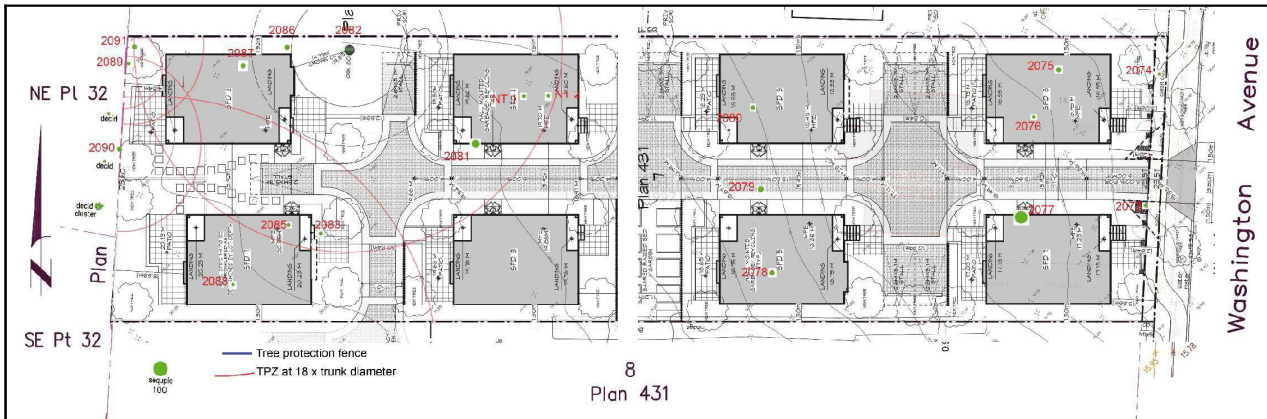
Figure 2. Proposed design with building footprints.

Figure 2 shows the footprints of the eight units planned. I have also included the tree protection zones for the trees to be retained. The three hawthorn trees along the west boundary (#2089, #2090, #2091) are all small and are also being retained. There may be a need to prune back some parts of them to clean them up after many years of bramble growth. Since that part of the site is a rear yard there will not be a major disturbance affecting them.

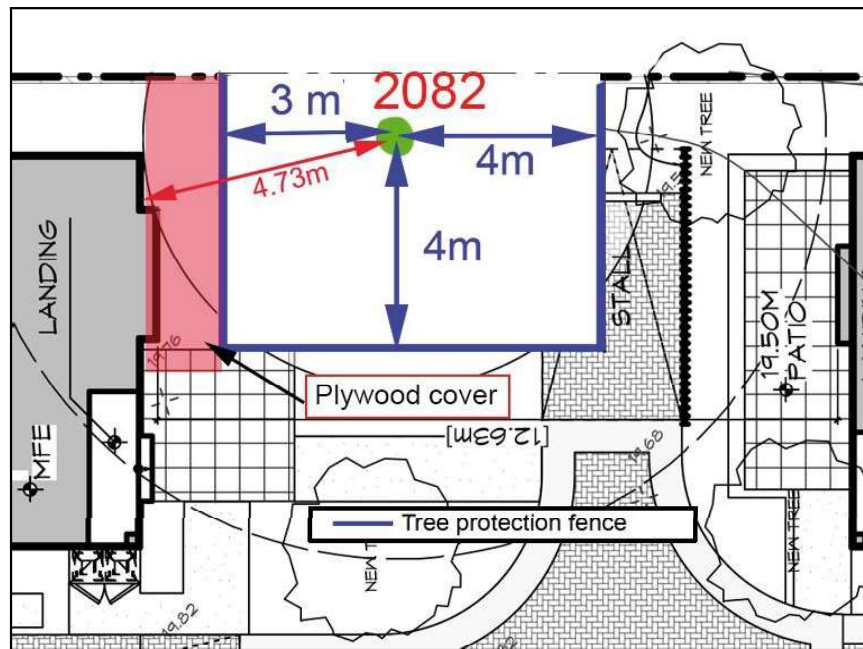
Figure 4. Fence detail by Oak tree.

The main focus for tree retention is on the oak tree, and how best to work around it. The unit in the northwest corner has been moved back to better accommodate the oak tree to be retained. The distance from the edge of the building to the oak tree is 4.73 metres. The fence is set at 3 metres so this will provide a working space of 1.73 metres between the fence and the new building. In order to minimise the disturbance to the ground and roots in this area, the following actions shall be implemented.

- 1 Prior to any other site preparation, the oak tree shall be fenced off at as shown in detail in Figure 4.

Once the protection fence is in place around the oak tree, the east edge of the building footprint shall be laid out on site. Prior to excavation of any other disturbance in the area just beyond the west side of the tree fence, there shall be a double layer of 5/8 plywood installed between the fence and the edge of the excavation. The west edge of that plywood layer can be no more than 10 centimetres back from the edge of the wall. The footing design in this area shall be an L shape not a T shape, and the footing shall be formed as a blind form along the west edge, with the intention to leave the plywood form in place after the concrete has been poured. That means that the excavation shall be limited to the edge of the wall plus 10 centimetres and no more. See Figure 5. This treatment shall extend along the east edge for a distance of 4 metres as shown in Figure 4 (red area).
