# **3130 Jutland Road, Victoria, BC**

## **Construction Impact Assessment & Tree Management Plan**

| DATE OF ISSUANCE: | December 10, 2020 |

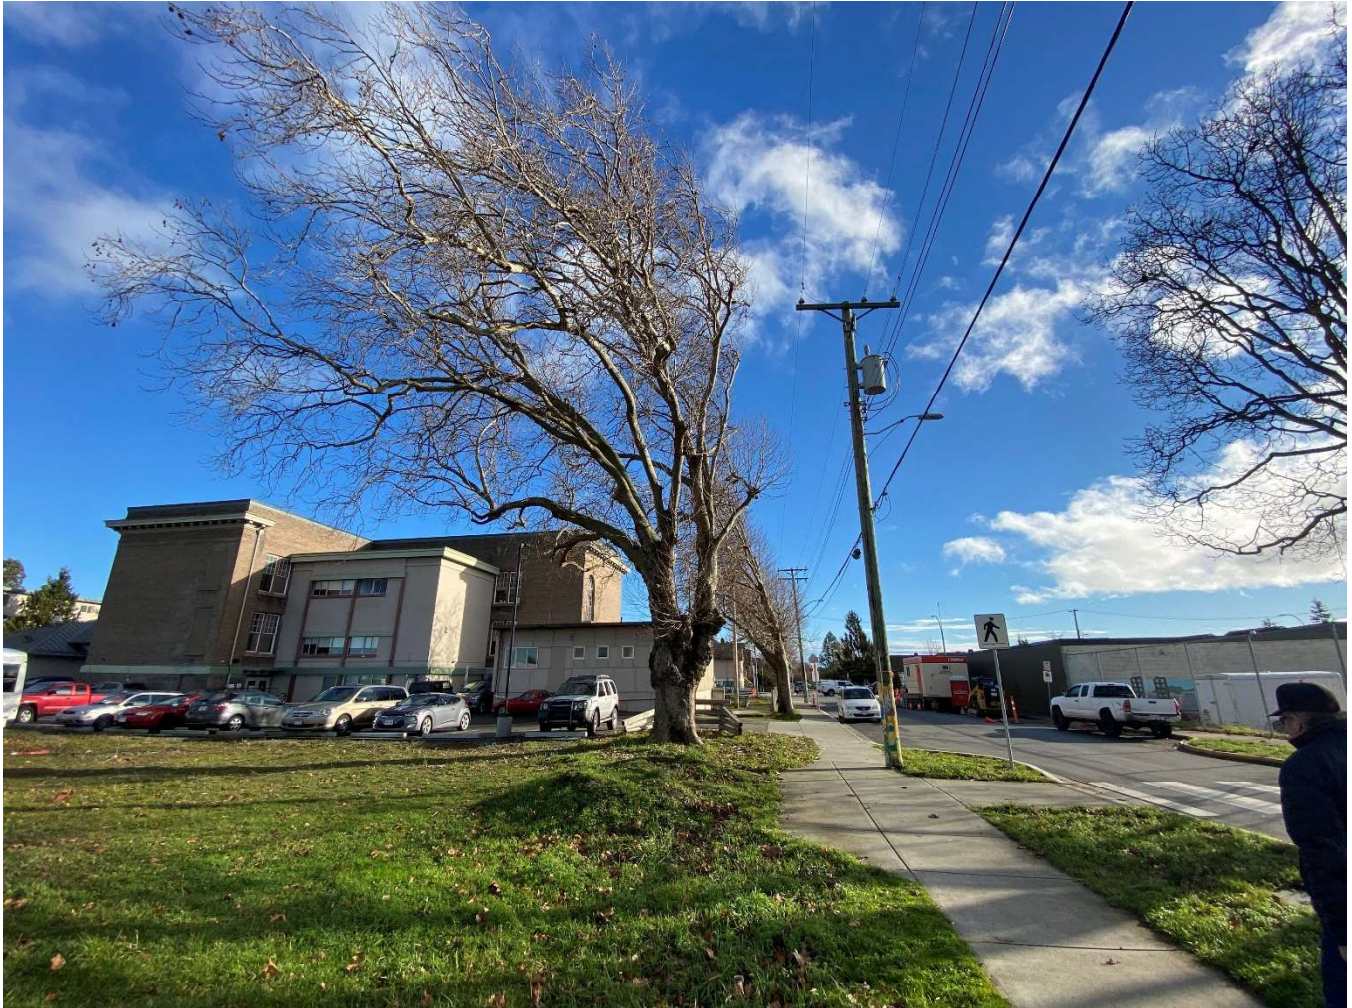
*Photograph 1. Onsite London Plane (NT 4).*

| ID # | Surveyed ?<br>(Yes / No) | Location<br>(On, Off,<br>Shared,<br>City) | Bylaw<br>protected ?<br>(Yes / No) | Name | | dbh (cm) | Ht (m) | Critical<br>root<br>zone<br>radius<br>(m) | Dripline<br>radius<br>(m) | Condition | | Retention<br>Suitability<br>(onsite<br>trees) | Relative<br>tolerance | General field observations/remarks | Tree retention comments | Retention<br>status |
|---|---|---|---|---|---|---|---|---|---|---|---|---|---|---|---|---|
| Nt4 | Yes | On | Yes | London<br>Plane | Platanus x<br>acerifolia | 110 | 20 | 11.55 | 11 | Fair | Fair | Good | Good | Tag 744, asymmetric crown on South side associated with historic hydro clearance pruning, history of large limb pruning with associated surface decay. End weighted limbs, small cavity openings in the upper crown. | * Excavation for storm and Sanitary services and a fire access lane (on modified grass surface) within the CRZ. The project arborist to supervise all excavation and fill placement required within the CRZ. Shoring recommended to minimize excavation requirements within the CRZ. | Retain* |

- All excavation within the critical root zone during proposed storm and sanitary sewer service installations (refer to Stantec civil servicing drawing).
- All excavation and fill placement required within the critical root zone to remove the existing turf and install new reinforced grass, for the proposed fire truck access (refer to LADR Landscape Architects - Landscape drawing).

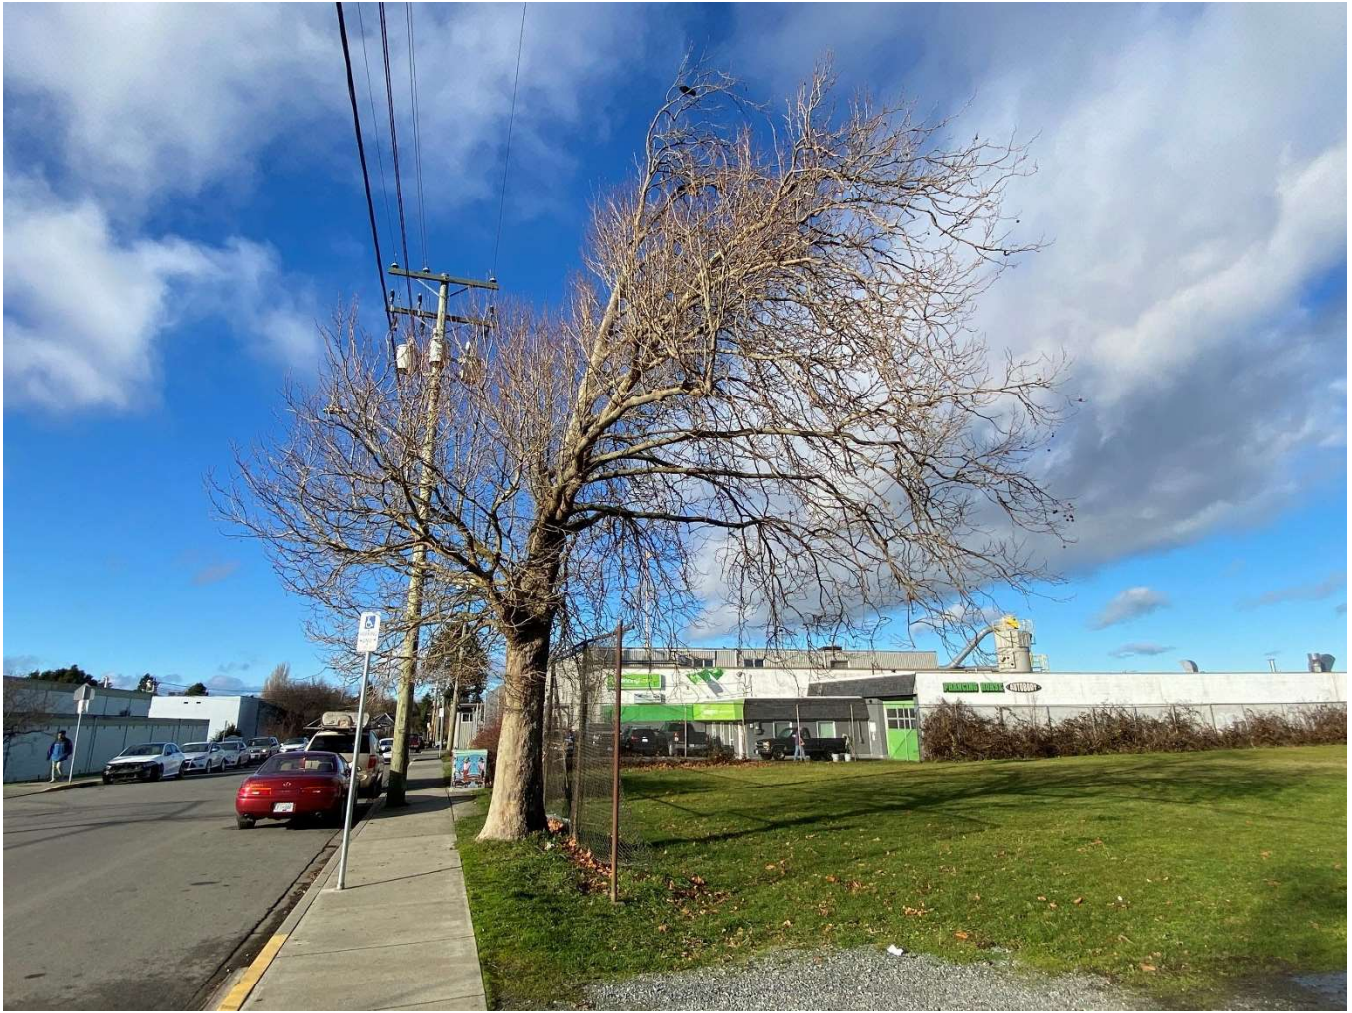
*Photograph 2. Municipal London Plane (NT5).*

| ID # | Surveyed ?<br>(Yes / No) | Location<br>(On, Off,<br>Shared,<br>City) | Bylaw<br>protected ?<br>(Yes / No) | Name | | dbh (cm) | Ht (m) | Critical<br>root<br>zone<br>radius<br>(m) | Dripline<br>radius<br>(m) | Condition | | Retention<br>Suitability<br>(onsite<br>trees) | Relative<br>tolerance | General field observations/remarks | Tree retention comments | Retention<br>status |
|---|---|---|---|---|---|---|---|---|---|---|---|---|---|---|---|---|
| Nt5 | Yes | City | Yes | London<br>Plane | Platanus x<br>acerifolia | 57 | 15 | 5.99 | 8 | Fair | Fair/poor | Good | Good | Municipal tree, asymmetric crown on South side associated with historic hydro clearance pruning, history of large limb pruning with associated surface decay, existing concrete sidewalk 20cm from South side of root collar. | *New sidewalk proposed within the CRZ. The parkade foundation proposed within the CRZ. If this tree is retained, the new sidewalk will need to be constructed using asphalt and raised above the grade of the buttress of the tree. If a concrete surface is required, the sidewalk should be shifted East – to avoid conflicts with the root flare of the tree. Recommend that the project arborist review a grading plan – once one is prepared. The project arborist to supervise all excavation and fill placement required within the CRZ. | Retain* |

\*Note – Retention will only be possible using a modified sidewalk design. A grading plan should be reviewed to determine the grade of the proposed sidewalk in relation to the root collar of NT 5.

- All excavation within the critical root zone to remove the existing City sidewalk (refer to Stantec civil servicing drawing) and any planting, soil or turf installation within the critical root zone (refer to LADR Landscape Architects - Landscape drawing).
- All excavation and fill placement within the critical root zone during installation of the new sidewalk along the new road dedication line (refer to Stantec - civil servicing drawing).
- All excavation within the critical root zone during exaction required for the footprint of the proposed underground parkade (refer to Christine Lintott Architects - architectural site plan).

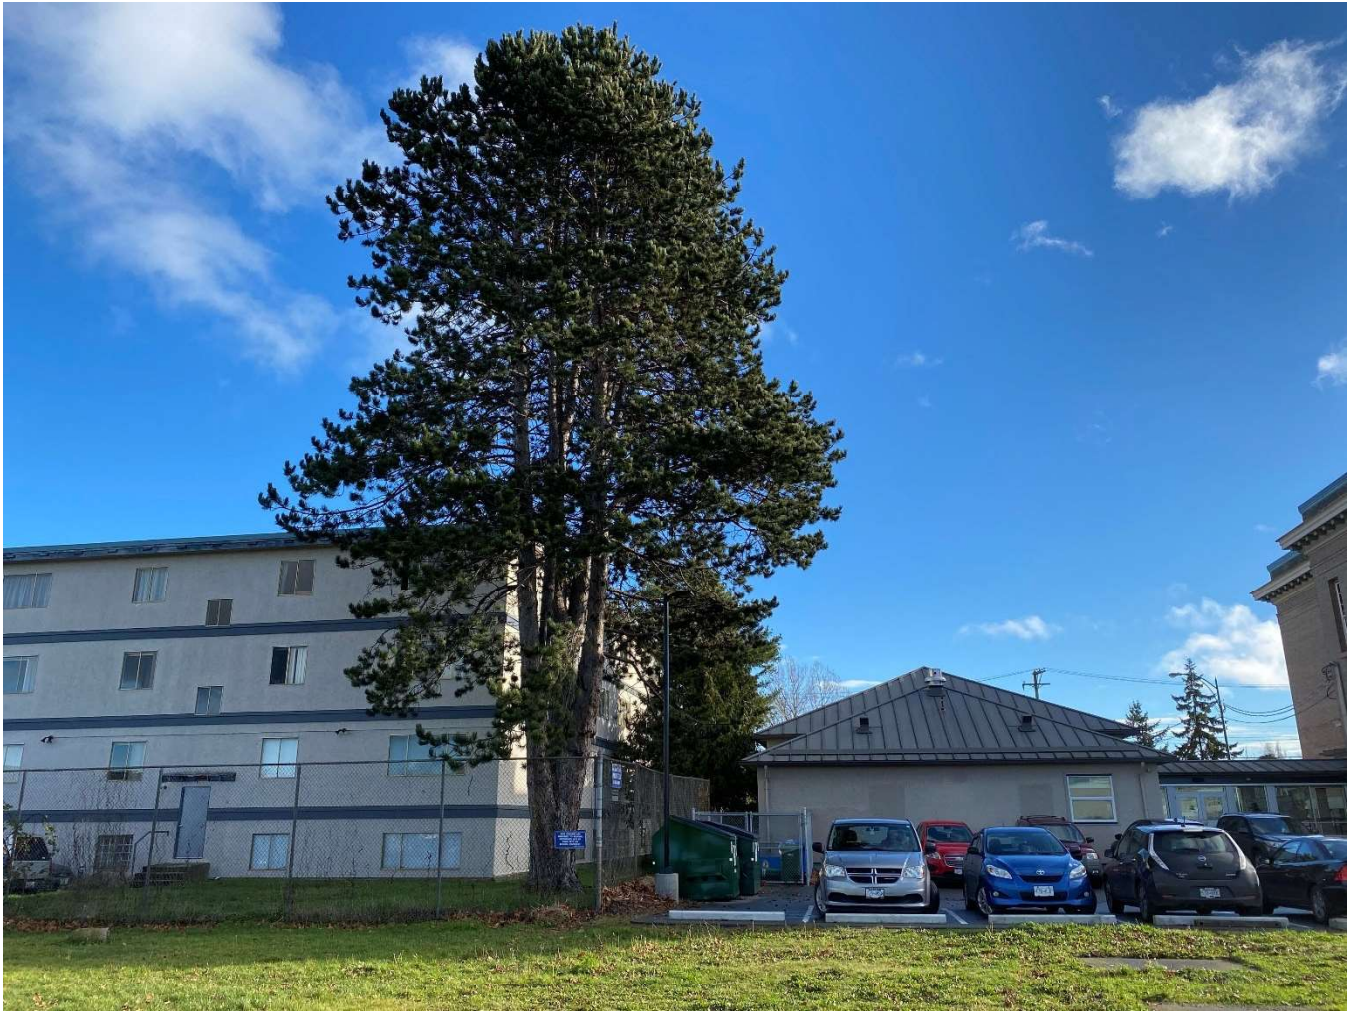
*Photograph 3. Offsite Austrian pine (NT6).*

| ID # | Surveyed ?<br>(Yes / No) | Location<br>(On, Off,<br>Shared,<br>City) | Bylaw<br>protected ?<br>(Yes / No) | Name | | dbh (cm) | Ht (m) | Critical<br>root<br>zone<br>radius<br>(m) | Dripline<br>radius<br>(m) | Condition | | Retention<br>Suitability<br>(onsite<br>trees) | Relative<br>tolerance | General field observations/remarks | Tree retention comments | Retention<br>status |
|---|---|---|---|---|---|---|---|---|---|---|---|---|---|---|---|---|
| Nt6 | Yes | Off | Yes | Austrian<br>pine | Pinus nigra | 100~ | 25 | 10.5 | 6 | Good | Fair/poor | Good | Good | Multiple stems form at 2 and 4 m above grade - Included unions, reaching wood visible below unions, crown raise pruned above the existing parking lot. | *The parkade foundation proposed within the CRZ. A sidewalk proposed within the CRZ. The project arborist to supervise all excavation and fill placement required within the CRZ. Shoring recommended to minimize excavation requirements within the CRZ. | Retain* |

The onsite tree resource consists of 1 London Plane tree (NT 4), located at the Southwest corner of the property. The offsite tree resource consists of 1 London Plane tree (NT 5) located on the Cecelia Road frontage, and 1 Austrian pine (NT 6) located on the neighbouring property at 3150 Jutland Road. The subject site is an open field, and all three trees included in the inventory are growing singularly, in open landscape conditions (see [figure 1](#)). London Plane NT 4 and NT 5 have been heavily side pruned historically for hydro clearance pruning (see photographs 1 and 2 - [appendix B](#)). Offsite Austrian pine (NT 6) was observed to have included bark at the stem unions (see photograph 3 – [appendix B](#)).

- All excavation within the critical root zone during exaction required for the footprint of the proposed underground parkade (refer to Christine Lintott Architects - architectural site plan).
- All excavation and fill placement required within the critical root zone to remove the existing turf and install new walkway (refer to LADR Landscape Architects - Landscape drawing).

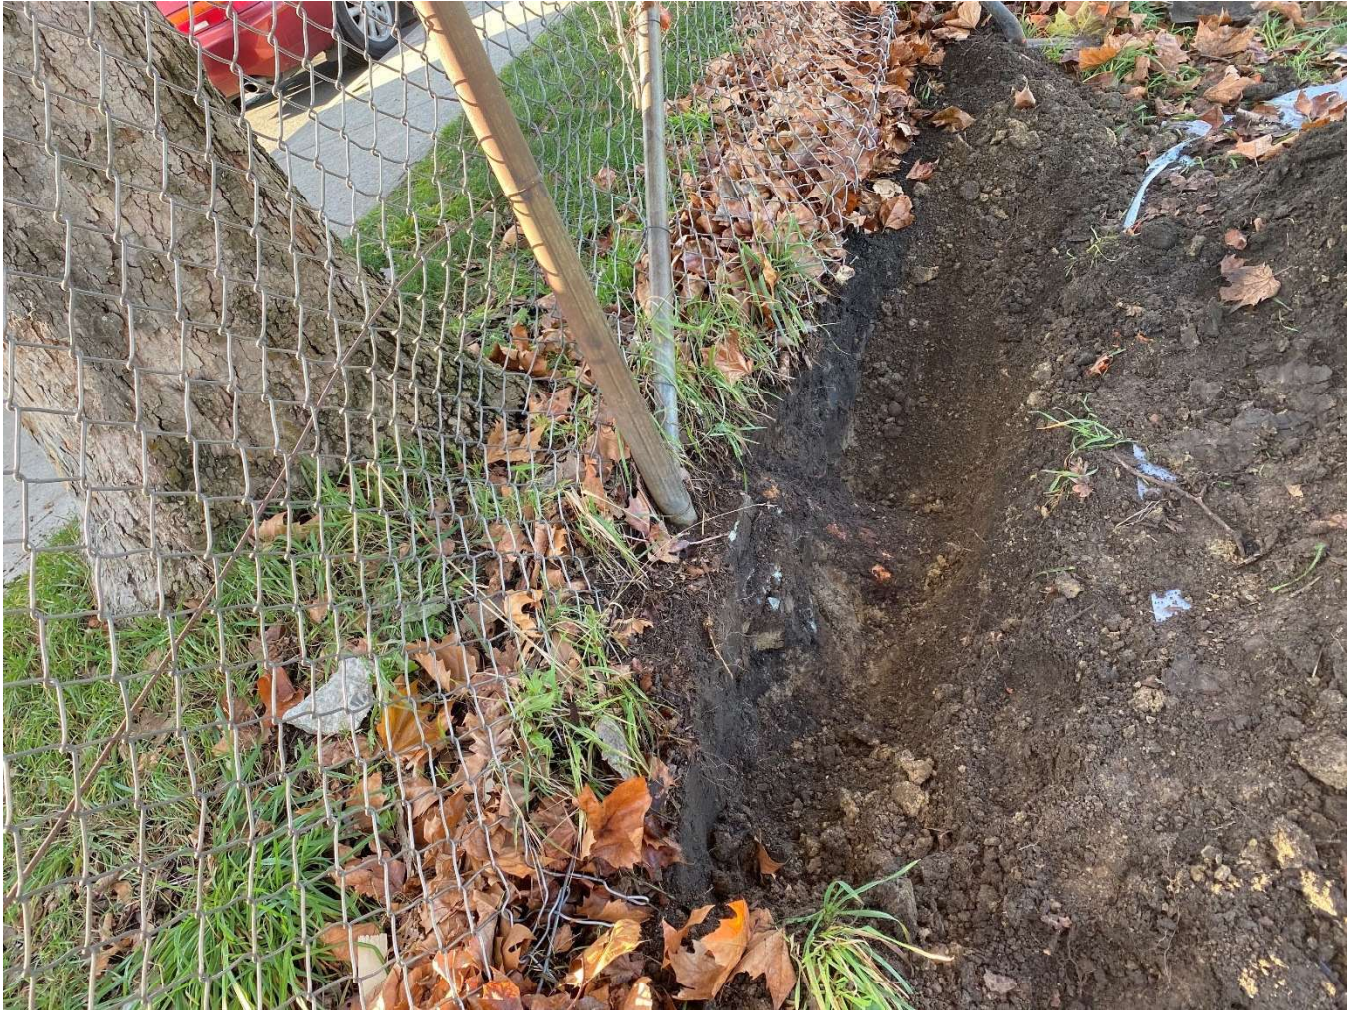
- Hand excavation was performed along the existing fence line (which is approximately the property boundary). The West edge of the exploratory trench is 0.8 meters from the center of the stem of NT 5.
- The depth of the exploratory excavation was 0.4 meters below the existing grade (at the location of the proposed sidewalk footprint).

- Based on the results of the exploratory excavation, the proposed new sidewalk is conflicting with the root flare of the tree; therefore the following is recommended:

*Photograph 4 – Municipal London Plane (NT5) – Exploratory excavation to determine root depth within the proposed sidewalk footprint.*

- An asphalt sidewalk is recommended, within the critical root zone of NT5, due to the close proximity of the proposed sidewalk to the trunk and root flare. There will not be sufficient working space for concrete forming on the West side of the proposed sidewalk.

- The sidewalk must be constructed above the elevation of the buttress root that was exposed by exploratory excavation. If the sidewalk is constructed in its proposed location, excavation cannot occur below the existing grade that would require the removal of this structural root.

- If a narrower sidewalk is possible, or if it can be shifted East – no closer than 1.1 meters from the center of the tree, it would avoid the conflicts with the root flare of NT 5, and could be constructed at grade (using concrete).

- It is recommended that the project arborist review a grading plan, once one is available, to review the proposed site grading within the critical root zone of NT 5.

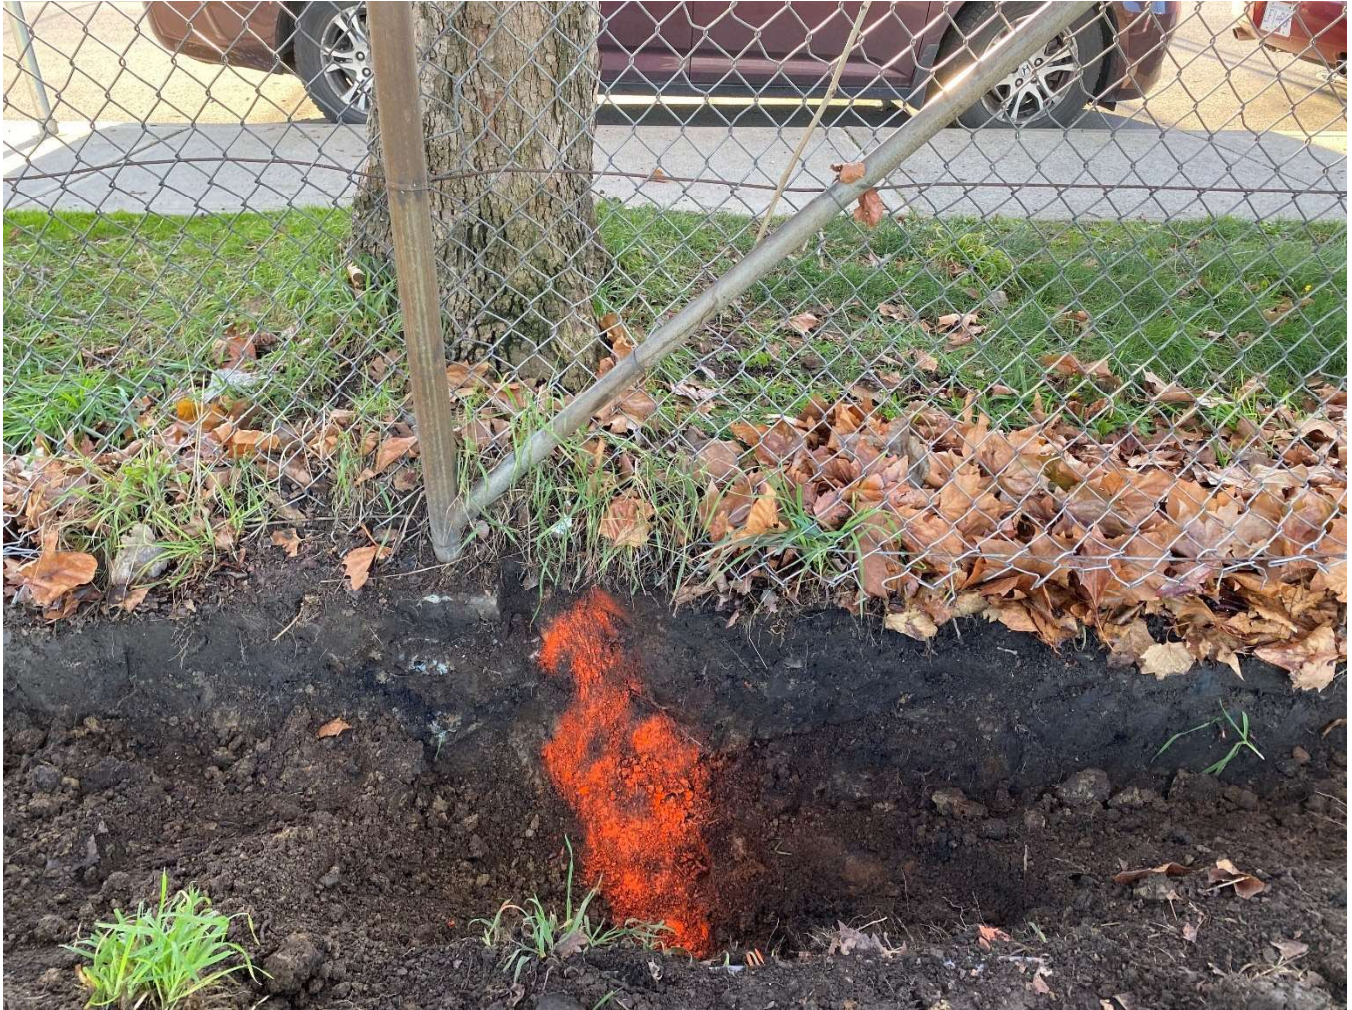
- A large buttress root (approximately 35 cm diameter) was encountered (see photographs 4 and 5 in [appendix B](#)) at 0.8 meters distance from the center of the stem of NT5). This root was observed to grow sharply downward at approximately the property boundary, then grows horizontally at 1.1 meters from the center of the stem.

- The topside of the root is approximately 40 cm below the existing grade – at a distance of 1.1 meters from the center of the stem of NT 5.
- No other roots were encountered from this tree, along the limits of our exploratory excavation.

*Photograph 5 – Large buttress root (painted orange) found within the exploratory trench. No other roots were found during exploratory excavation.*
