MEMORANDUM

Date: March 17, 2020
To: File
From: John O'Reilly, Senior Planner- Heritage
Subject: 506 & 514 Government Street- Final Inspection

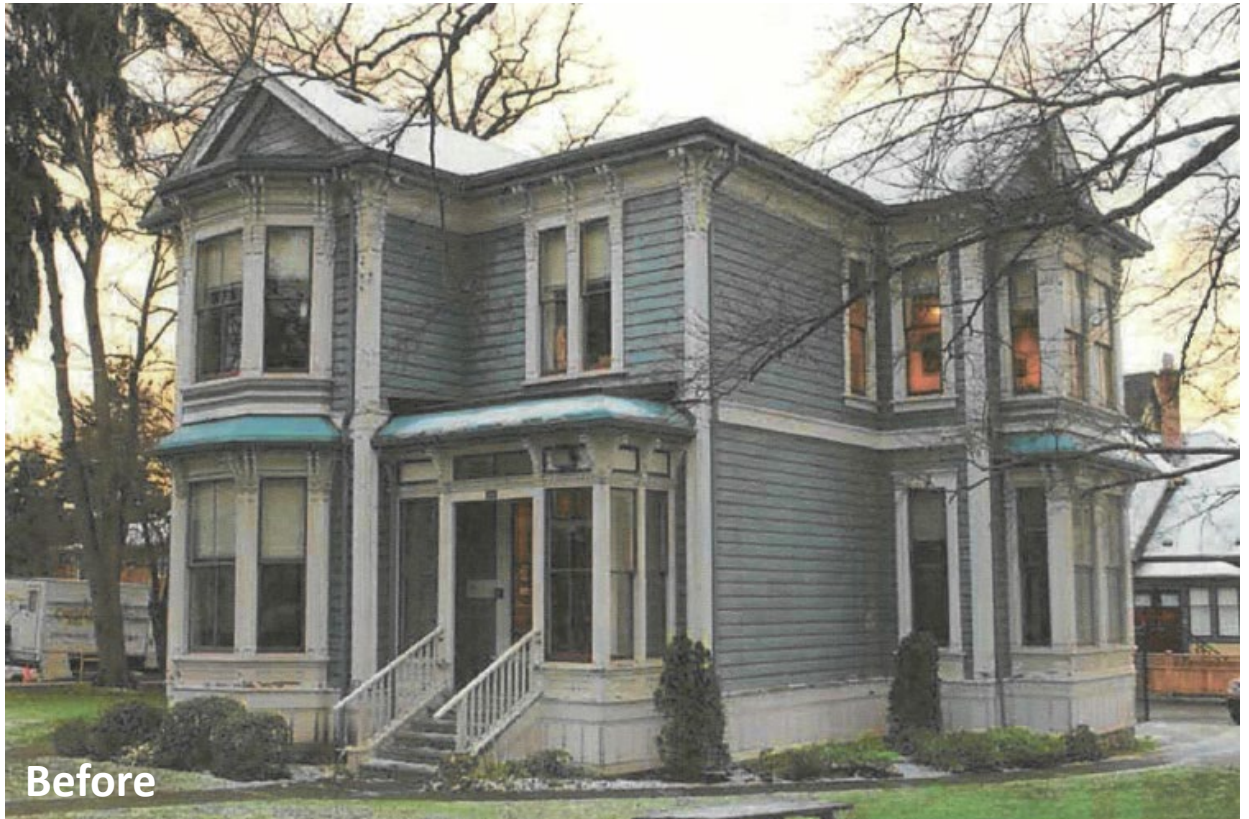
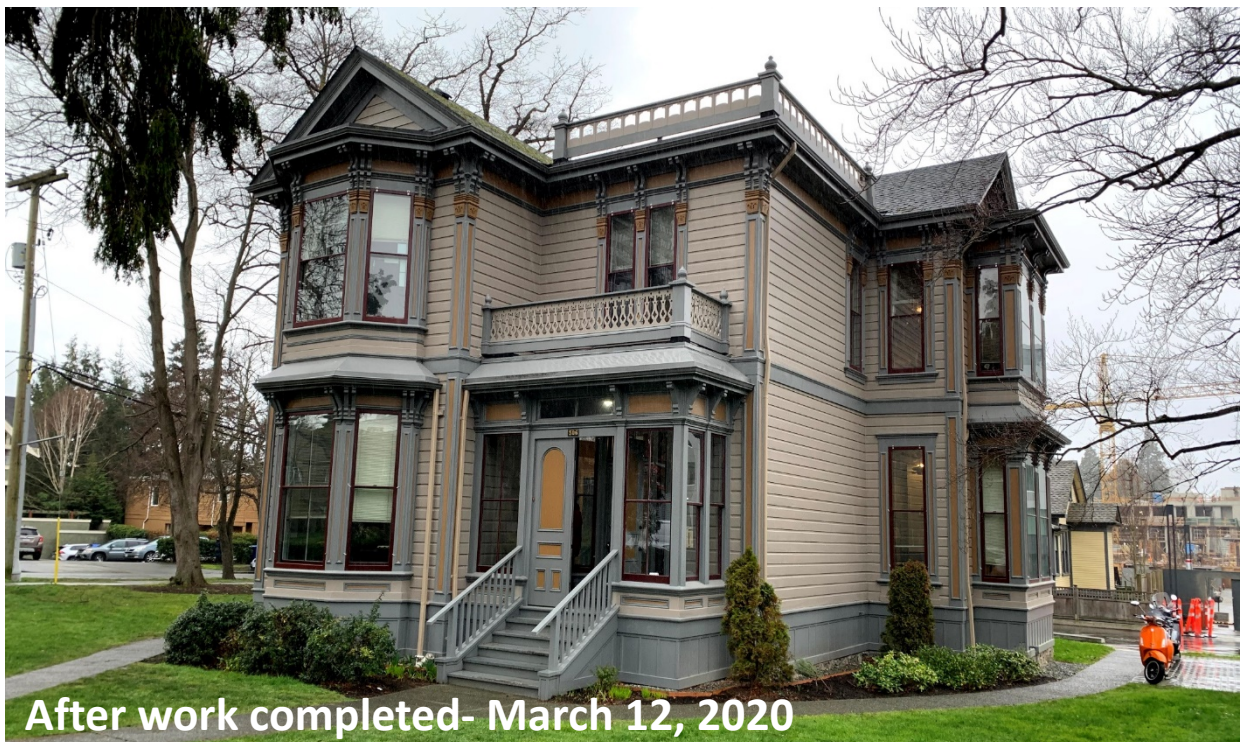
Cresting reinstalled at roof and balcony levels, lead abatement and re-painting

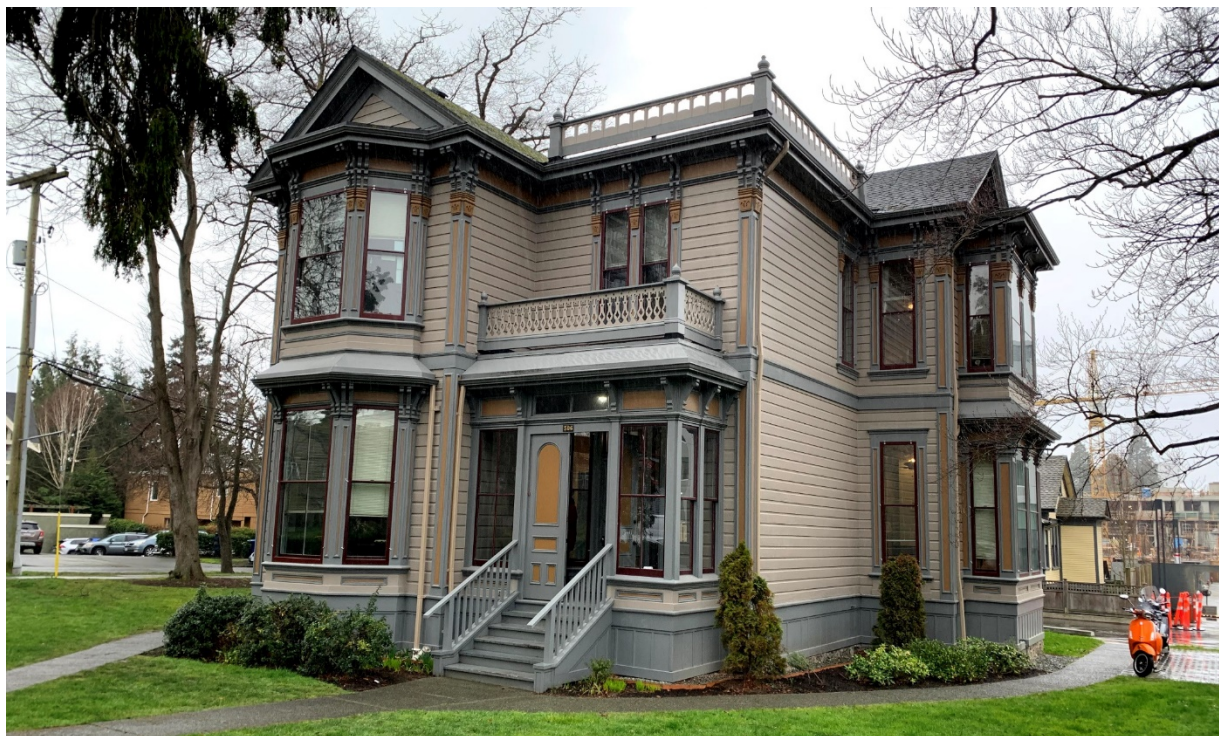
506 Government Street- Front (East) Elevation

Results of Evaluation of 506 Government Street		
Elevation	Conservation Work	Evaluation
Front (East) Elevation	Reconstruct Upper Roof Balustrade	Completed
	Re-paint soffit, siding, foundation skirting and trim	Whole building re-painted in historically appropriate colours
	Reconstruct portico balustrade as detailed. New roof membrane to be installed to accommodate post base and flashing details	Portico balustrade reconstructed. Scroll cut balusters have accurate proportions. Did not confirm if roof membrane installed.
	Remove and reinstate belt course flashing as necessary to accommodate membrane and flashing transitions with wall assembly	Belt course present on all building elevations. It has been painted in a different colour than the siding to accentuate it.
	New portico doors	Completed and installed
	Restore siding to cover electrical boxes if possible	No electrical boxes observed.
West (side) Elevation	Reinstate dislocated trim	Surveyed trim, it was firmly installed.

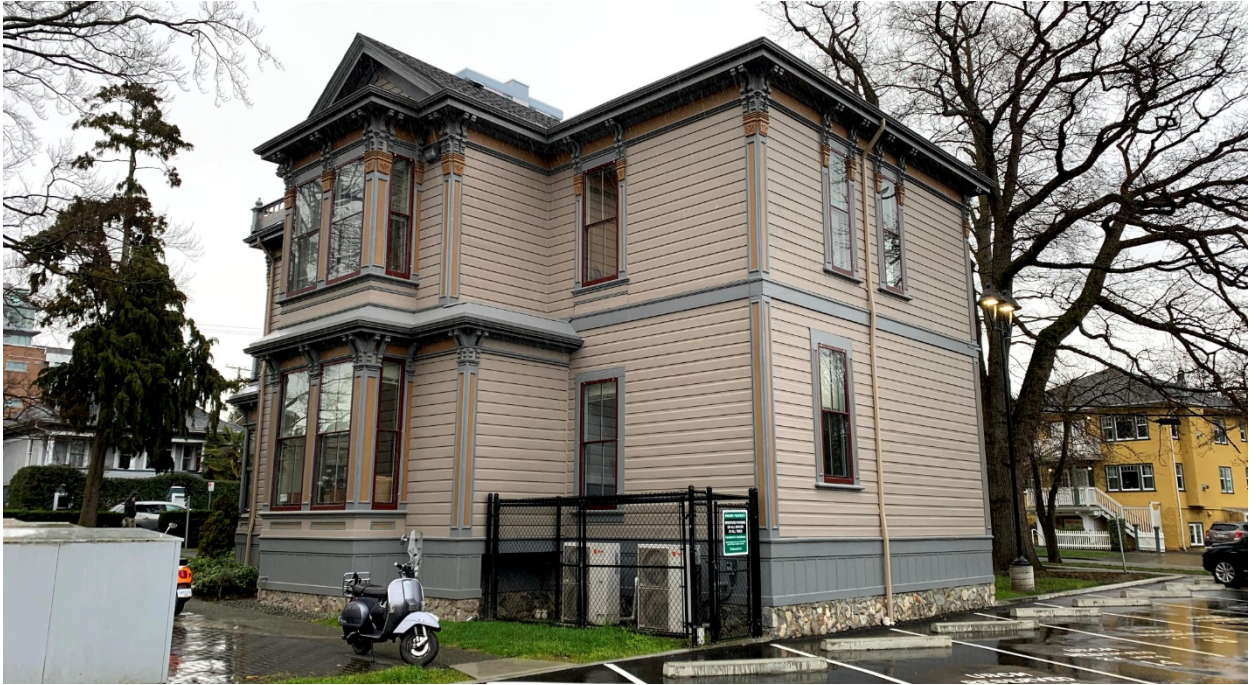
506 Government Street- West (side) Elevation

Repaint soffit, siding, foundation skirting and trim	All components repainted
	Existing flashing to be removed and reinstated see R201 for details.	Portico balustrade reconstructed. Scroll cut balusters have accurate proportions. Did not confirm if roof membrane installed.
	Fire escape staircase to be renewed	Fire escape staircase completely rebuilt
	Replace water table trim where necessary	Present on all elevations. Appears to be securely fastened
South (side) elevation	Repaint soffit, siding, foundation skirting and trim	All elements re-painted.

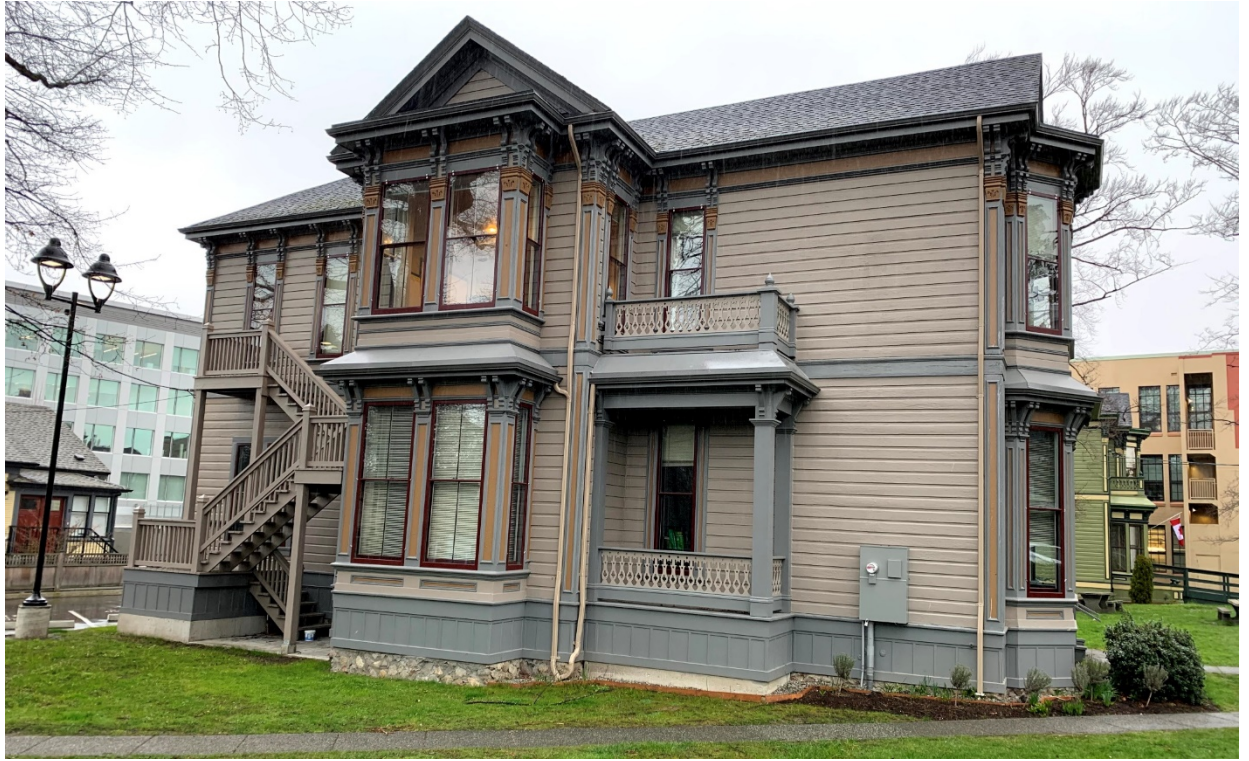
506 Government Street- Side (South) Elevation

Reconstruct south porch and upper balustrade based on the form and detailing of the existing front portico. Similar building details and historic photographs. All design work to be reviewed and approved by JDA	Completely rebuilt as new. Finished product uses over-the-post handrail, which differs slightly from drawing. This is an acceptable variance in design, however.
	Fire escape to be renewed	Done
North (side) elevation	Reconstruct upper roof balustrade	Done
	Reconstruct portico balustrade as detailed. New roof membrane to be installed to accommodate post base and flashing details	Portico balustrade reconstructed. Scroll cut balusters have accurate proportions. Did not confirm if roof membrane installed.
	Remove and reinstate belt course flashing as necessary to accommodate membrane and flashing transitions with wall assembly	Belt course present on all building elevations. It has been painted in a different colour than the siding to accentuate it.

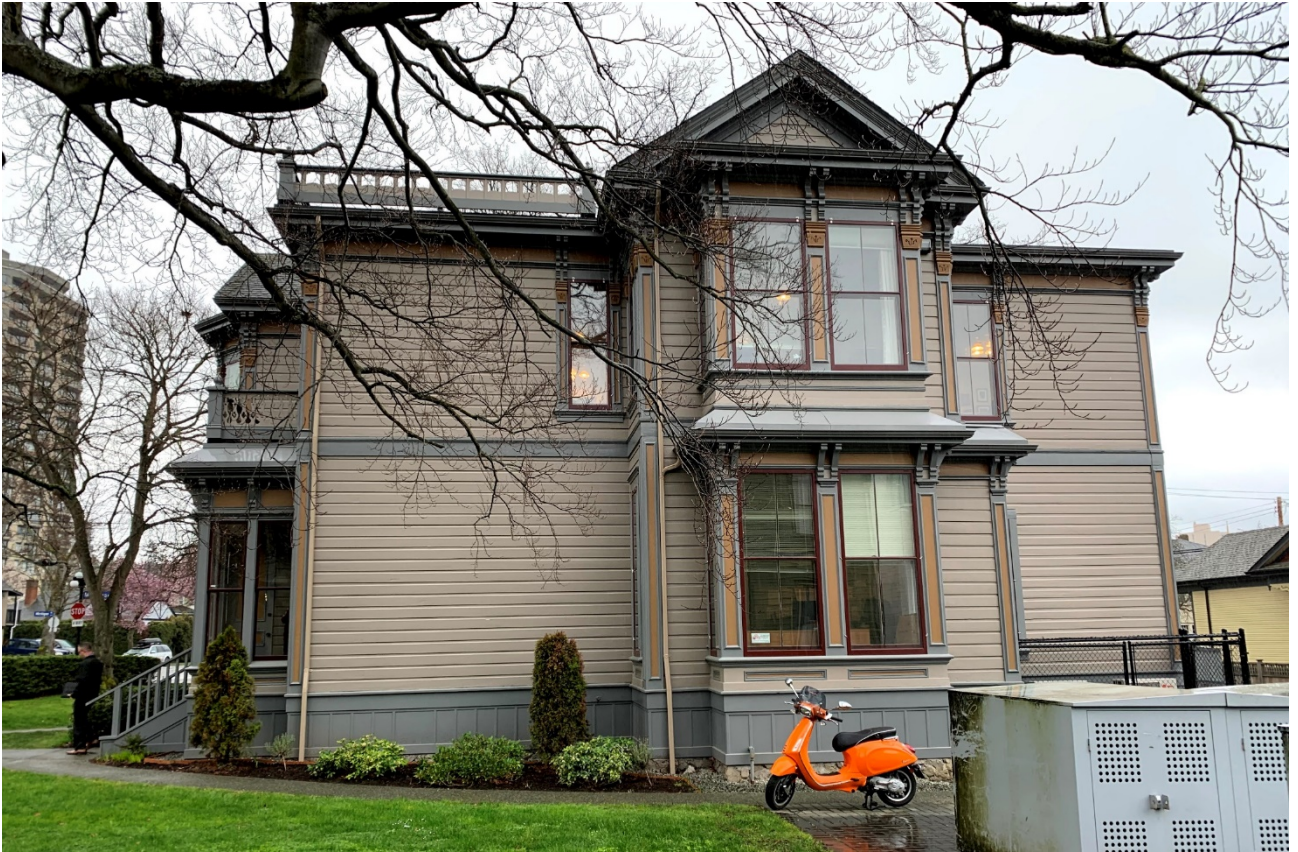
506 Government Street- North (side) elevation

Existing flashing to be removed and reinstated	Reinstated and appears to be brand new.
	Re-paint soffit, siding, foundation skirting and trim	Whole building re-painted in historically appropriate colours.

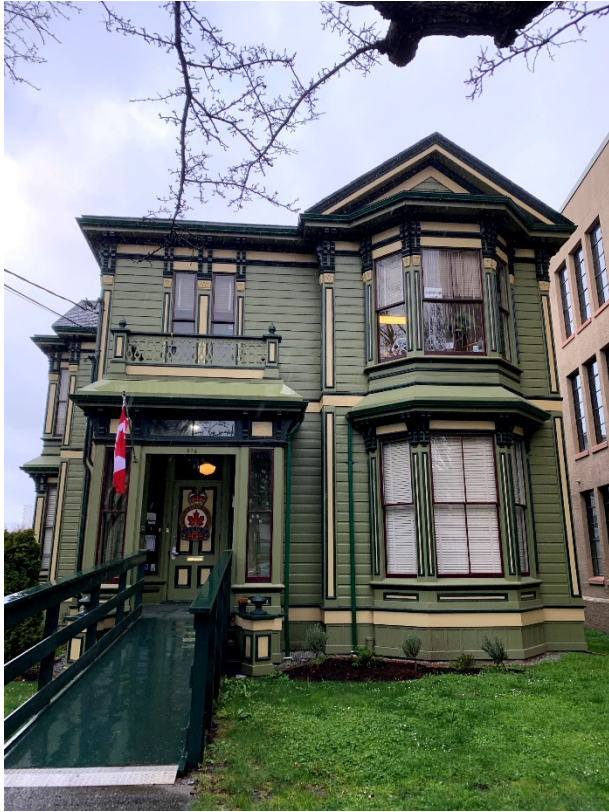
Front (east) elevation

I photographed 514 Government Street, which appeared to be in excellent condition, however it was not the subject of a detailed review due to a lack of information about planned restoration measures.
