1114-1126 BLANSHARD STREET, VICTORIA, BC

# **OUTLINE HERITAGE CONSERVATION PLAN**

MARCH 2021

#### MONTROSE APARTMENTS

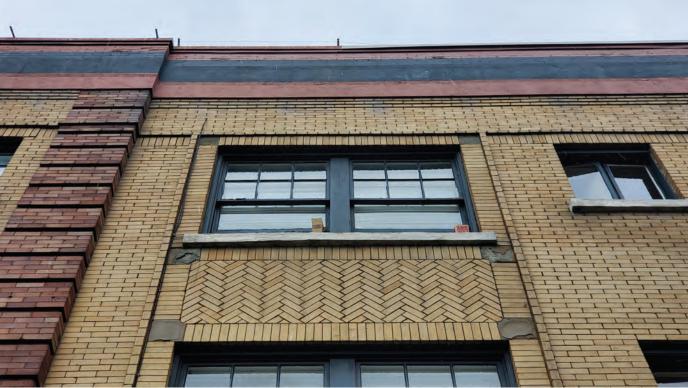
Figure 20: Detail photo showing typical paired wood window assembly with double-hung sashes. Note typical deterioration of brick masonry units below missing parapet cornice.

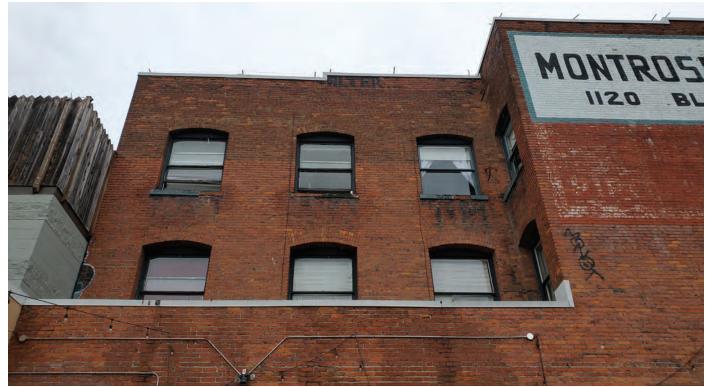
Figure 21: Detail photo showing arched window openings with double-hung wood window sashes at south elevation. Note deteriorated parging of wood window sills, exposing brick masonry units in rowlock coursing underneath.

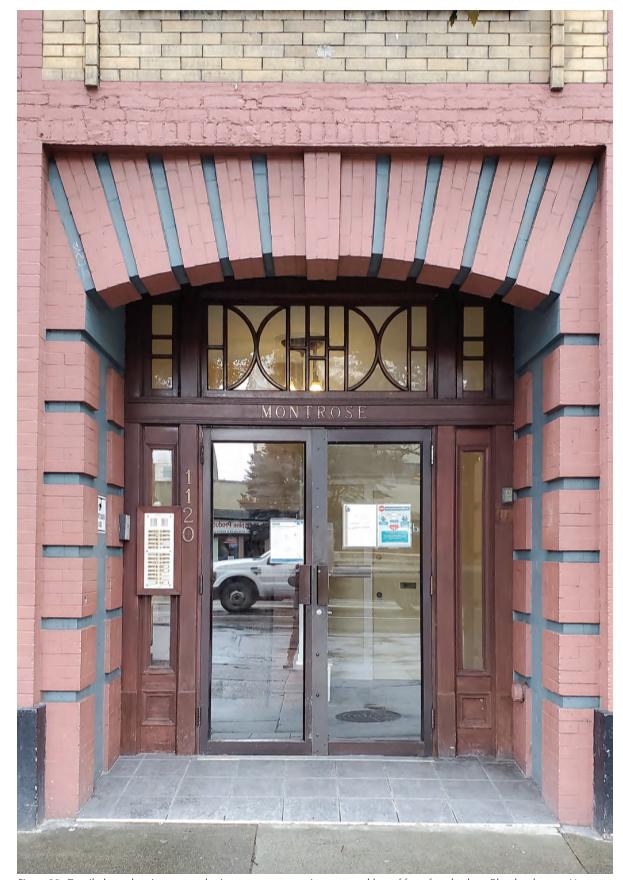
Figure 22: Detail photo showing recessed primary entrance portico at central bay of front facade along Blanshard street. Note existing replacement door sashes (paired narrow-stile metal doors with glass inset) that are not historically appropriate.

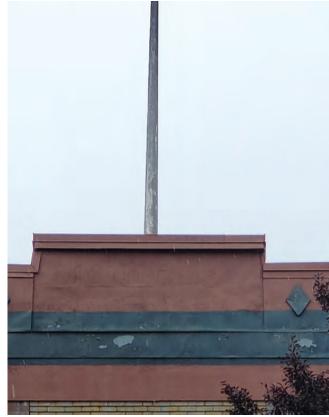
Figure 25: Detail photo showing existing typical deteriorated condition of pediment above the central bay of the historic front facade along Blanshard Street. Note existing flagpole partially shown in the background.

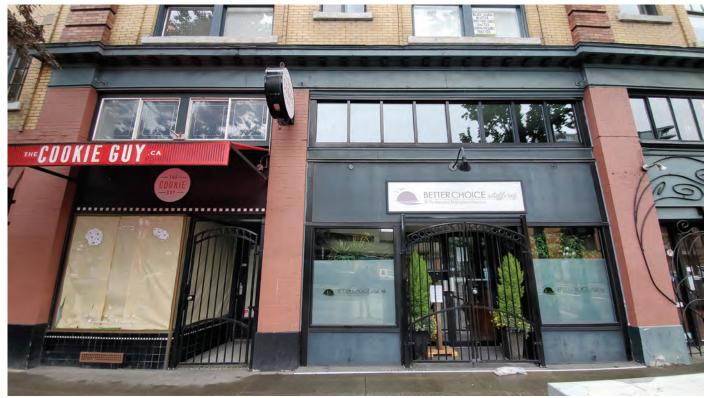
Figure 26: Detail photo showing existing typical condition of storefronts along Blanshard Street. Note ribbon of transom windows above "The Cookie Guy" does not reflect original configuration as shown above "Better Choice Staffing").

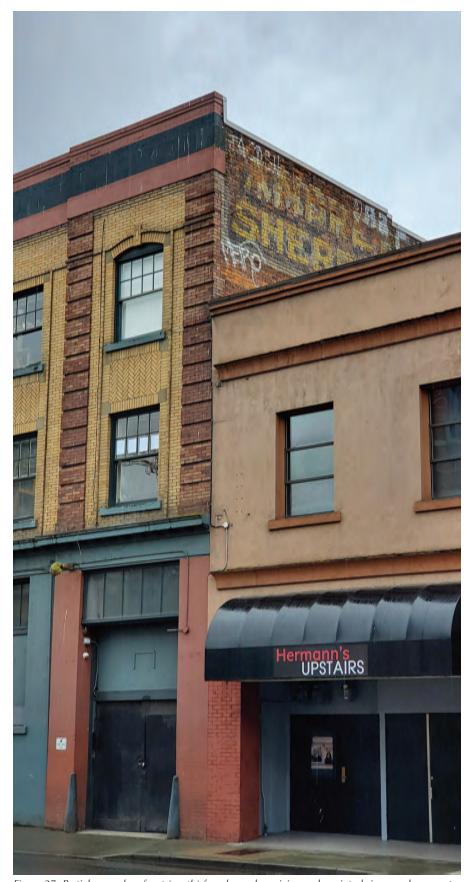
Figure 27: Partial secondary front (north) facade, and surviving early painted signage along west (rear) elevation.

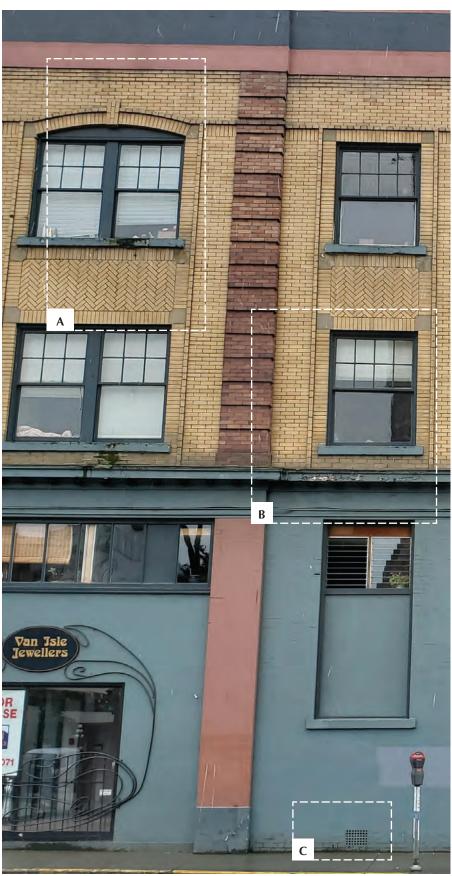
Figure 28: Detail photo showing partial North Elevation (along View Street) showing typical deterioration of exterior character-defining elements caused by water ingress and saturation.

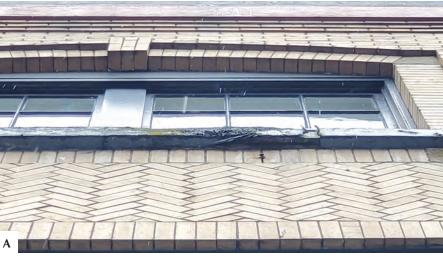
Figure 29: Detail photo showing typical deterioration of window sill. Note discolouration and biological growth, and paint failure.

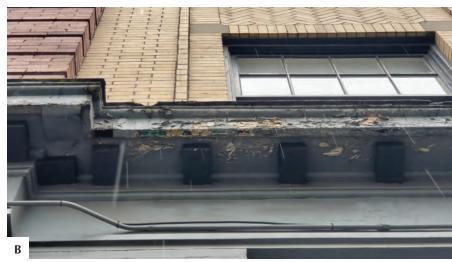
Figure 30: Detail photo showing typical deterioration of architectural metal cornice. Note discolouration and biological growth; paint failure; and, corrosion of metal elements.

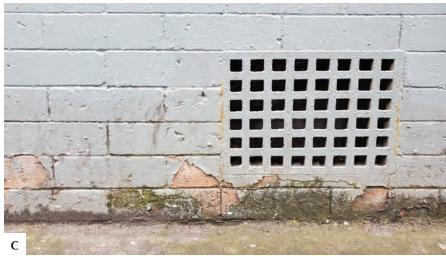
Figure 31: Detail photos showing unsympathetic paint finish over brick masonry units. Note discolouration and biological growth; further investigation is required to determine if face brick are spalling underneath.
