## **Arborist Report for Development**

Site Address: 912 Vancouver St, Victoria  
Christ Church Cathedral

Date of Report: April 22, 2021

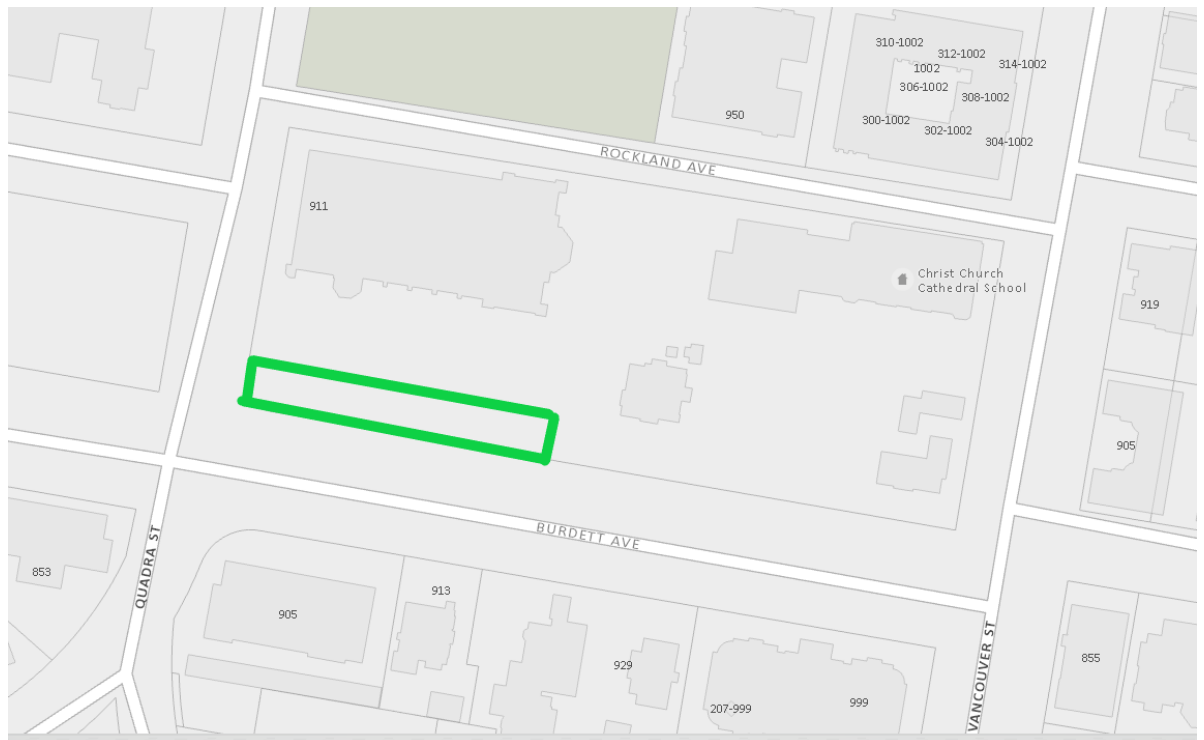
Recommended location for replacement trees.

Two replacement trees are required to be planted on the site to mitigate the removal of Tree 940. There are many optional locations for this block wide property. The park lawn area near the corner of Burdett and Quadra has lost three well located trees recently, these locations are excellent for planting the replacement trees. Gye and Associates recommends large maturing shade trees such as:

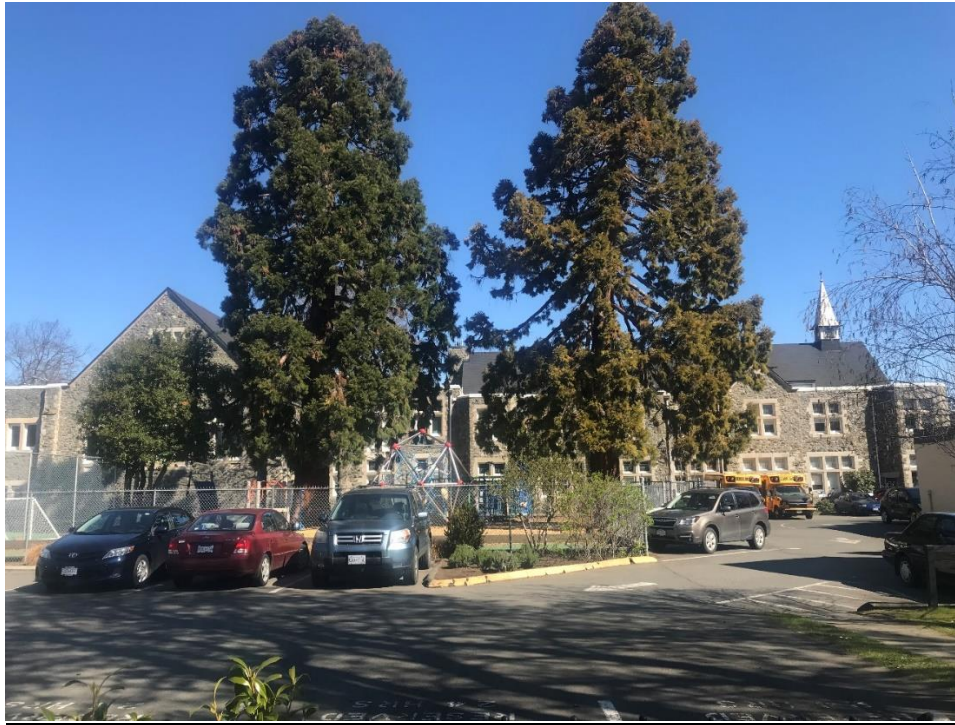
| Tag # | Common Name | Bylaw status | Stem diameter (DBH cm) | PRZ radius (m) | Crown diameter (m) | Structural condition | Health | Location | Retention suitability | Species tolerance to disturbance | Comments | Recommendations |
|---|---|---|---|---|---|---|---|---|---|---|---|---|
| 937 | Giant redwood | Protected | 134 | 17 | Fair | Good | Fair | On-site | Suitable | Good | Moderate symptoms of stress manifest in past three years. No visible defects in main stem. No history of large branch failure. Small dead branches in upper crown. | Retain and protect |

Giant sequoia on right (tag # 937) showing symptoms of stress

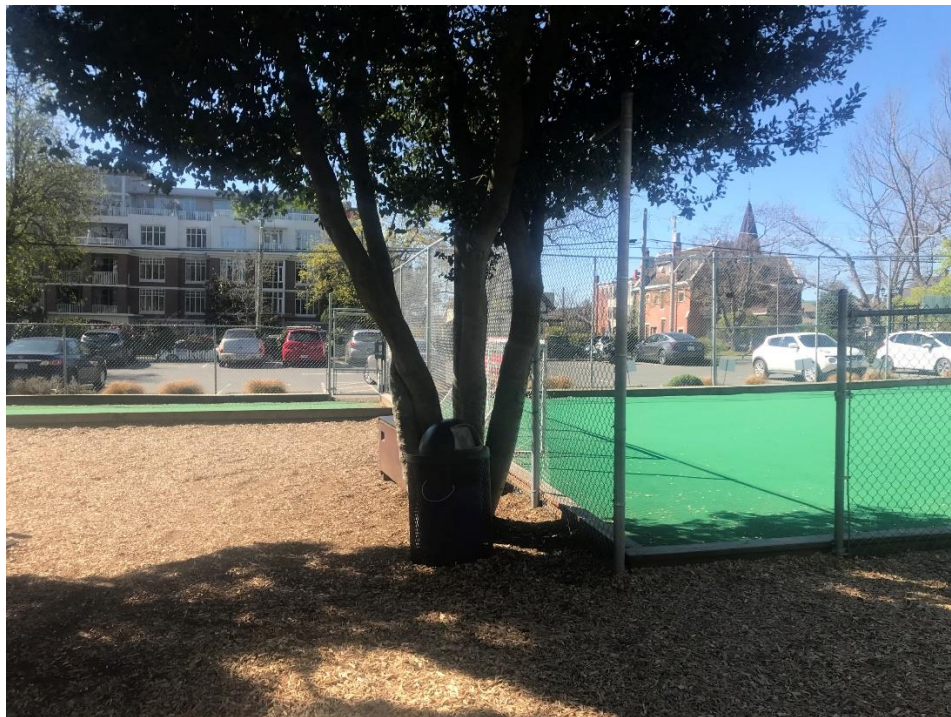
The position of the American holly (tag # 0940) abutting the proposed structure makes its successful retention unlikely. Half of its crown and half of its root system are in direct spatial conflict. Any surviving stems will become unstable in the direction of the active play area or will physically interfere with the building. Trees replacing it in the garden area nearby will make a much more significant contribution to Victoria's urban forest over time.

| Tag # | Common Name | Bylaw status | Stem diameter (DBH cm) | PRZ radius (m) | Crown diameter (m) | Structural condition | Health | Location | Retention suitability | Species tolerance to disturbance | Comments | Recommendations |
|---|---|---|---|---|---|---|---|---|---|---|---|---|
| 940 | American holly | Protected | 49 | 4 | Good | Fair | Good | On-site | Suitable | Good | Multistem. Some stems damaged by rubbing together. | Remove and replace elsewhere on church property. |

Holly # 940 to be removed. Sports Court on its right is location of proposed modular building.

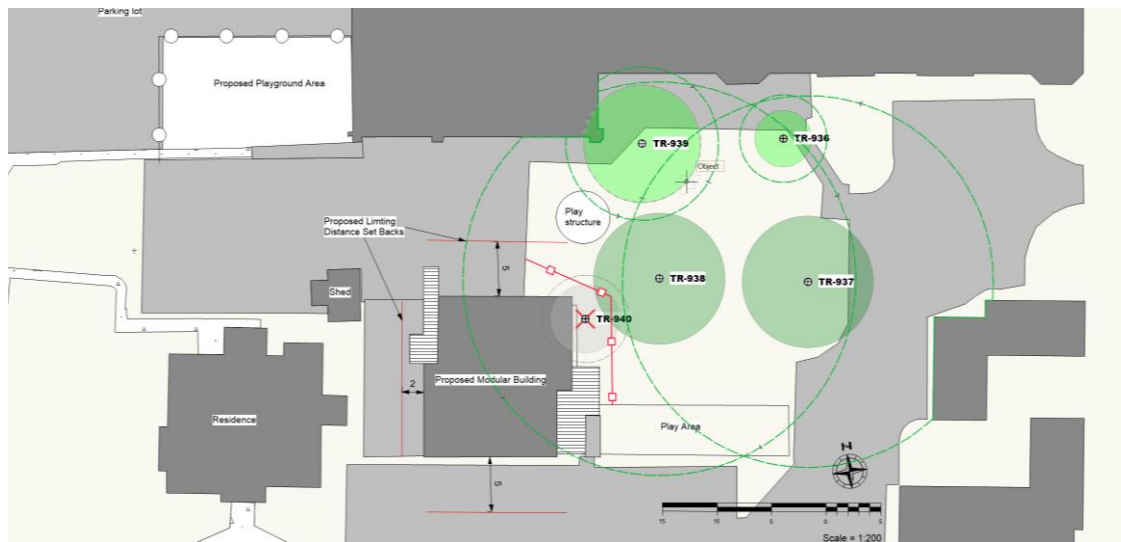
Site plan showing proposed modular building, tree locations, and other landscape features. Tree roots from Sequoias # 937 and # 938 have adapted to the decades old land uses, with preferential feeder root growth within the mulched play area and other softscapes. The artificial turf of the long-established sports court produces an environment that is inhospitable to roots.

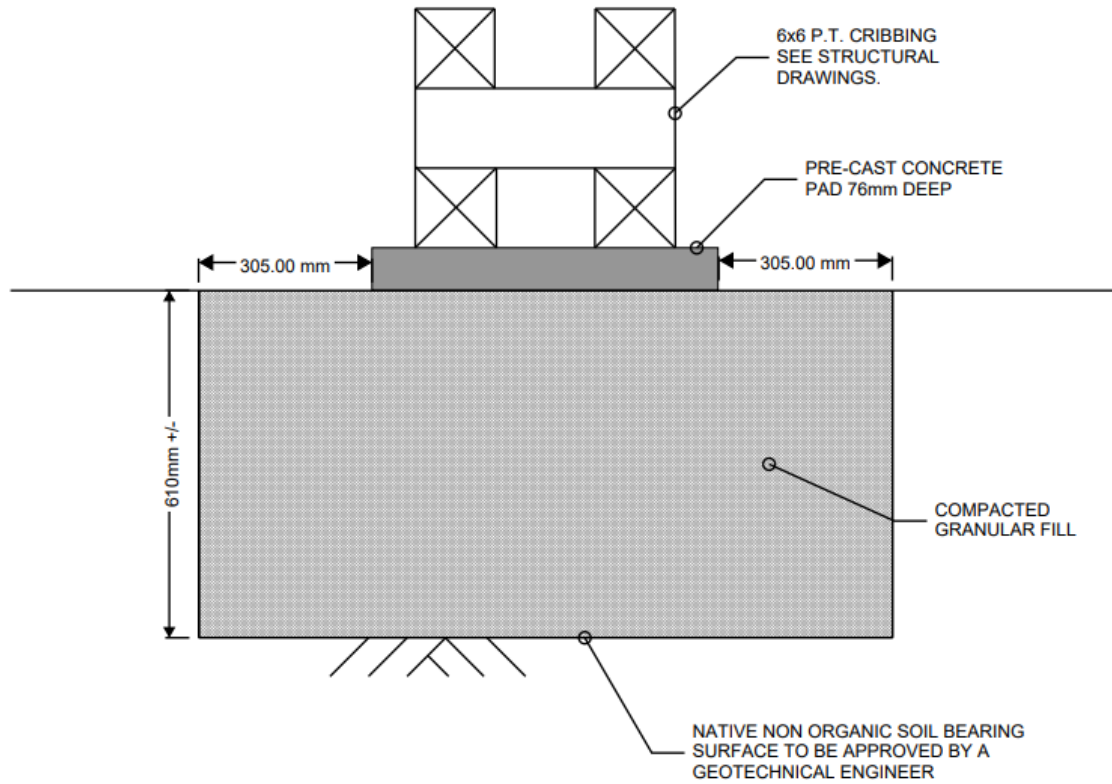
Installation of the concrete footings and placement of the structure will mainly impact a multi-stemmed holly immediately adjacent to the proposed building location (tag # 940); this tree will need to be removed. The structure will also sit just inside the protected root zone of a Giant redwood (Tree 938) with a stem diameter of 1.6m. The other on-site trees nearby can be isolated from impact of the work with protection fencing. Root impacts to Tree 938 can be minimized by implementing standard tree protection measures, detailed below and on the attached Tree Protection Plan drawing.

Design of support blocks for proposed modular building. Some native soil will be preserved, allowing limited expansion of root system from Sequoia # 938 into the area.
