# Arborist Report

## 3150/3152 Somerset Street, Victoria

Date submitted: January 08, 2021.  
March 25, 2021 Amended.  
June 03, 2021 Amended

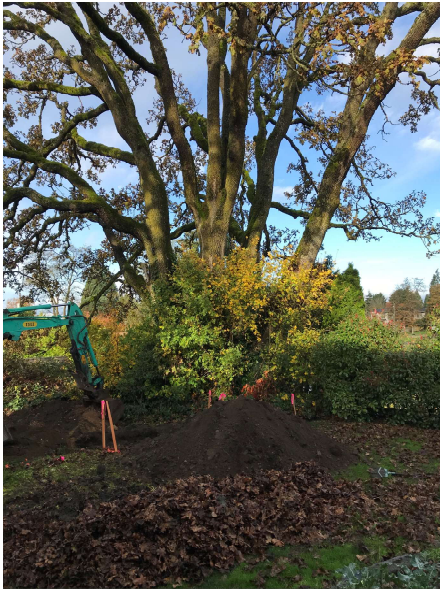
During our November 04, 2020 site visit, exploratory excavation was conducted along the edge of the proposed building footprint on this lot, to determine whether Garry oak #592 can be retained. The following information was compiled.

- The soils that were excavated appear to be mostly fill soil that extended to a depth of 1.7 metres and contained granular sand, construction material including degraded stucco. Between the 1.5 and 1.7 metre depth a layer of brown sandy medium was encountered along the length of the excavation.
- Other than the 5 cm root encountered and retained at the north end of the excavation, no other roots larger than 2 cm in diameter were encountered.

Garry oak #592 excavation location

The project arborist must supervise the excavation along the edge of the footprint, closest to Garry oak #592 to observe the number and size of roots that are encountered to determine the impacts on the tree, the options available to mitigate any impacts and determine the retention status of this tree.

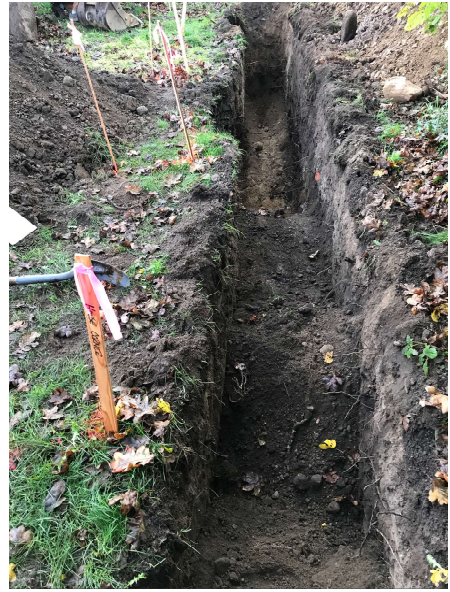
- At the north end of the excavation closest to the tree, bedrock was encountered 76 cm below the surface grade. One 5 cm diameter root that grows over the rock was encountered and retained. No other roots were encountered in this location.

Excavation at north footprint corner

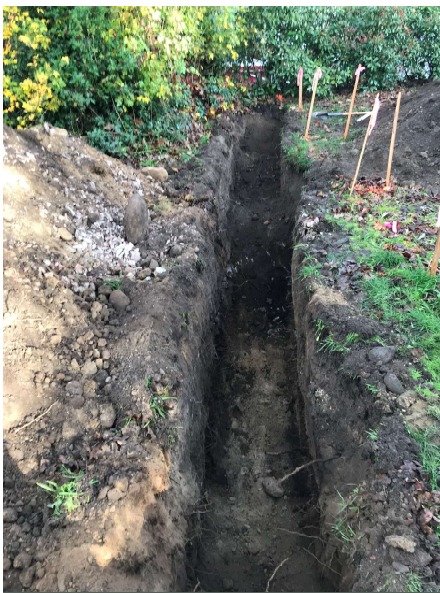
- The excavation was completed with the use of a small excavator under the direct supervision of the project arborist.
- The excavation conducted was within one quadrant (north east) of the trees root zone where fill soil had been installed within the lot historically. The excavation was approximately 1 metre closer to the tree than the building footprint location as staked out on site (2 metres from the base of the tree at its closest point) and extended approximately 7 metres toward the south property boundary.

Excavation viewed from south.

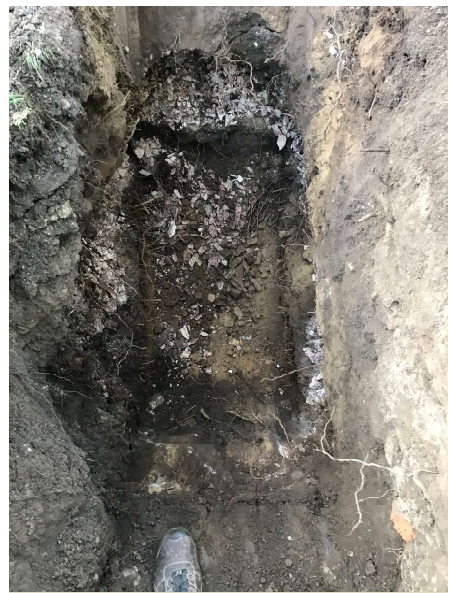
Fill material encountered.

Based on our exploratory excavation, in our opinion it should be possible to remove most if not all the fill soil that has been placed between the tree and the proposed house footprint historically. The patio in the rear garden is proposed to be constructed at or above the (31.50) existing site grade. There is a hump of soil (31.92) between the tree grade (31.57) and the patio grade (31.50). The removal of up to 0.5 metres of soil would be required to reduce this grade to the grade at the patio. The project arborist must supervise any excavation that occurs between the tree and the patio and determine how much depth of soil can be removed without compromising the roots of this protected Garry oak tree. It may be determined that the grade in this location cannot be reduced to the patio grade and therefore a gentle slope must be maintained between the tree and this patio.

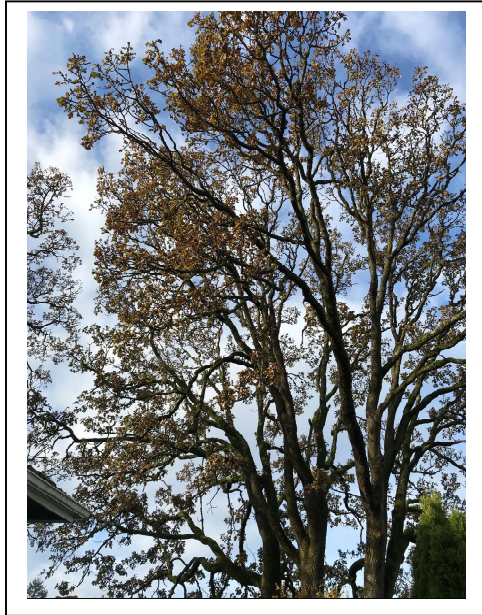
Canopy pruning will be required for clearance above the building footprint. Two lateral limbs 10 cm in diameter or larger will require pruning or removal for clearance above the structure however this pruning is unlikely to remove more than 5% of the total existing canopy and therefore would not have a detrimental impact on the health of the tree.

Canopy at north corner of footprint

**Canopy Pruning:** The canopy of Garry oak #592 will require pruning for clearance above the building footprint. The house footprint is located where the large stem that extends out from the northeast side of the tree and extends along the north property boundary can be retained. Where possible pruning cuts should be limited to limbs smaller than 10 cm in diameter. However, two lateral limbs 10 cm in diameter or larger will require pruning or removal for clearance above the structure. This pruning is unlikely to remove more than 5% of the total existing canopy and therefore would not have a detrimental impact on the health of the tree.

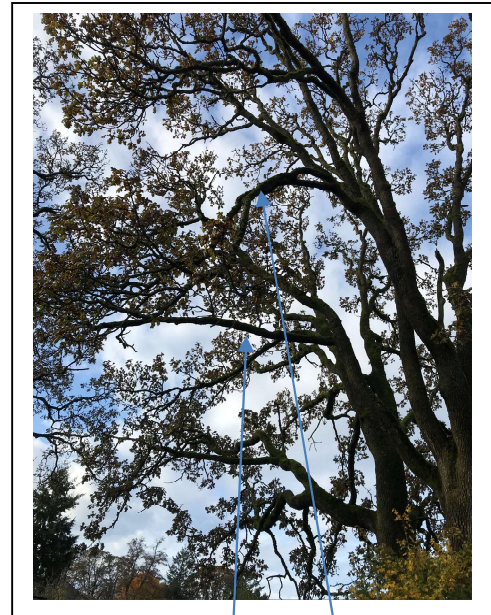
Limbs to be pruned or removed.
