Talbot Mackenzie & Associates

Construction Impact Assessment & Tree Preservation Plan

Reissued: May 12, 2020
(revisions within the May 12, 2020
report are marked with a red asterisk *)

Jobsite Property: 1150 Cook St, Victoria, BC

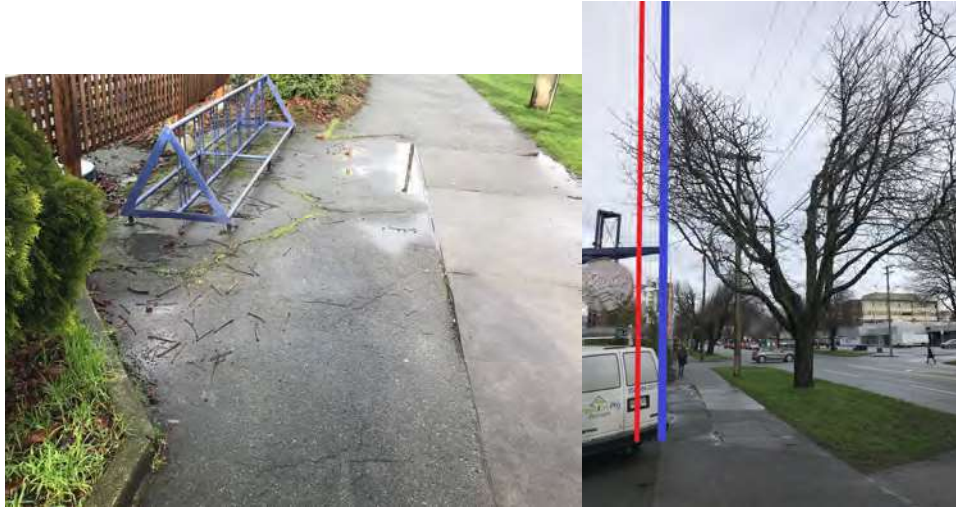
The asphalt portion of the sidewalk on municipal property is currently cracking in places, indicating potential locations of surface roots from chestnut #2. If the sidewalk requires replacement in this area, to avoid significant root loss, we recommend the guidelines in our “Paved Surfaces Above Tree Roots” specifications be followed. If a greater depth of base material and concrete is desired, this may require the finished grade of the sidewalk be raised above existing grade. Final grading plans of the paved areas outside the retail spaces should take this into account (e.g. if a slope away from the building is desired, the ground floor elevation may have to be raised above the grade of the sidewalk).

Picture #1 (left) showing the cracks likely caused by roots of Horse Chestnut #2. All roots within private property will be removed due to the underground parkade excavation to the property line (the edge of the concrete sidewalk at the top and bottom of the photo).

Picture #2 (right) showing the overall V-shaped canopy of chestnut #2. The red line indicates the approximate location of the balconies and the blue line indicates the property line; pruning to the property line would provide 60cm of clearance from the balconies.

The canopy of the tree has been severely pruned into a V-shape due to the clearance pruning for the overhead hydro lines. As a result, a larger proportion of the remaining canopy is growing over private property. The balconies will extend to 60cm from the property line resulting in approximately 15-20% of the remaining canopy being removed (depending on the desired and allowed clearance distance from the building and final cut locations). All pruning wounds are likely to be less than 10cm in diameter. We recommend the pruning take place at the framing stage of the project and be completed by an ISA Certified Arborist.

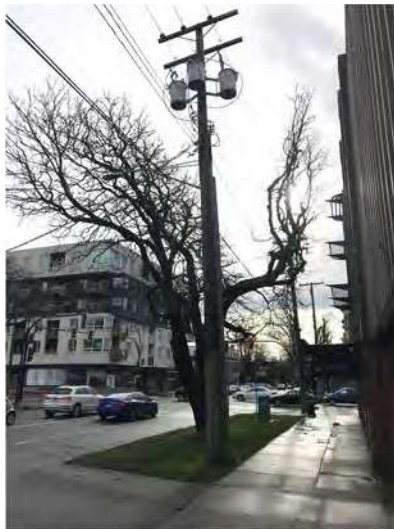
Picture #3 showing the Horse Chestnut tree south of the subject property (south of Horse Chestnut #1), on Cook St just north of Fort St. Like many of the chestnut trees along Cook St, this tree has been pruned back beyond the property line for building clearance. The overall form is representative of what Horse Chestnut #2 will likely look like in the future, if the development proceeds. However, in the case of the tree in this picture, the pruning cuts have been made even farther away from the property line than would be necessary for Horse Chestnut #2.

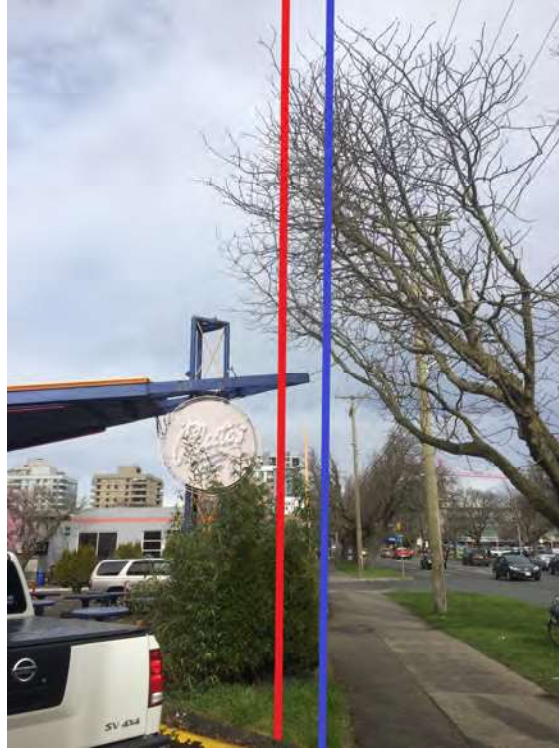
We do not anticipate the tree will decline as a result of the pruning; the form will look similar to the form of the Horse Chestnut trees located south of Horse Chestnut #1 on Cook St (Picture #3). The approximate location of the balcony and expected pruning is shown in Picture #4.

Picture #4: The red line indicates the location of the balconies and the minimum amount of canopy loss. 60cm of clearance from the building would result in pruning cuts made at or behind the property line (blue line).
