Capital Tree Service Inc.

Arborist Report

737 Belton Ave, Victoria, BC

April 21, 2021

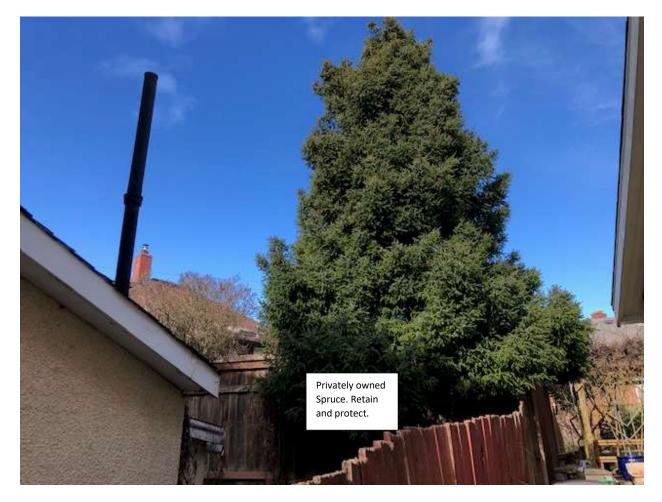
| TAG | Spec. | DBH | Ht | PRZ | Cond. | Reta | Rem | Comments/Recommendations |
|---|---|---|---|---|---|---|---|---|
| N/T 3 | Spruce | 27 est. | 8 | 3 | F/F | x | | Full canopy. Good colour. Private tree. Retain and protect. |

Figure 3 – N/T 3 Privately owned Spruce
