SHEAM & LOW BUILDING

LEE MONG KOW BUILDING

SING LEE BUILDING

VICTORIA'S CHINATOWN NATIONAL HISTORIC SITE, VICTORIA, BC

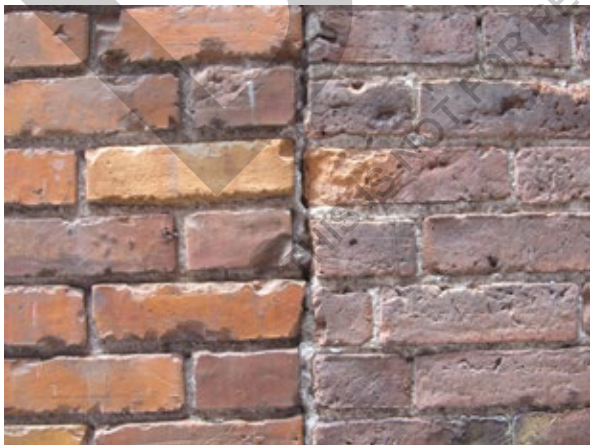
Exposed masonry of 16-20 Fan Tan Alley, left; exposed side wall of 543-545 Figgard Street, right.

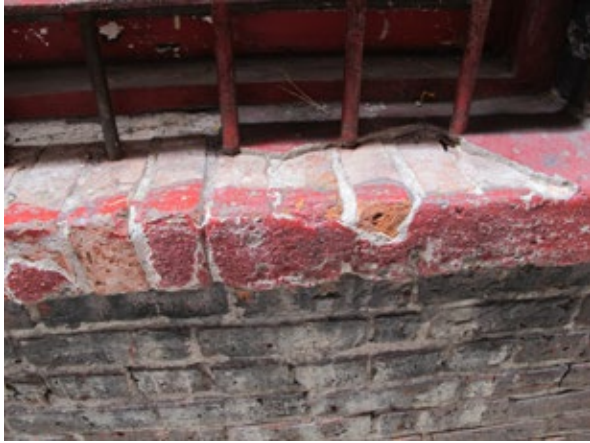
Exposed ground floor sill of 543-545 Fisgard Street facing Fan Tan Alley, showing delamination of parging.

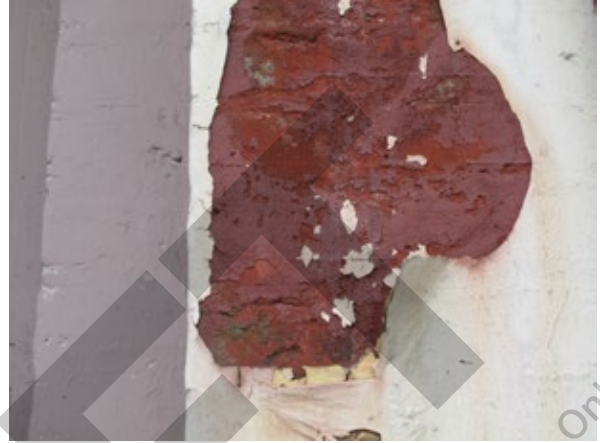
Damaged paint surface of storefront column at 543 Fisgard Street. The brick was originally unpainted. Note peeling down to early paint layers; the earliest application appears to be a red lead hydrophobic coating.

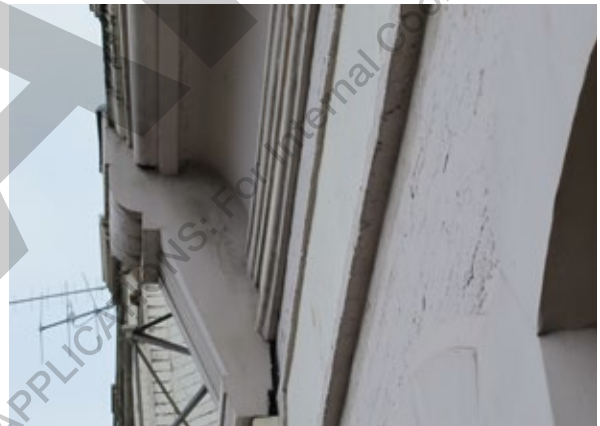
Close-up view of sheet metal cornice, showing detachment from wall surface at east end.

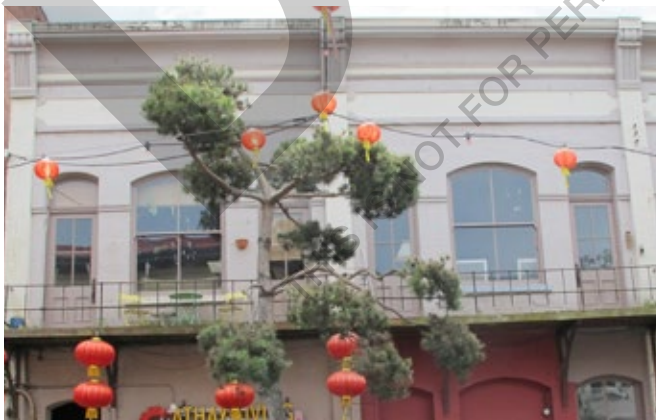
Upper floor replaced windows and doors of 543-545 1/2 Fisgard Street.

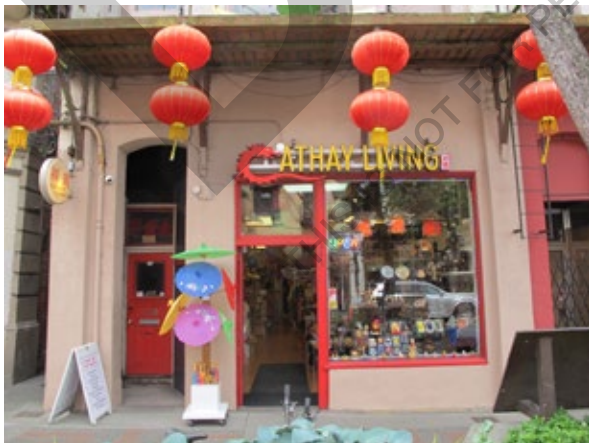
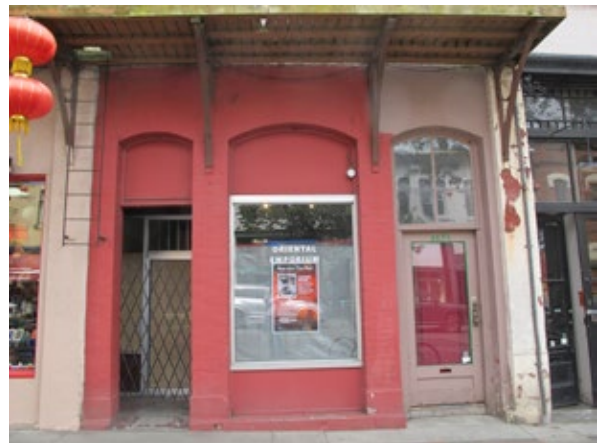
Below: Photos showing existing storefront configuration as viewed from Fisgard Street. Note original door and window openings have been altered at some point in time.

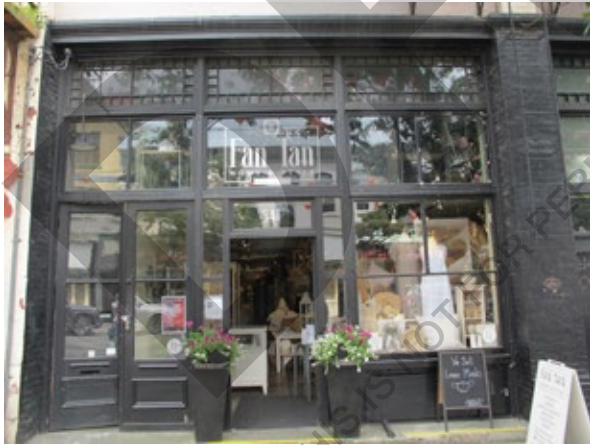
Existing condition of the original storefront shown in the photo above. Note existing replacement storefront door assembly, including sidelights and transom (with decal of address "541").

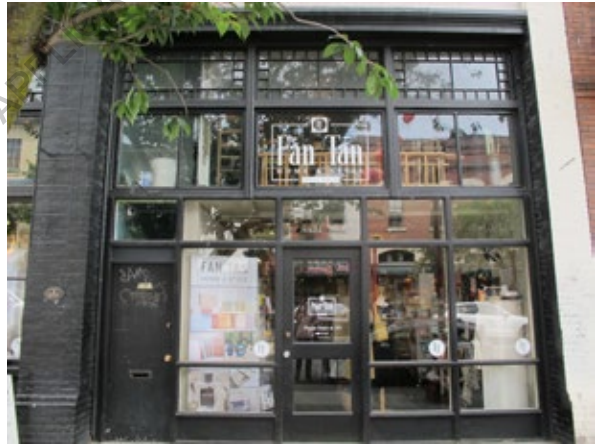
Existing condition of the adjacent original storefront, which is partially shown in the photo above. Note existing replacement door to access upper floor units.

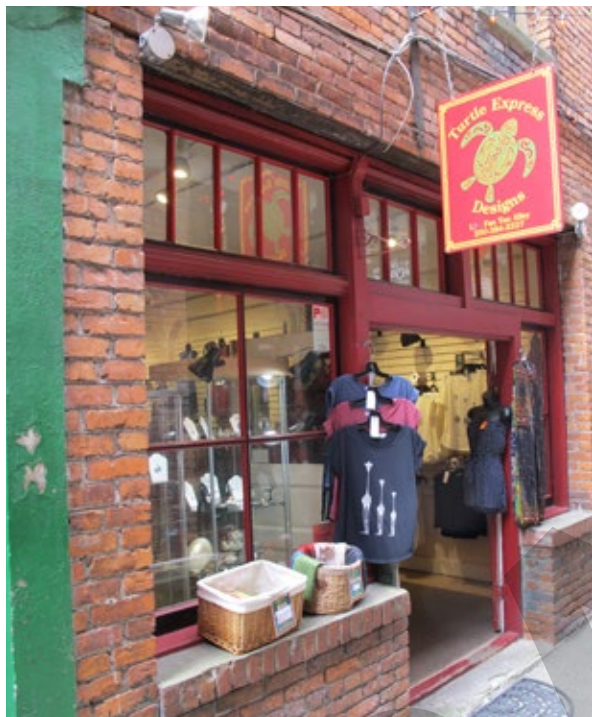
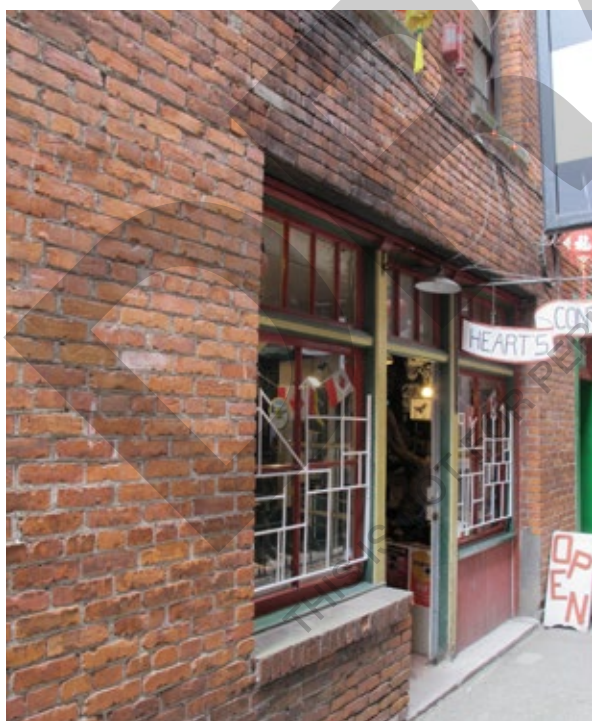
Photos showing existing storefront conditions along Fan Tan Alley.

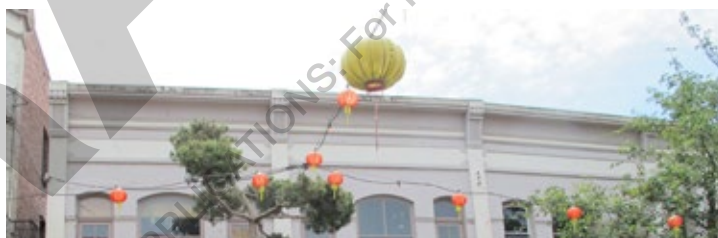
Existing condition of signage band below the parapet cornice.
