Fisgard Courtyard, Victoria, BC

Construction Impact Assessment & Tree Management Plan

PREPARED FOR: Salient Group
#225-209 Carrall Street
Vancouver, BC
V6B 2J2

DATE OF ISSUANCE: May 13, 2021

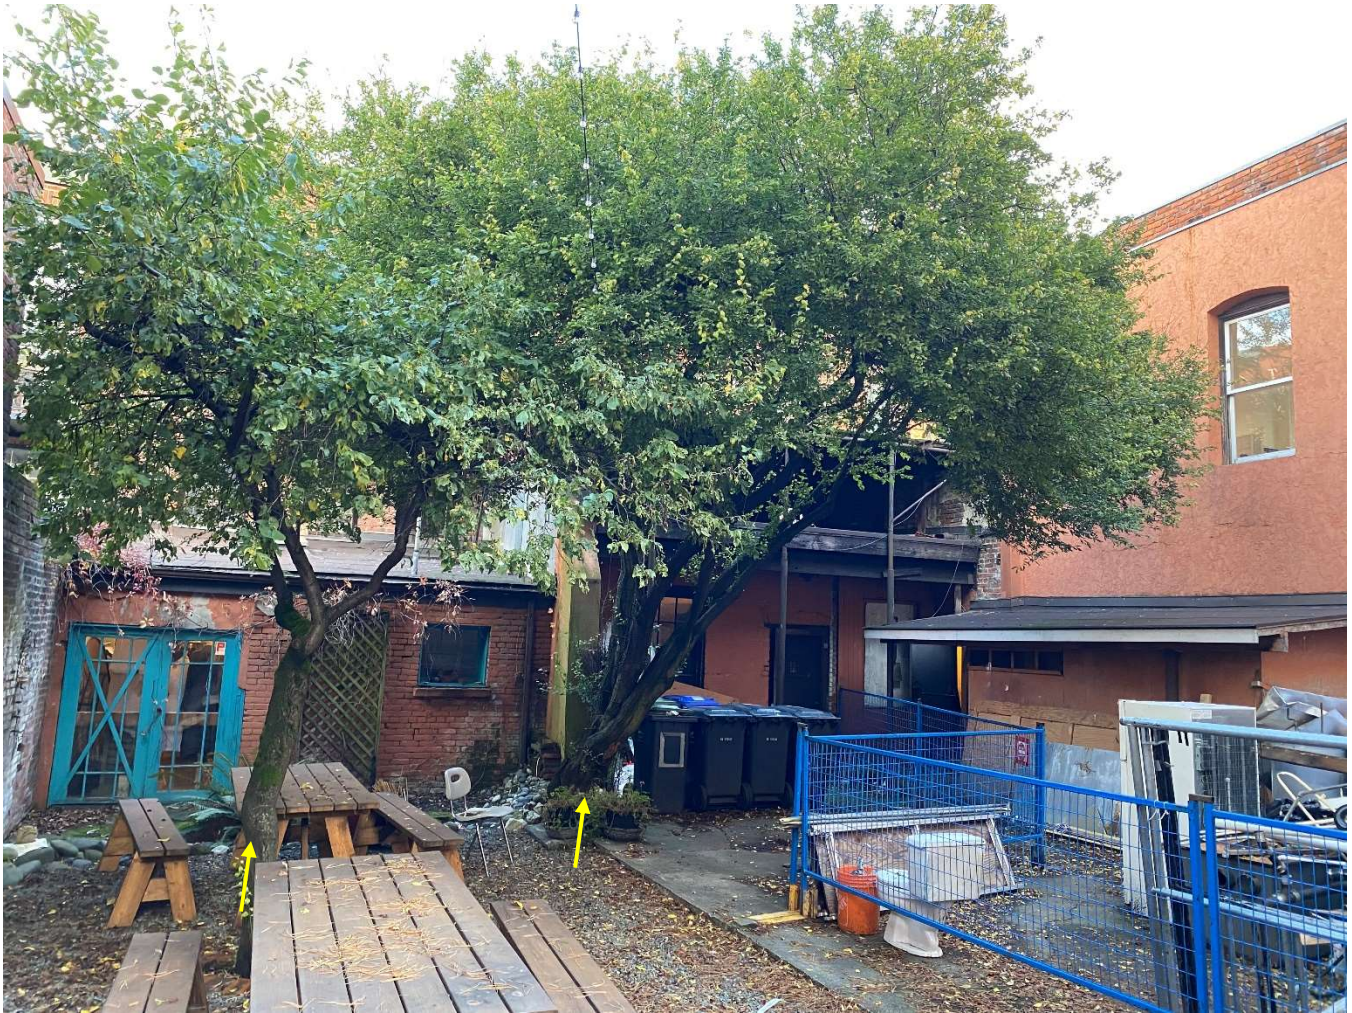
Photograph 1- Yellow arrows indicated bylaw protected plum (tag# 1792) on the right and non bylaw protected plum (tag# 1793) on the left.

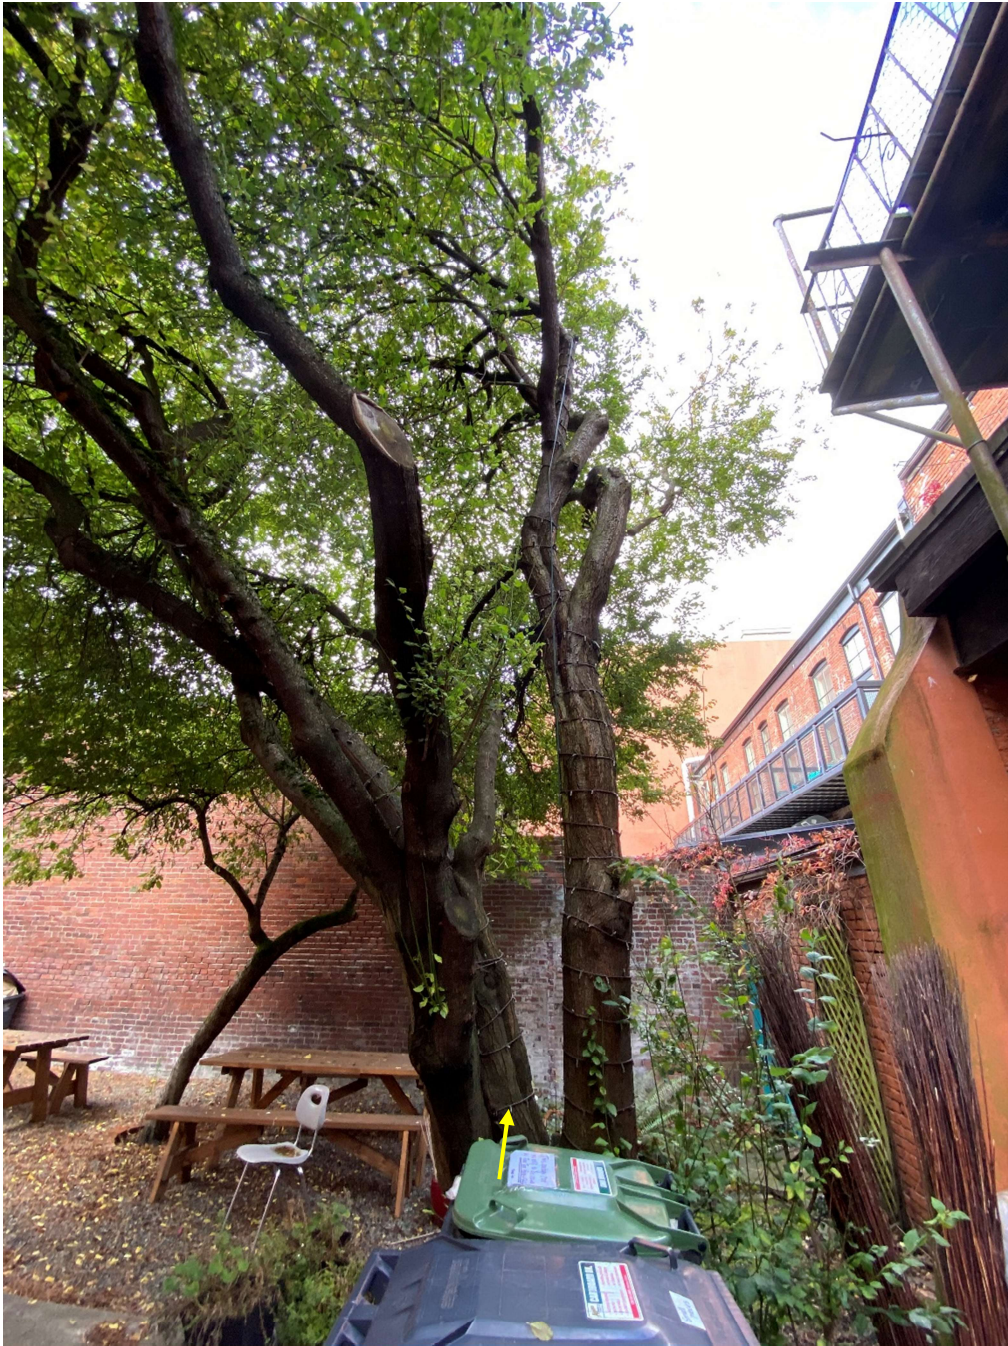
Tag #	Surveyed ? (Yes / No)	Bylaw protected ? (Yes / No)	Name		dbh (cm)	Ht (m)	Critical Root Zone(m)	Dripline radius (m)	Condition		Retention Suitability (onsite trees)	Relative Tolerance	Remarks	Tree Retention/Location Comments	Action
			Common	Botanical					Health	Structural					
1792	No	Yes	European plum	<i>Prunus domestica</i>	24,26,28	6	7.3	5	Good	Fair/poor	Conditional	Moderate	Tridominant stems form at .5 - 1m above grade - included/narrow unions with active growth tissue, crown has been heavily pruned historically on North side for building clearance - resulting in major asymmetry, decay forming in old pruning wounds - appears localized at this time, some suckering at lower trunk, shallow soil conditions, surface rooted on West side - injuries to topsides of surface roots, existing concrete surface over East side of CRZ. Concrete cracking, back filled over North side of crz with soil and small boulders, stucco cracking on wall adjacent to North side of tree - 1.1m from root collar. Basal suckers on North side.	Will be heavily impacted by excavation required to install the proposed new timber posts that support the proposed glass canopy structure. Will be heavily impacted by crown reduction required to install the proposed glass canopy.	Remove

Photograph 2 – yellow arrow indicates bylaw protected plum (tag# 1792). Note large historic pruning wounds on the West side of the crown from building clearance pruning.

The following bylaw protected tree is located where it will be heavily impacted by crown reduction required to install the proposed glass canopy and root impacts to required install the proposed timber post and is proposed for removal:

- 1792

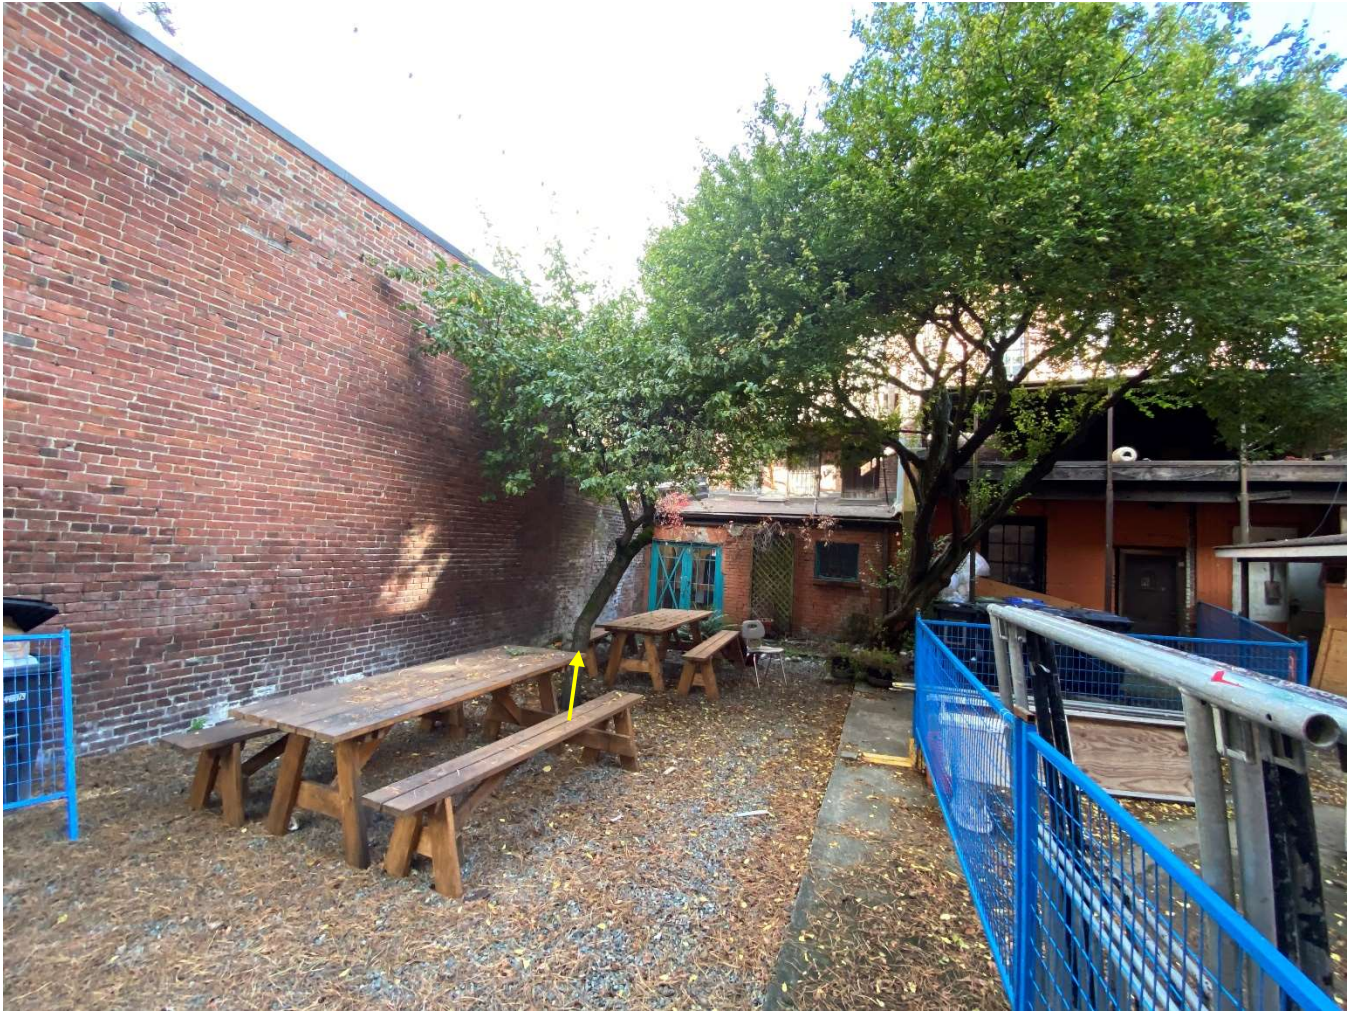
1793	No	No	European plum	<i>Prunus domestica</i>	21	5	2.6	3	Good	Fair/poor	Conditional	Moderate	Suppressed by 1792 - poor stem taper - major crown asymmetry due to shading, shaded by existing wall on West side as well, branches beginning to conflict with wall on West side, basal suckers, rooted in crushed gravel - does not appear to be compacted at this time. Historic pruning wounds with decay forming - appears to be localized at this time, growing 2m from existing wall on West side.	*Sloped pavers proposed to be installed within the crz. Project arborist to supervise all excavation required within the crz. Any required crown pruning for clearance from the proposed glass canopy to be performed to ANSI A300 standards.	Retain*
1794	No	Yes	Scots pine	<i>Pinus sylevstris</i>	35	12	4.4	5	Fair	Fair/poor	Conditional	Moderate	Growing within confined area - .6m from existing wall and concrete sidewalk on South side, 1.2m from existing retaining wall on West side, branches beginning to conflict with wall on South side, recent branch tearout injury on West side - lowest limb. Seam on East side of lower trunk - active - pitching. Poor growing location for a tree of this species - large growth potential. In Center of path and gate to adjacent property, branches likely rub against adjacent building on East side in the wind.	*timber post proposed to be installed within the crz. Project arborist to supervise all excavation required within the crz.	Retain*

Photograph 3 – Yellow arrow indicates non bylaw protected plum (tag# 1793.

- Excavation required within the critical root zone of pine (tag# 1794) to install the proposed wood support beam.
- Excavation required within the critical root zone of plum (tag# 1793) for the proposed sloped pavers.
*Note that this tree is not protected by the current municipal tree bylaw.

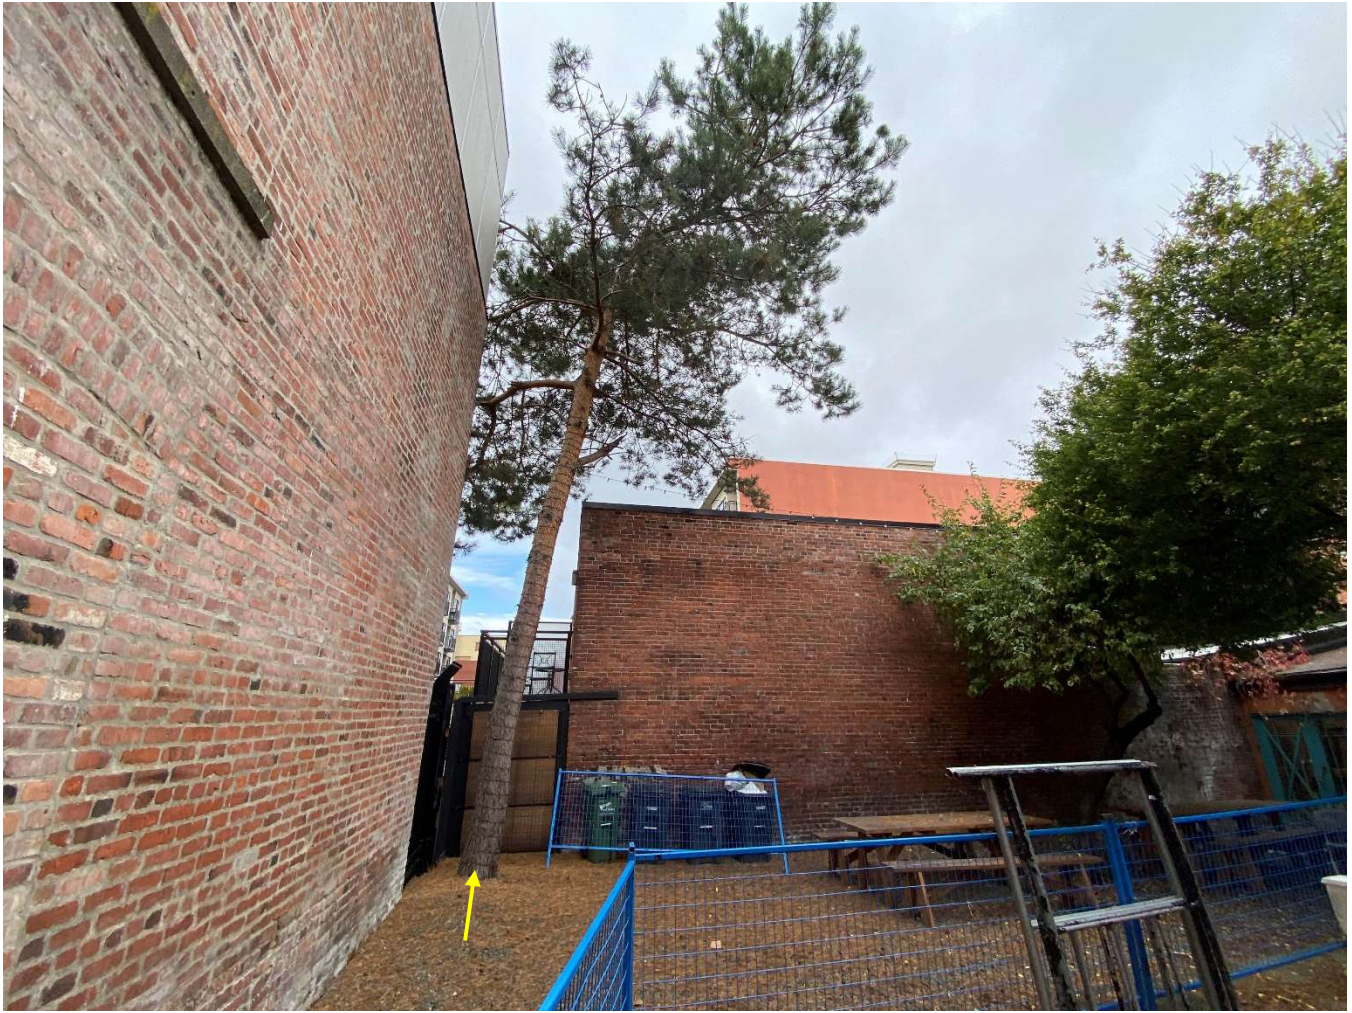
Photograph 4 – Yellow arrow indicates bylaw protected Scots pine (tag# 1794).
