Arborist Report for Development Purposes  
Re: Proposed Subdivision and New Homes Construction

Site Location: 1737 Rockland Ave., Victoria BC  
Darryl Clark PN-6253A TRAQ Certified  
May 9, 2021

Re. 1737 Rockland Ave. - Proposed Subdivision and New Homes Construction

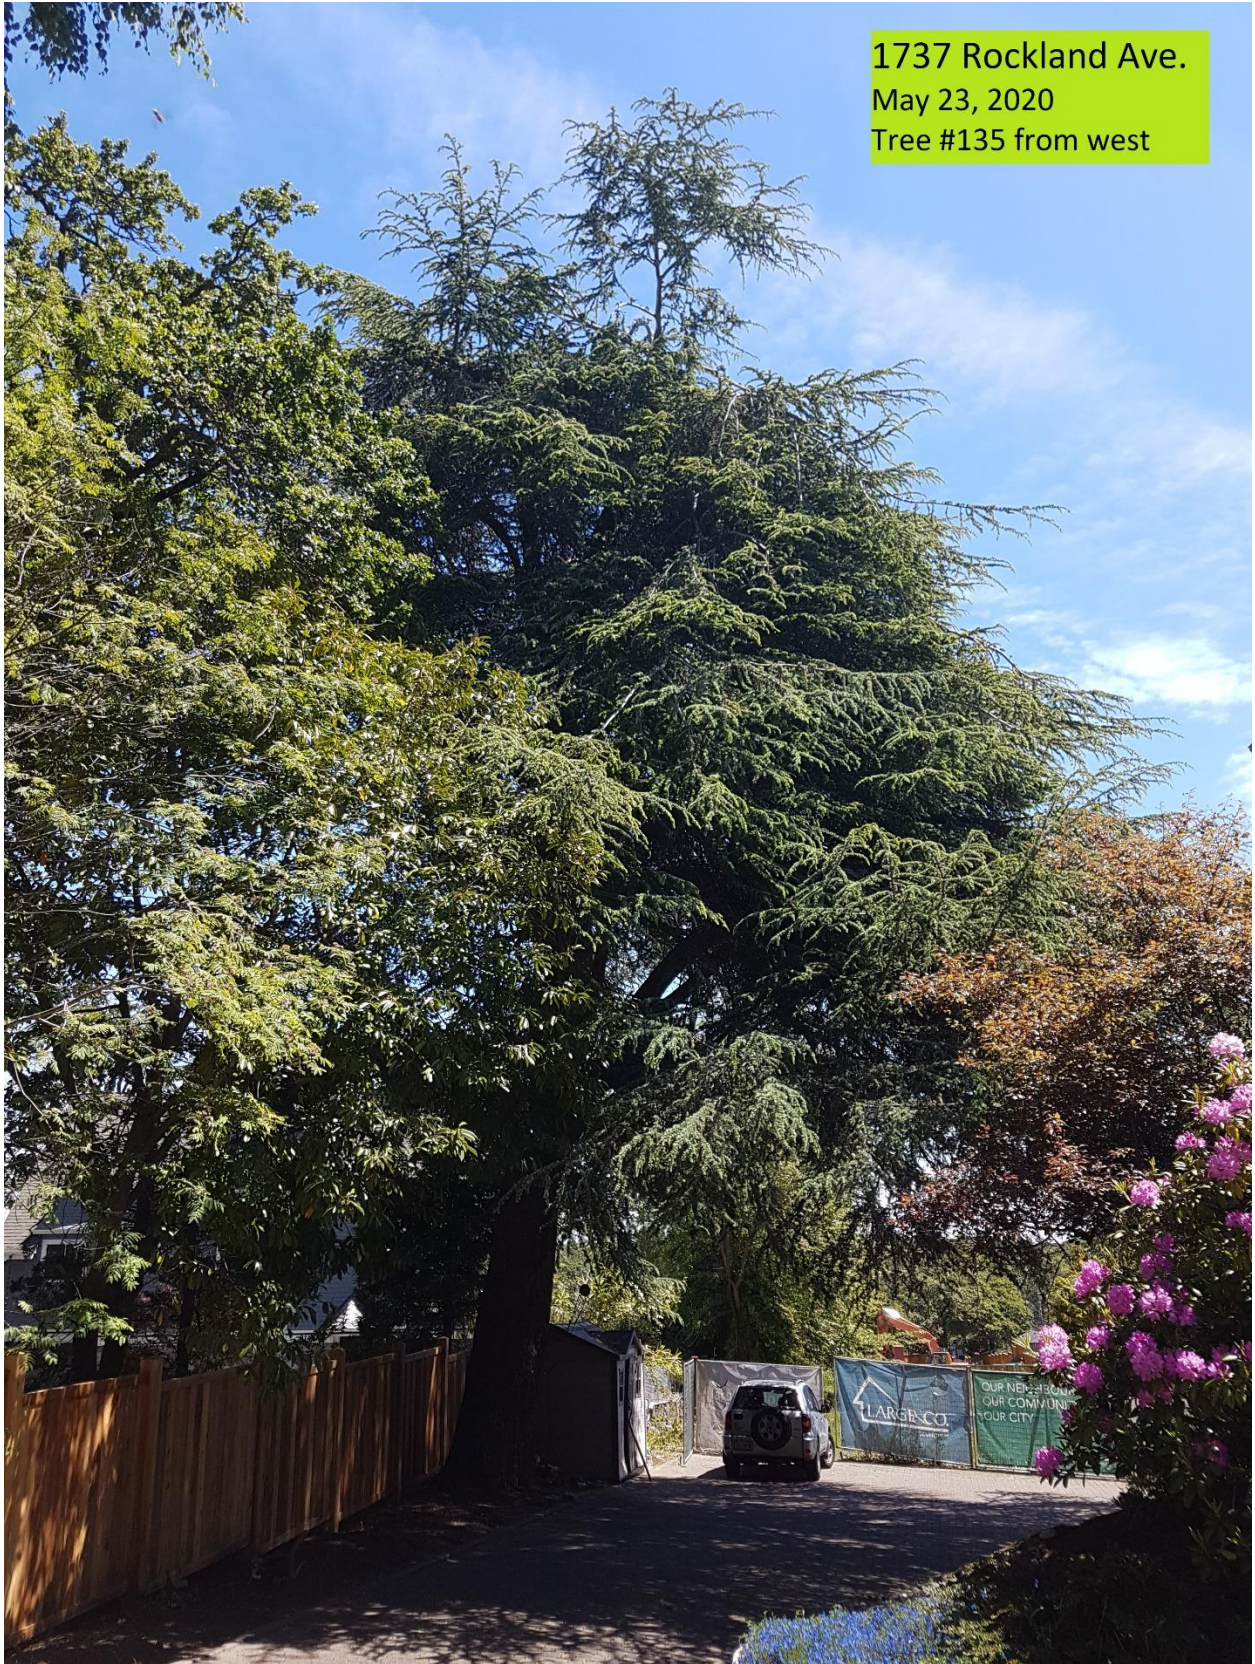
1737 Rockland Ave.  
May 23, 2020  
Tree #135 from west

Tree #135 is a Deodar cedar with a DBH of 115cm is 22m high and has an approximate canopy spread of 18m. It is in generally good health for the species with average taper in the trunk and main stems and reasonably good branch attachments. It appears to have been maintained for driveway clearance and some dead-wood pruning of the lower canopy in the past. The tree will be impacted by pre-construction activities as it requires clearance for access. Some pruning of branches up to 20cm in diameter to achieve a canopy height of 6m will be required for tree #135 to accommodate the access of large construction equipment and materials. This tree will also be impacted by excavations for water, and hydro/tel/cable, and may be slightly impacted by re-compaction of base material under the driveway.

- Hydroexcavation in the driveway for water and hydro/tel/cable is required to the extent of the PRZ of tree #135
- Arborist supervision is required for all the above activities.

- Some pruning on tree #135 to a height of 6m will require the removal of branches up to 20cm in diameter to accommodate equipment access.

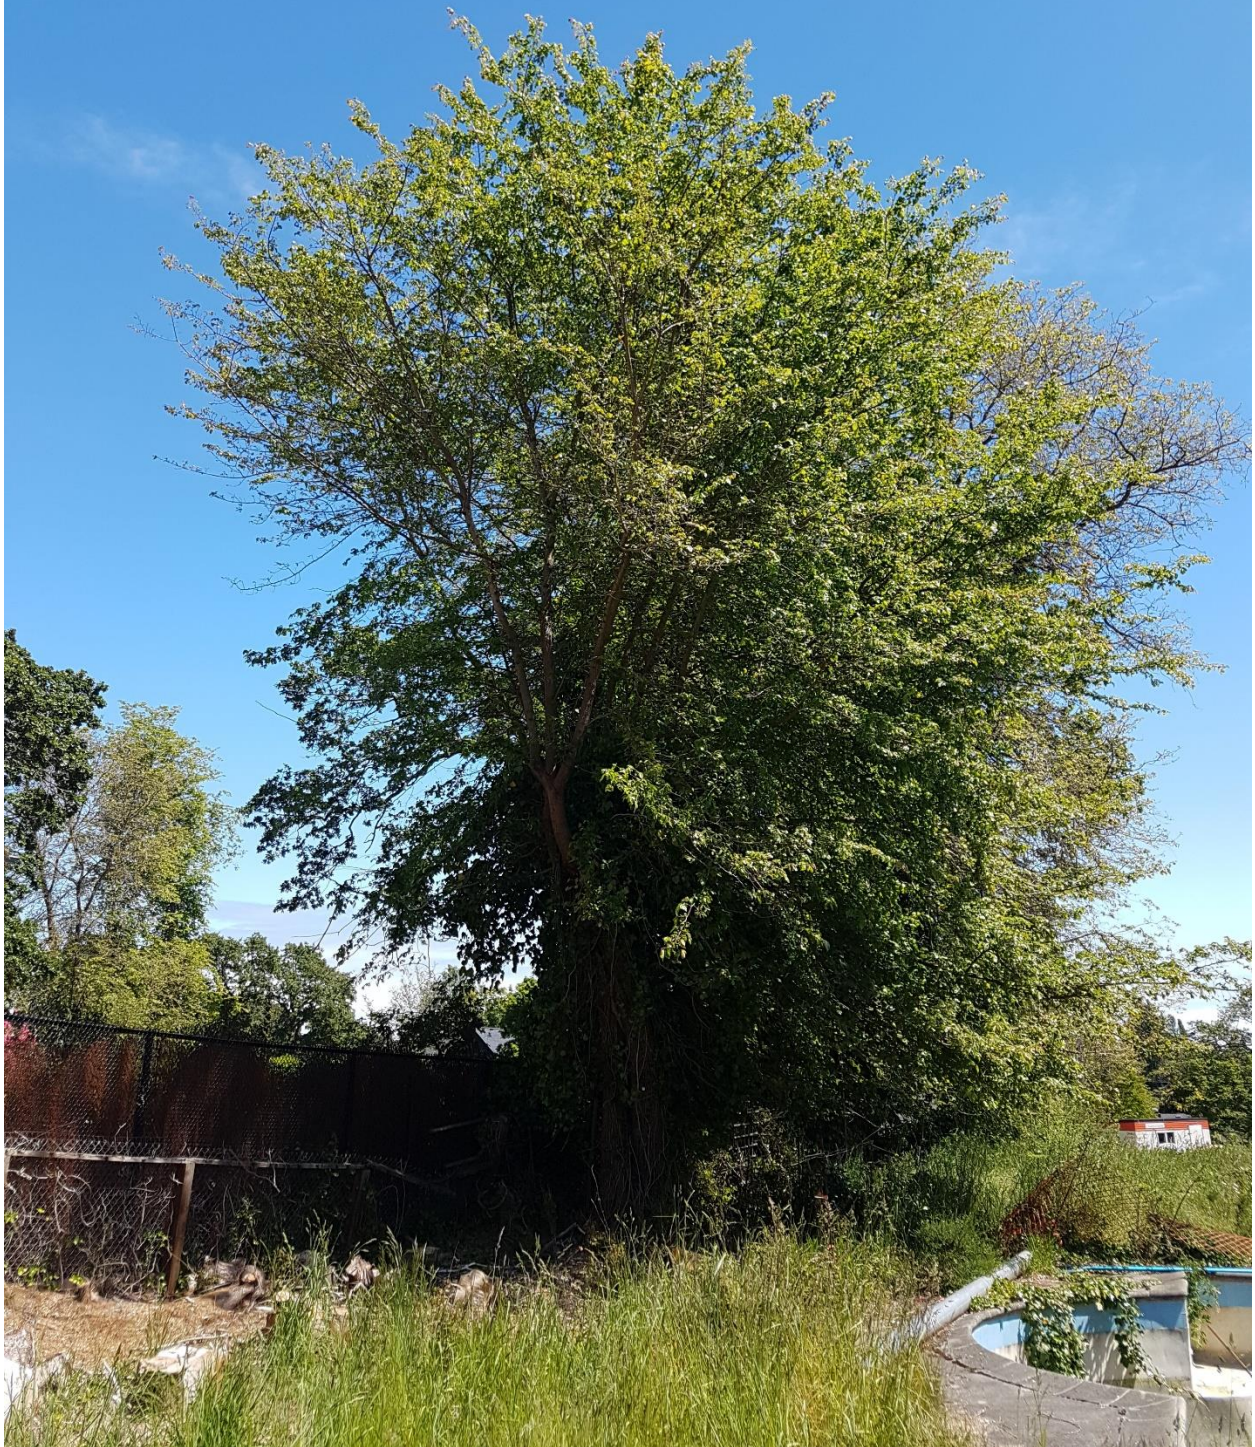
1737 Rockland Ave.  
May 23, 2020  
Tree #136 from west

Tree #136 is an American Elm with a DBH of 53cm (co-dominant stems measuring 39cm and 33cm), is 16m high and has an approximate canopy spread of 14m. The two stems are pushing against each other beginning at grade and there is no bark ridge apparent. The smaller stem wraps around the larger stem on the east side. This tree was topped at 5 m many years ago and the canopy is made up entirely of regrowth from that activity. This tree will be impacted by excavation for the foundation of “Strata Lot B” and the driveway. These excavations will impact upwards of 50% of the PRZ of the tree. The canopy

would be impacted by the new building as well. It is a poor candidate for retention not only because of its poor structure but because American elm responds to over pruning and root damage with aggressive suckering and epicormic growth. They are a poor choice of tree to plant in paved areas because of root heave.

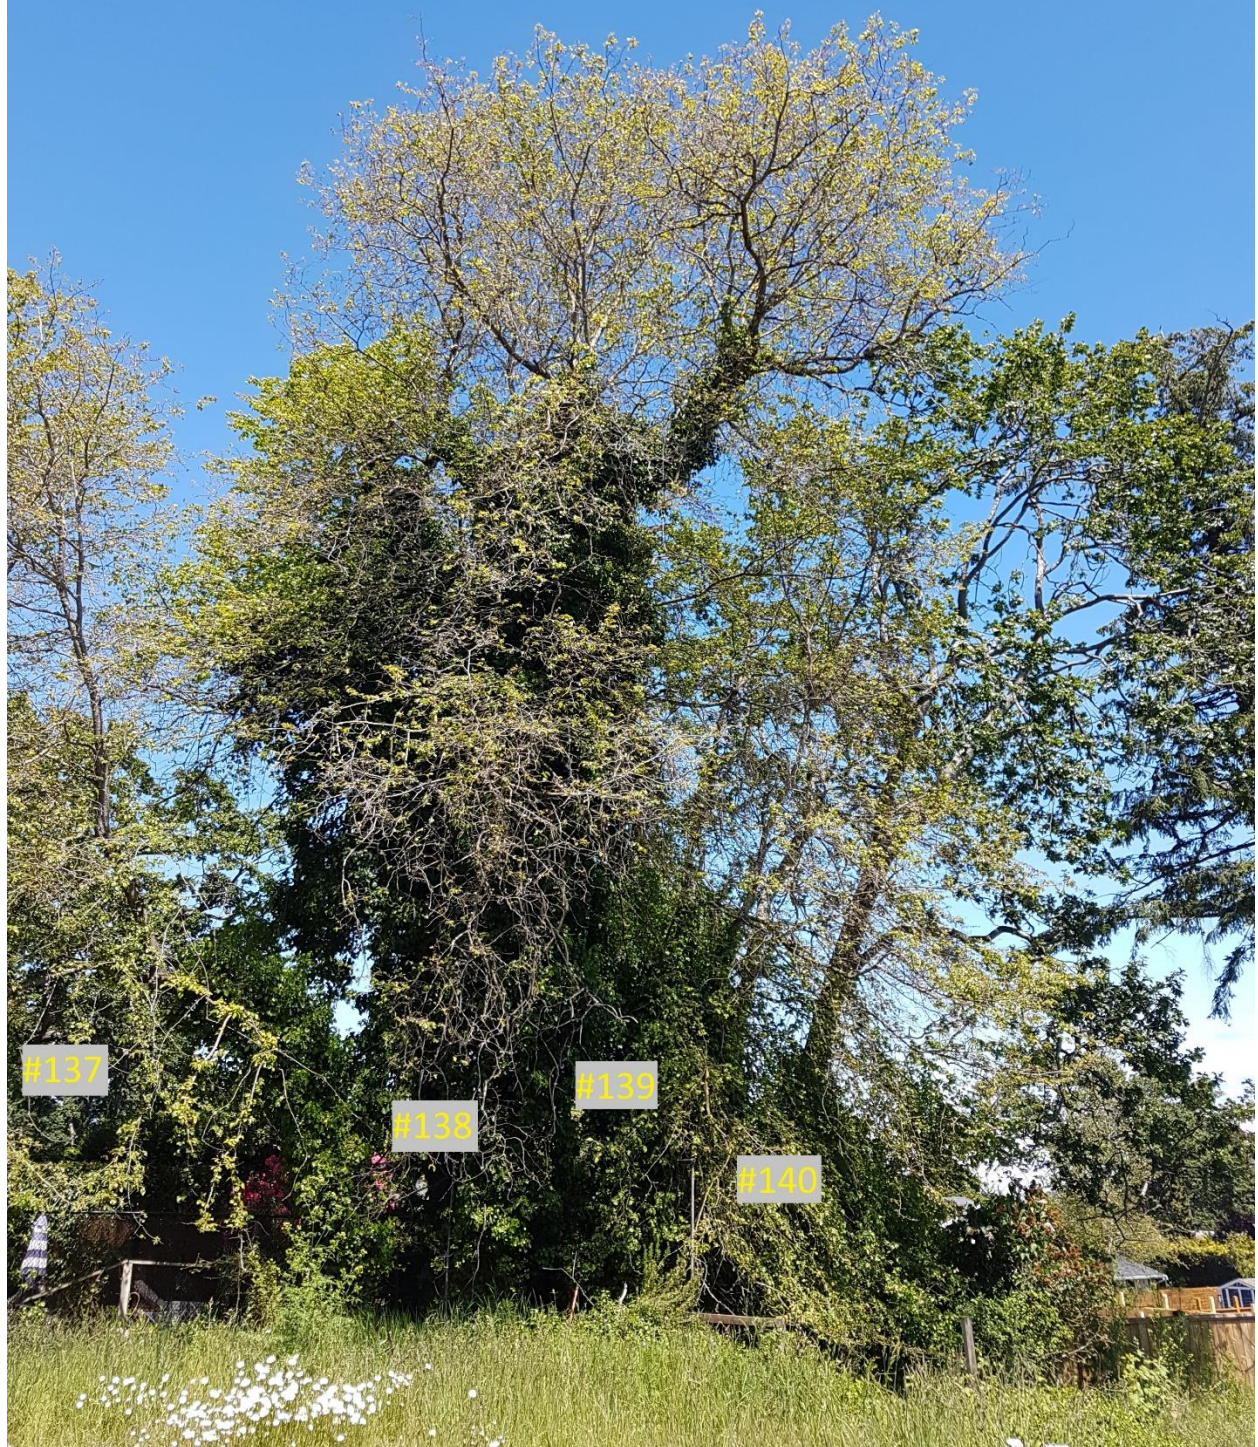
Trees #137, 138, 139, and 140 from south

Tree #137 is an American Elm with a DBH of 60cm, is 16m high and has an approximate canopy spread of 12m. The tree exhibits fair structure and fair health. It has fairly low trunk taper and leans west as it is slightly subordinated by trees to the east. This tree will be impacted by excavation for the foundation of "Strata Lot B" and the driveway. These excavations will impact almost 50% of the PRZ of the tree. The canopy would be impacted by the new building as well. It is a poor candidate for retention not only because of its poor structure but because American elm responds to over pruning and root damage with aggressive suckering and epicormic growth. They are a poor choice of tree to plant in paved areas because of root heave.

Tree #138 is an American Elm with a DBH of 31cm, is 16m high and has an approximate canopy spread of 6m. The tree exhibits poor structure and fair health. The tree has poor taper and leans west, sweeping upward for a few meters before leaning west again. It is heavily subordinated by the tree to the east. This tree will be impacted by excavation for the foundation of "Strata Lot B" and the driveway. These excavations will impact almost 50% of the PRZ of the tree. The canopy would be impacted by the new building as well. It is a poor candidate for retention not only because of its poor structure but because American elm responds to over pruning and root damage with aggressive suckering and epicormic growth. They are a poor choice of tree to plant in paved areas because of root heave.

Tree #139 is an American Elm with a DBH of 90cm (co-dominant stems at approximately 60cm above grade measuring 60cm and 50cm), is 20m high and has an approximate canopy spread of 15m. The tree exhibits fair structure and fair health. There is a seam of inclusion on the west side that runs to the base of the tree with a very pronounced bark ridge on robust reaction wood. On the east side there is no ridge or reaction wood evident. A sounding mallet was utilized in this area with inconclusive results. The tree has abundant epicormic growth. This tree will be impacted by excavation for the foundation of "Strata Lot B" and the driveway. These excavations will impact almost 50% of the PRZ of the tree. The canopy would be impacted by the new building as well. It is a poor candidate for retention not only because of its poor structure but because American elm responds to over pruning and root damage with aggressive suckering and epicormic growth. They are a poor choice of tree to plant in paved areas because of root heave.

Tree #140 is an American Elm with a DBH of 50cm, is 15m high and has an approximate canopy spread of 12m. The tree exhibits poor structure and fair health. The tree has an old wound and cavity on the north side that has not compartmentalized well. There is decay and what appears to be early-stage canker. It is ivy covered from approximately 2m up into the canopy and grows easterly as it has been subordinated by the neighbouring tree to the west. This tree will be impacted by excavation for the foundation of "Strata Lot B" and the driveway. These excavations will impact almost 50% of the PRZ of the tree. The canopy would be impacted by the new building as well. It is a poor candidate for retention not only because of its poor structure but because American elm responds to over pruning and root damage with aggressive suckering and epicormic growth. They are a poor choice of tree to plant in paved areas because of root heave.

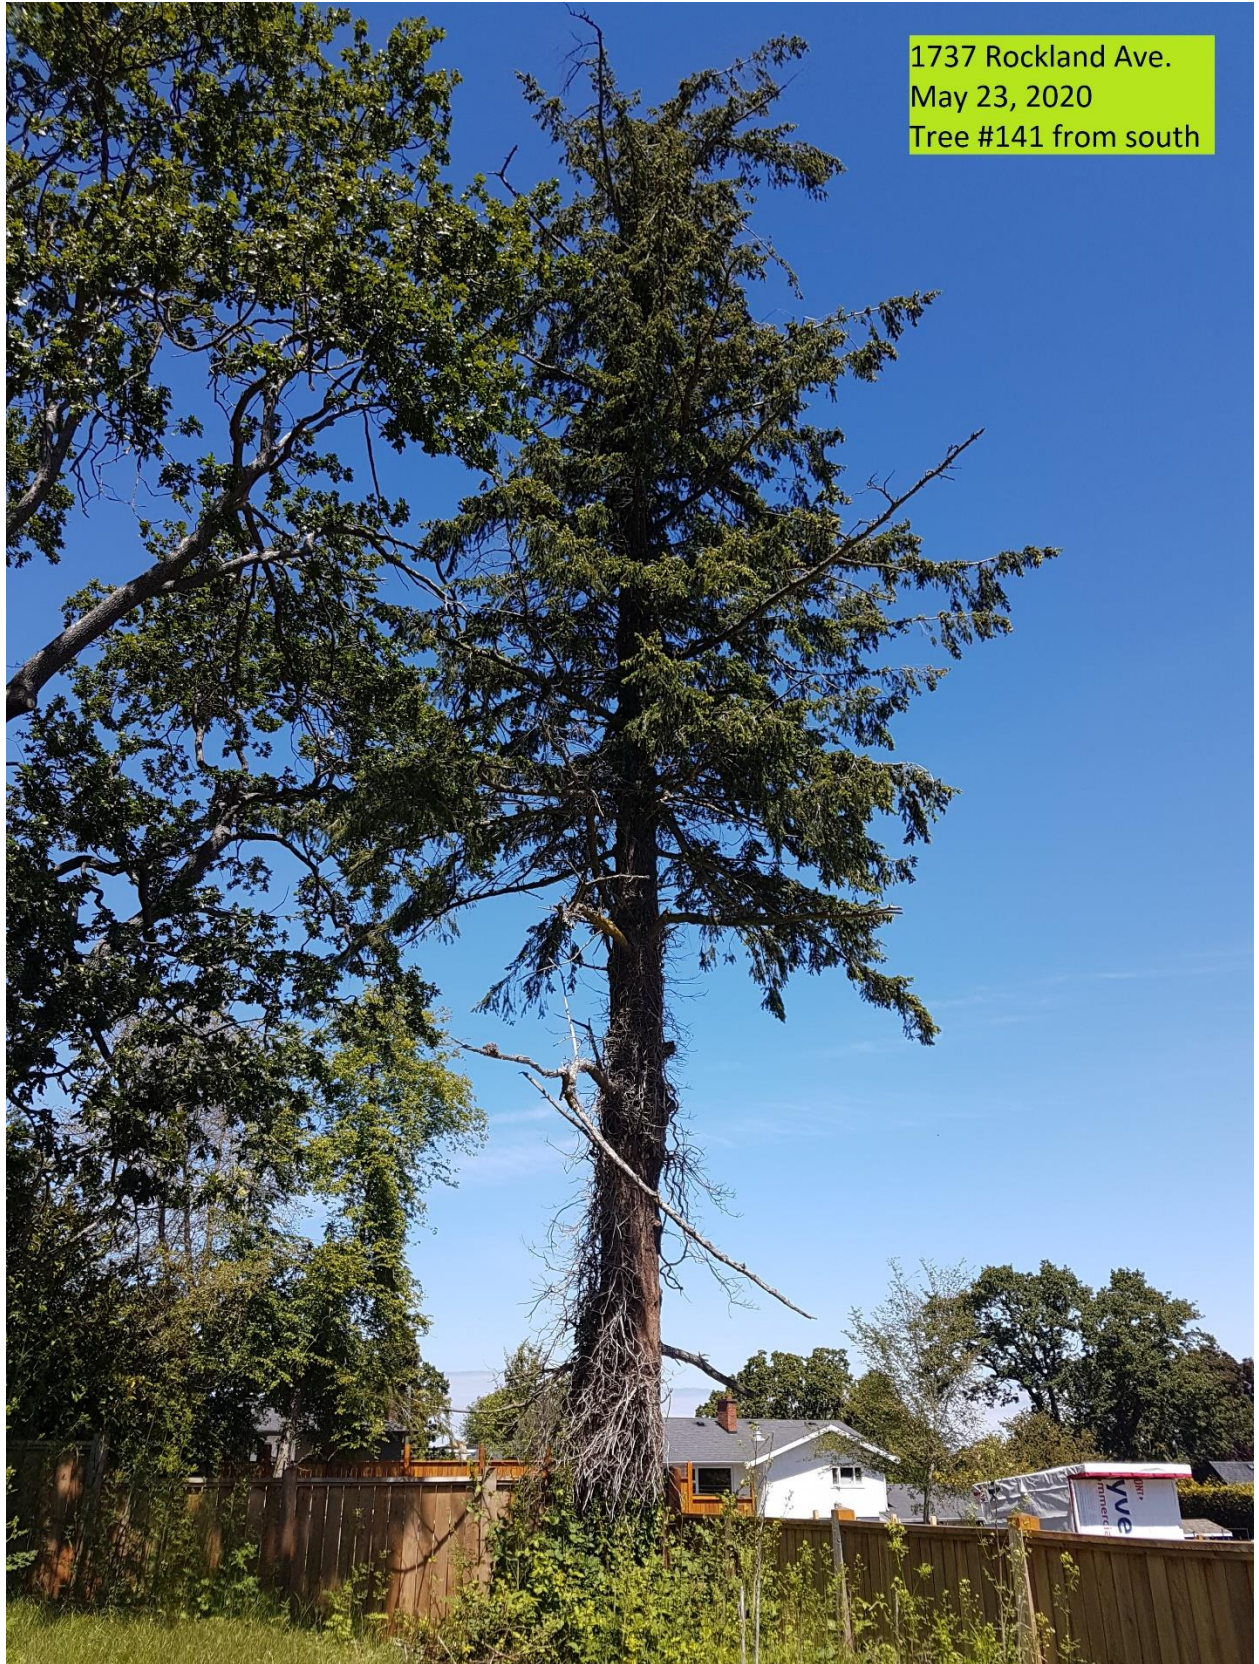
1737 Rockland Ave.  
May 23, 2020  
Tree #141 from south

Tree #141 is a Douglas fir with a DBH of 65cm, is 10m high and has an approximate canopy spread of 19m. The tree exhibits poor structure and poor health. The tree from the base up has overall good taper and appears cylindrical on the south and east sides but is remarkably flat on the north and west side. There is pronounced bark buckling on the west side at the base. On the north side there appears to be a lateral crack in the stem that reaches 3m from grade. A sounding mallet was employed and produced inconclusive results. There is strong tip dieback throughout the entire canopy indicating stress and decline in the tree's health. The tree has been impacted by excavations on the north and east sides by a development on that property. The PRZ will be impacted by excavations for the foundation of "Strata Lot B" including a semi submerged basement suite and perimeter drains. The tree is exposed to prevailing winds with some moderate buffers from other treed properties in the neighbourhood. No assessment of risk was undertaken because the impacts of development require removal.

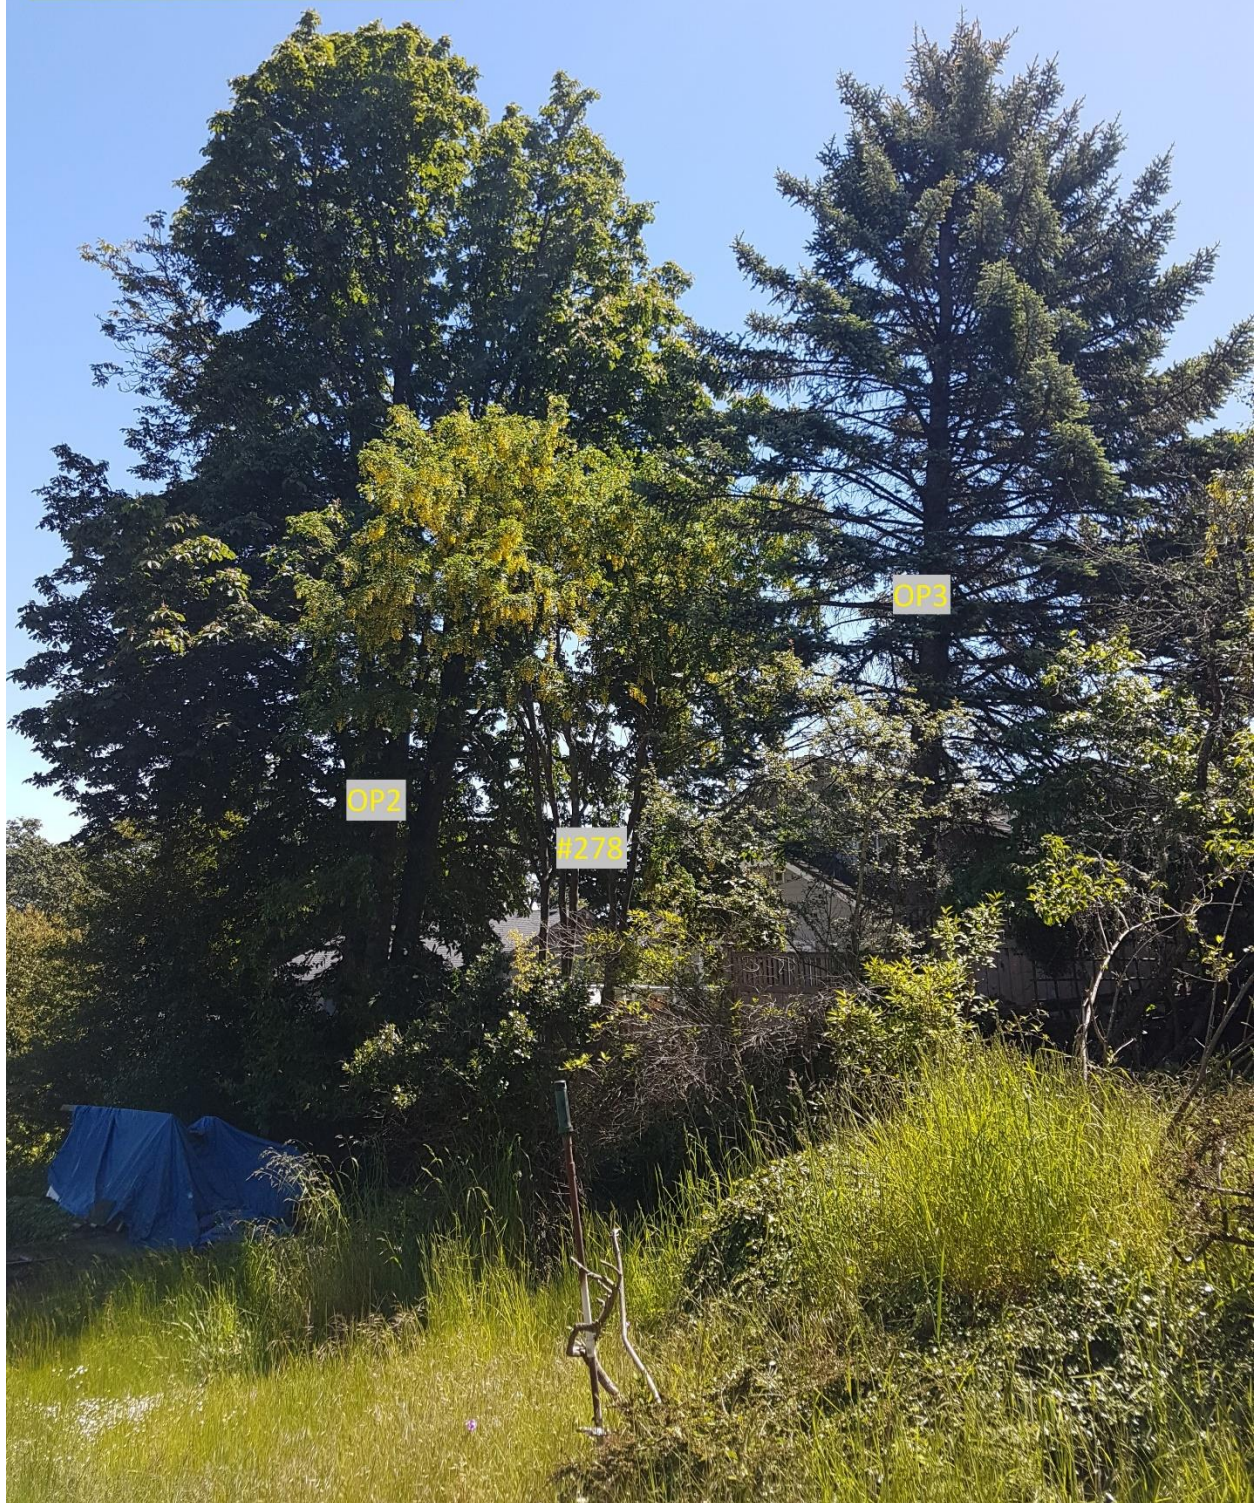
171 Rockland Ave.  
February 22, 2021  
Trees OP2 and OP3 from north

Tree #OP2 is a Horsechestnut with a DBH of 80cm (becoming [4] co-dominant stems above the DBH area) is 16m high and has an approximate canopy spread of 12m. It is in generally good health for the species with average taper in the trunk and main stems, although the attachments of the co-dominant stems are tight and there may be areas of long bark inclusion. The tree will be impacted by construction including grading and excavations for the foundation of the Strata Lot A building, excavations for sewer and storm laterals from the east and landscaping. It may also be impacted by blasting for the accessory building and services.

Tree #OP3 is a Grand fir with a DBH of 40cm is 14m high and has an approximate canopy spread of 10m. It is in generally good health for the species with average taper in the trunk. The tree will be impacted by construction including grading and excavations for the foundation of the Strata Lot A building (outside the dig area but potentially impacted by bucket creep or machine positioning), excavations for sewer and storm laterals from the east and north and landscaping. It may also be impacted by blasting for the accessory building and services.

- Root armoring is recommended on the north side of trees #OP2 and OP3.

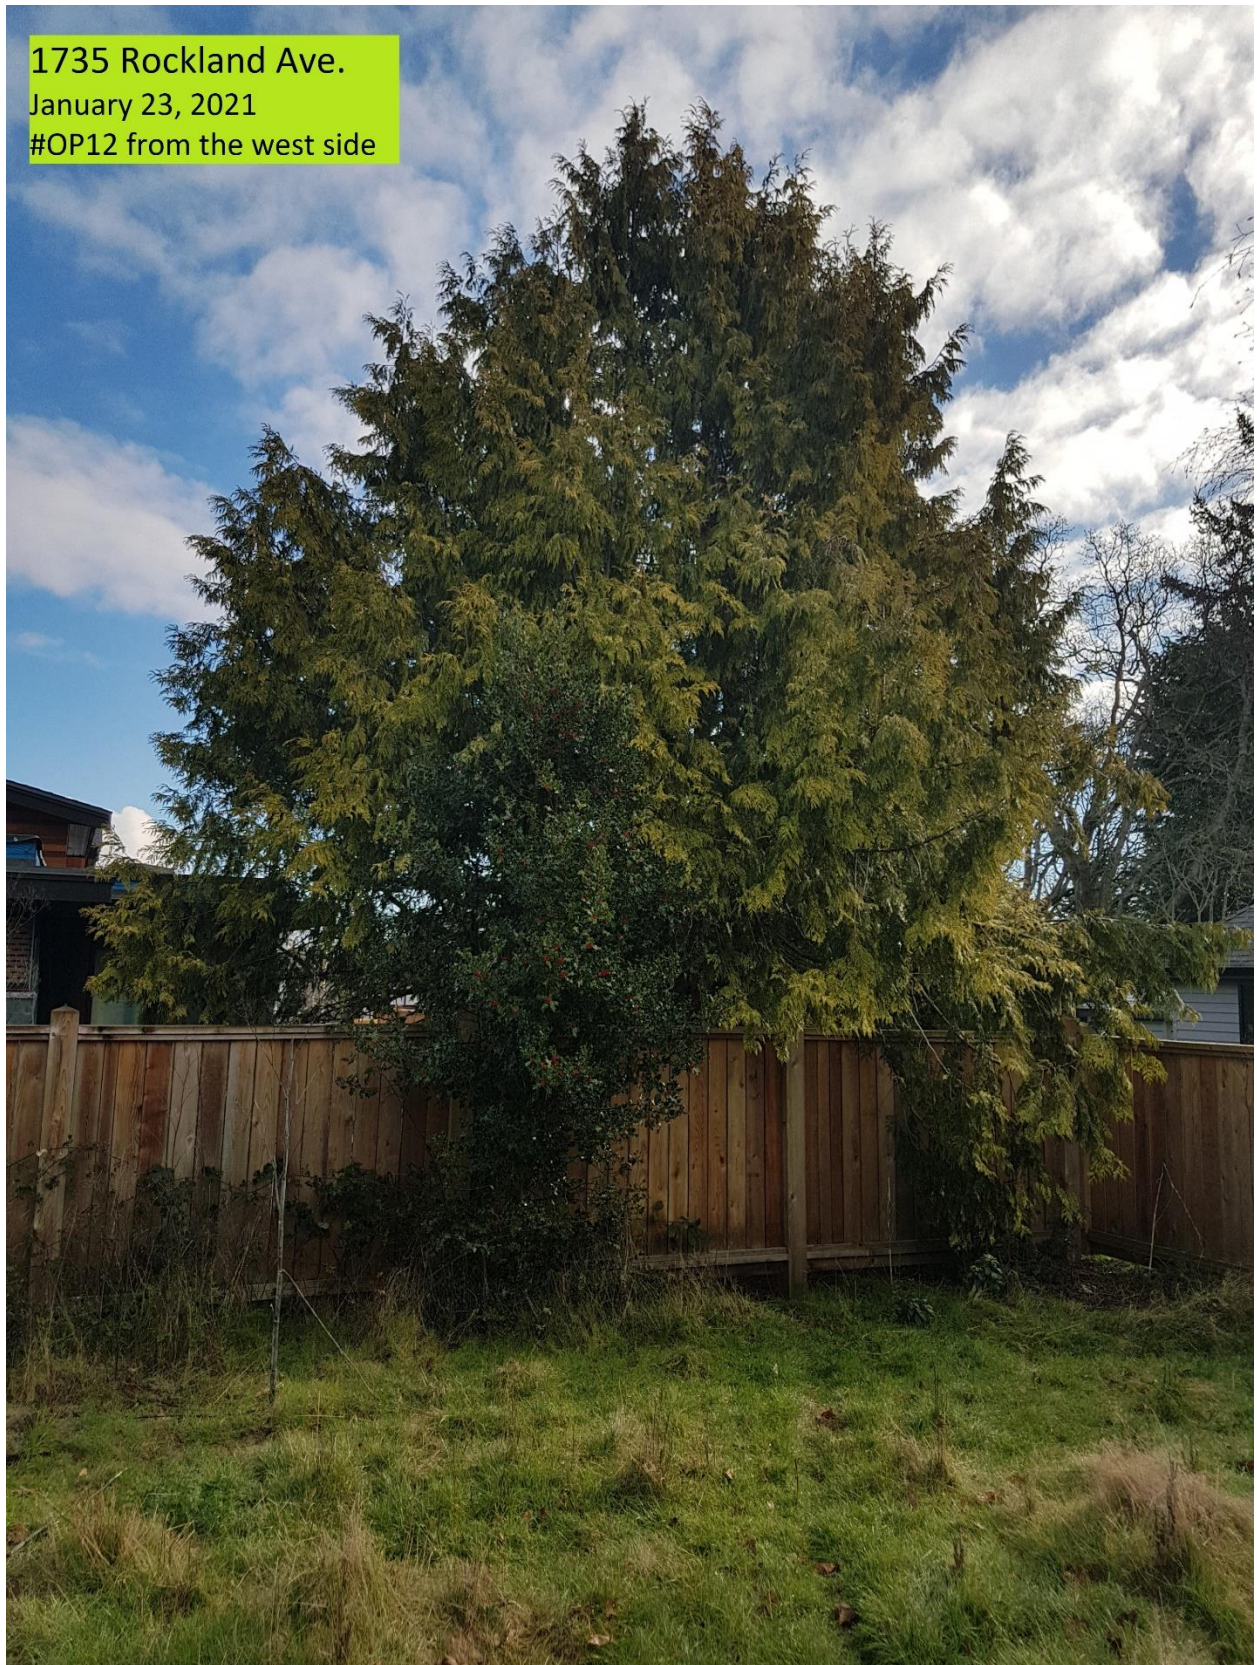
1735 Rockland Ave.  
January 23, 2021  
#OP12 from the west side

Tree #OP12 is a “Zebrina” red cedar with a DBH of 96cm (co-dominant stems approximately 45cm, 45cm, and 40cm), is 9m high and has an approximate canopy spread of 9m. It is in generally good health for the species with average taper in the trunks and a vigorous crown. The tree will be impacted by construction including grading and excavations for the foundation of the Strata Lot B building, sewer and storm lateral installation from the west, and landscaping.

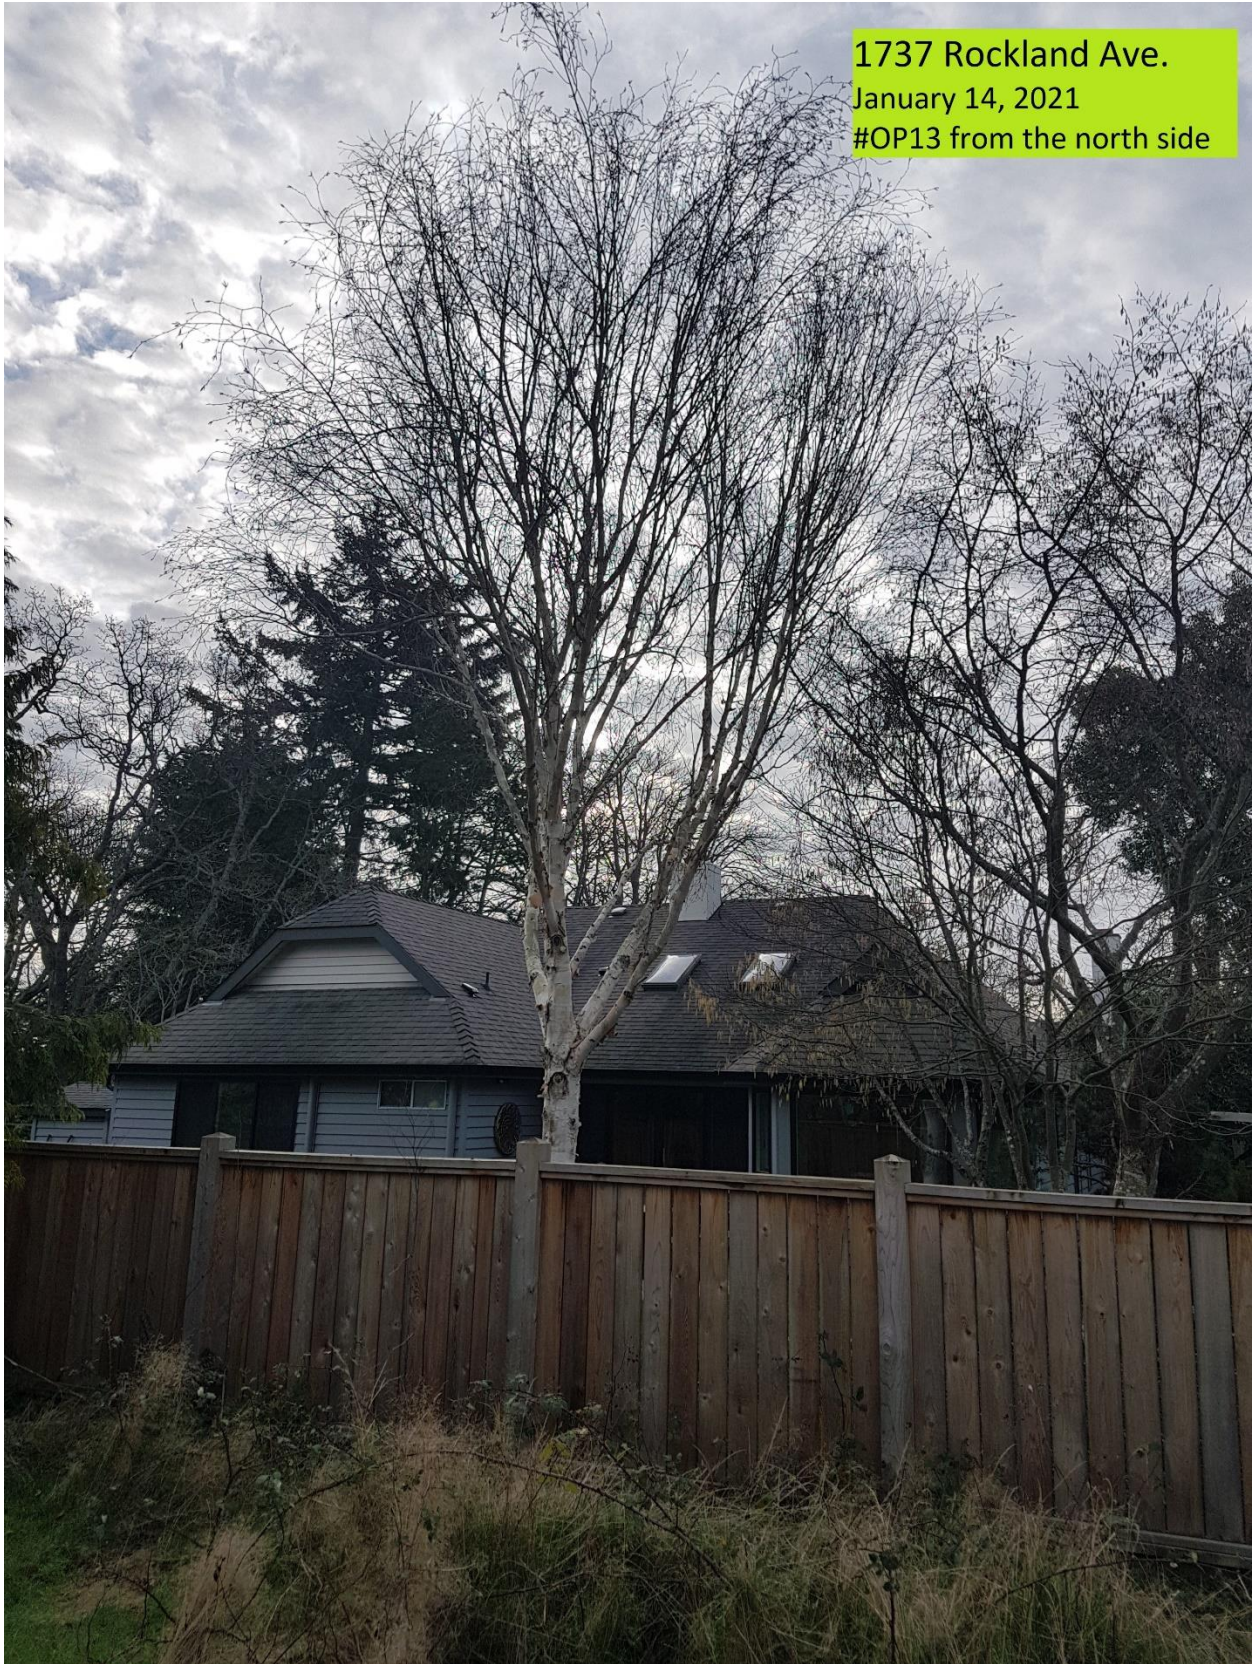
#OP13 from the north side

Tree #OP13 is a Paper birch with a DBH of 25cm, is 8m high and has an approximate canopy spread of 5m. It is in generally good health for the species with average taper in the trunk. The tree will be slightly impacted by excavations for sewer and storm drain excavations for connection to the easement main.

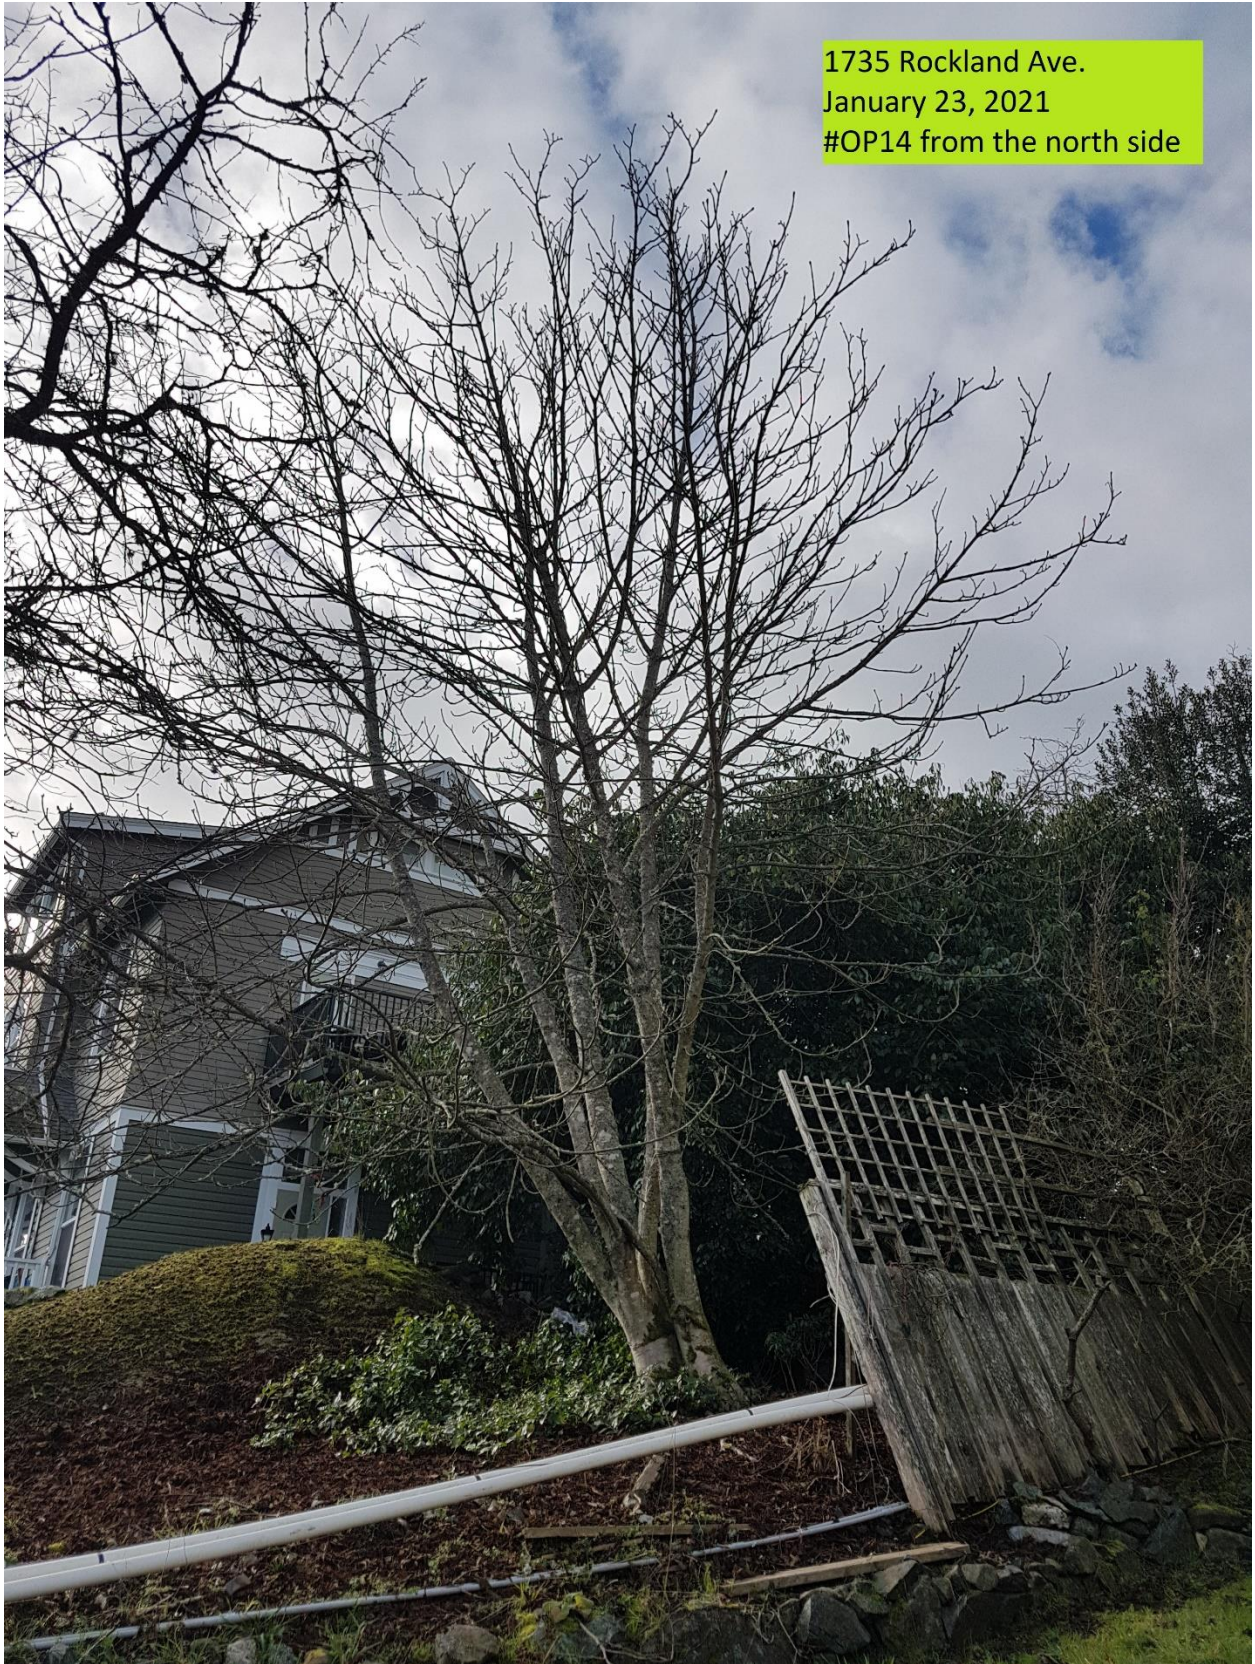
1735 Rockland Ave.  
January 23, 2021  
#OP14 from the north side

Tree #OP14 is a Horsechestnut with a DBH of 59cm (co-dominant stems approximately 20cm, 20cm, 15cm, 15cm, and 15cm) is 9m high and has an approximate canopy spread of 9m. It is in generally good health for the species with average taper in the trunk and main stems, although the attachments of the co-dominant stems are tight at the base of the tree. The overall structure is listed as fair, but the tree has never been maintained and there are long lever arms and crossing trunks and branches. The tree will be impacted by construction including blasting, grading and excavations for the foundation of the Accessory Gym building, excavations for sewer and storm laterals from the east and north, and landscaping.

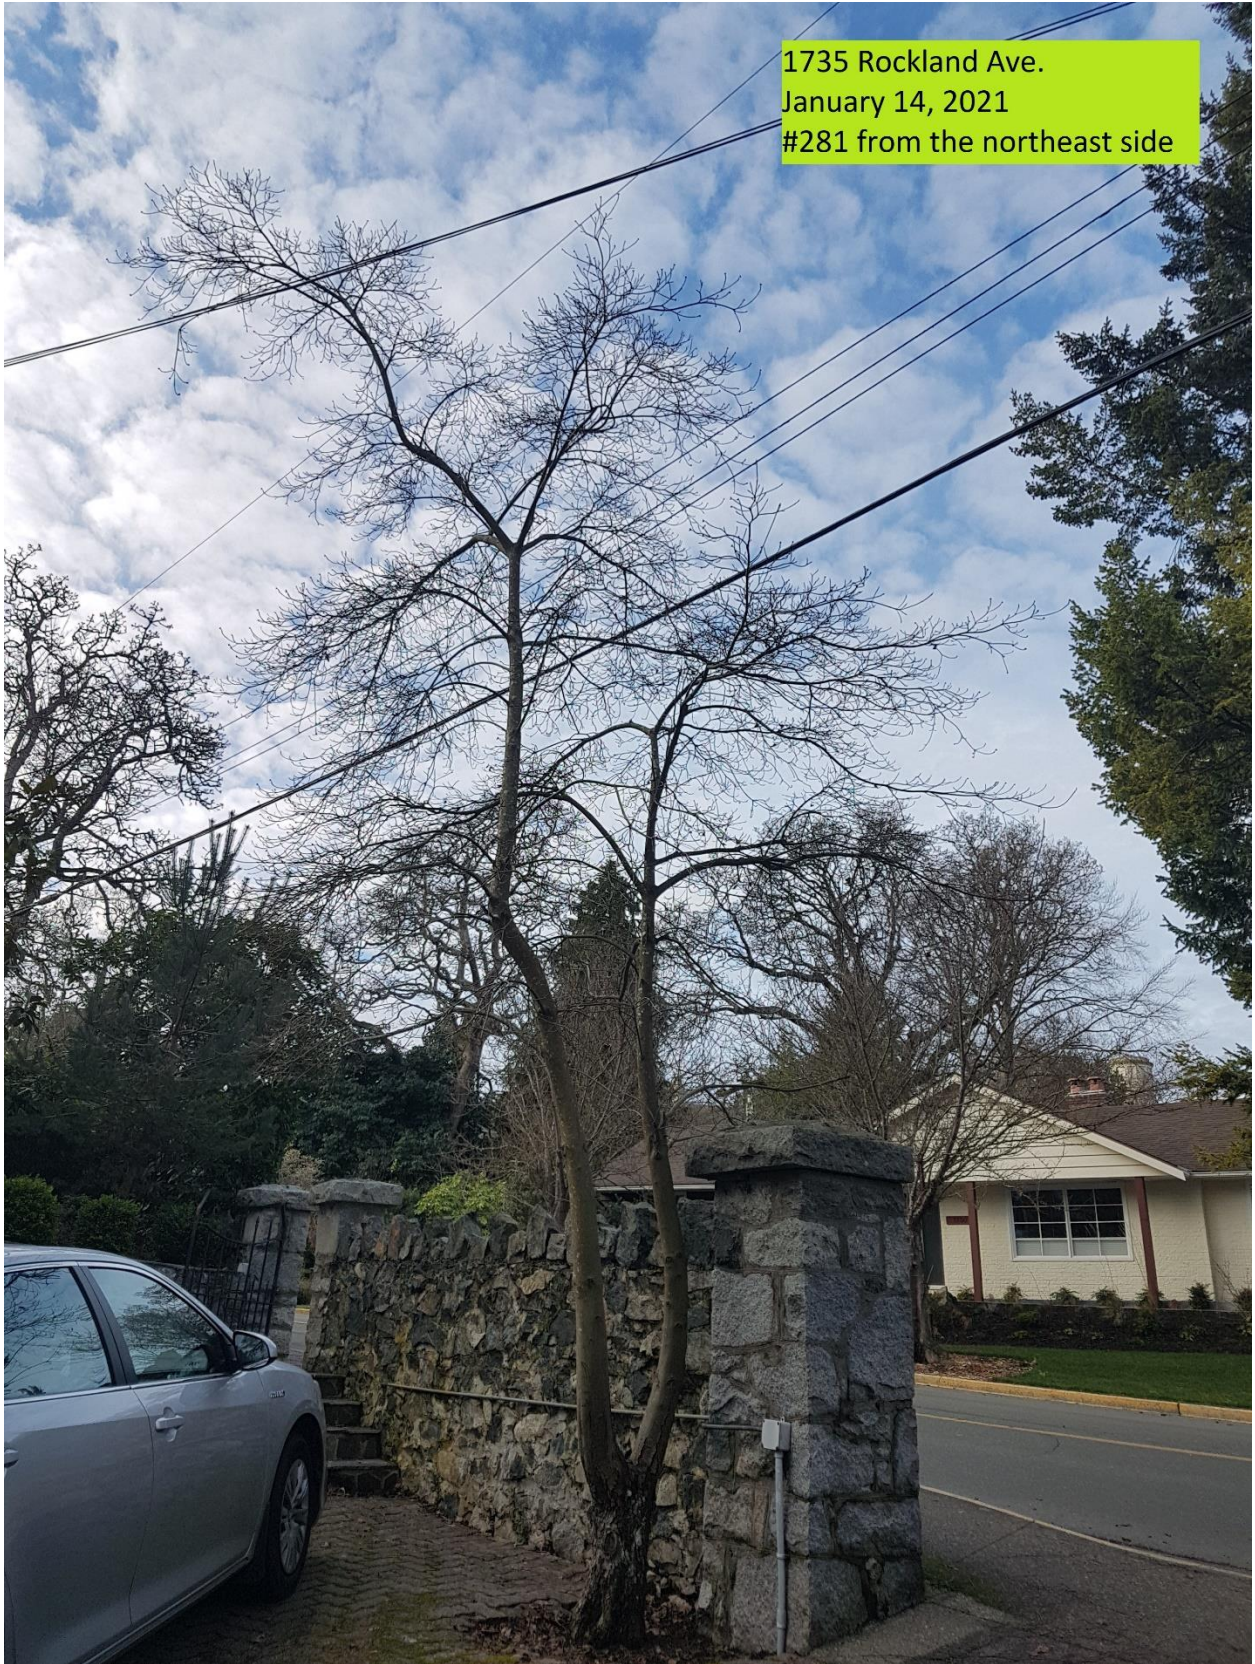
1735 Rockland Ave.  
January 14, 2021  
#281 from the northeast side

Tree #281 is a Korean dogwood with a DBH of 16cm (co-dominant stems at approximately 60cm above grade measuring 11cm and 10cm), is 5m high and has an approximate canopy spread of 2m. The tree exhibits good structure and good health. It is located behind a stone pillar and surrounded by pavement. It will require removal due to its location in the new widened driveway area. There are no options for the retention of this tree.
