# 1025 Kings Road, Victoria, BC

## Construction Impact Assessment &

## **Tree Preservation Plan**

Date of Issuance: August 6, 2020 Amended May 5, 2021 Amended August 27, 2021

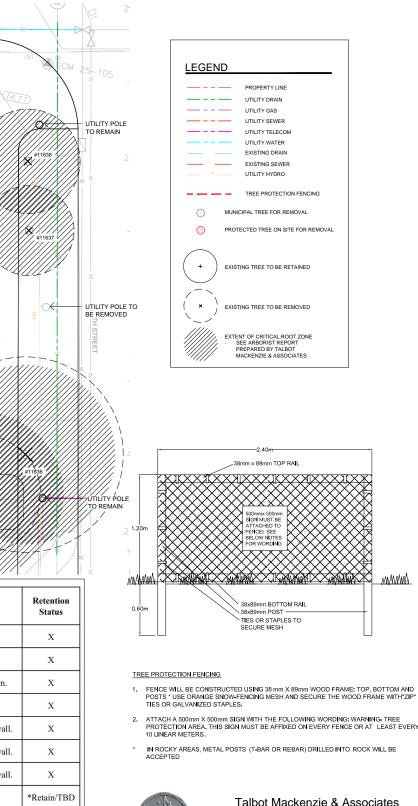
## 1025 Kings Road, Tree Management Plan, 08.27.21

Municipal Hedge maple #11614 - retention to be determined at the time of excavation. Retention will depend on the ability to minimize the impacts from the excavation associated with the building footings, new service installations and			PROPOSED DRAI	PROPOSED UTILITY POLE				POSED BOULEVA				
sidewalk configuration. Project arborist to supervise and document any excavation within critical root zone of tree during excavation for building and servicing. Provided the tree isn't too		0 1 2.5 METERS		10		[]		-00	]			#11
heavily impacted by this excavation work, proposed sidewalk	Tree ID	Common Name	Latin Name	<b>DBH (cm)</b> ~ approximate	Crown Spread (diameter in metres)	CRZ (radius in metres)	Relative Tolerance	Health	Structure	Remarks and Recommendations		
configuration to be	Nt1	Western Red cedar	Thuja plicata	44.0	8.0	5.5	Moderate	Good	Good	Roots likely restricted by retaining	wall on West side.	1

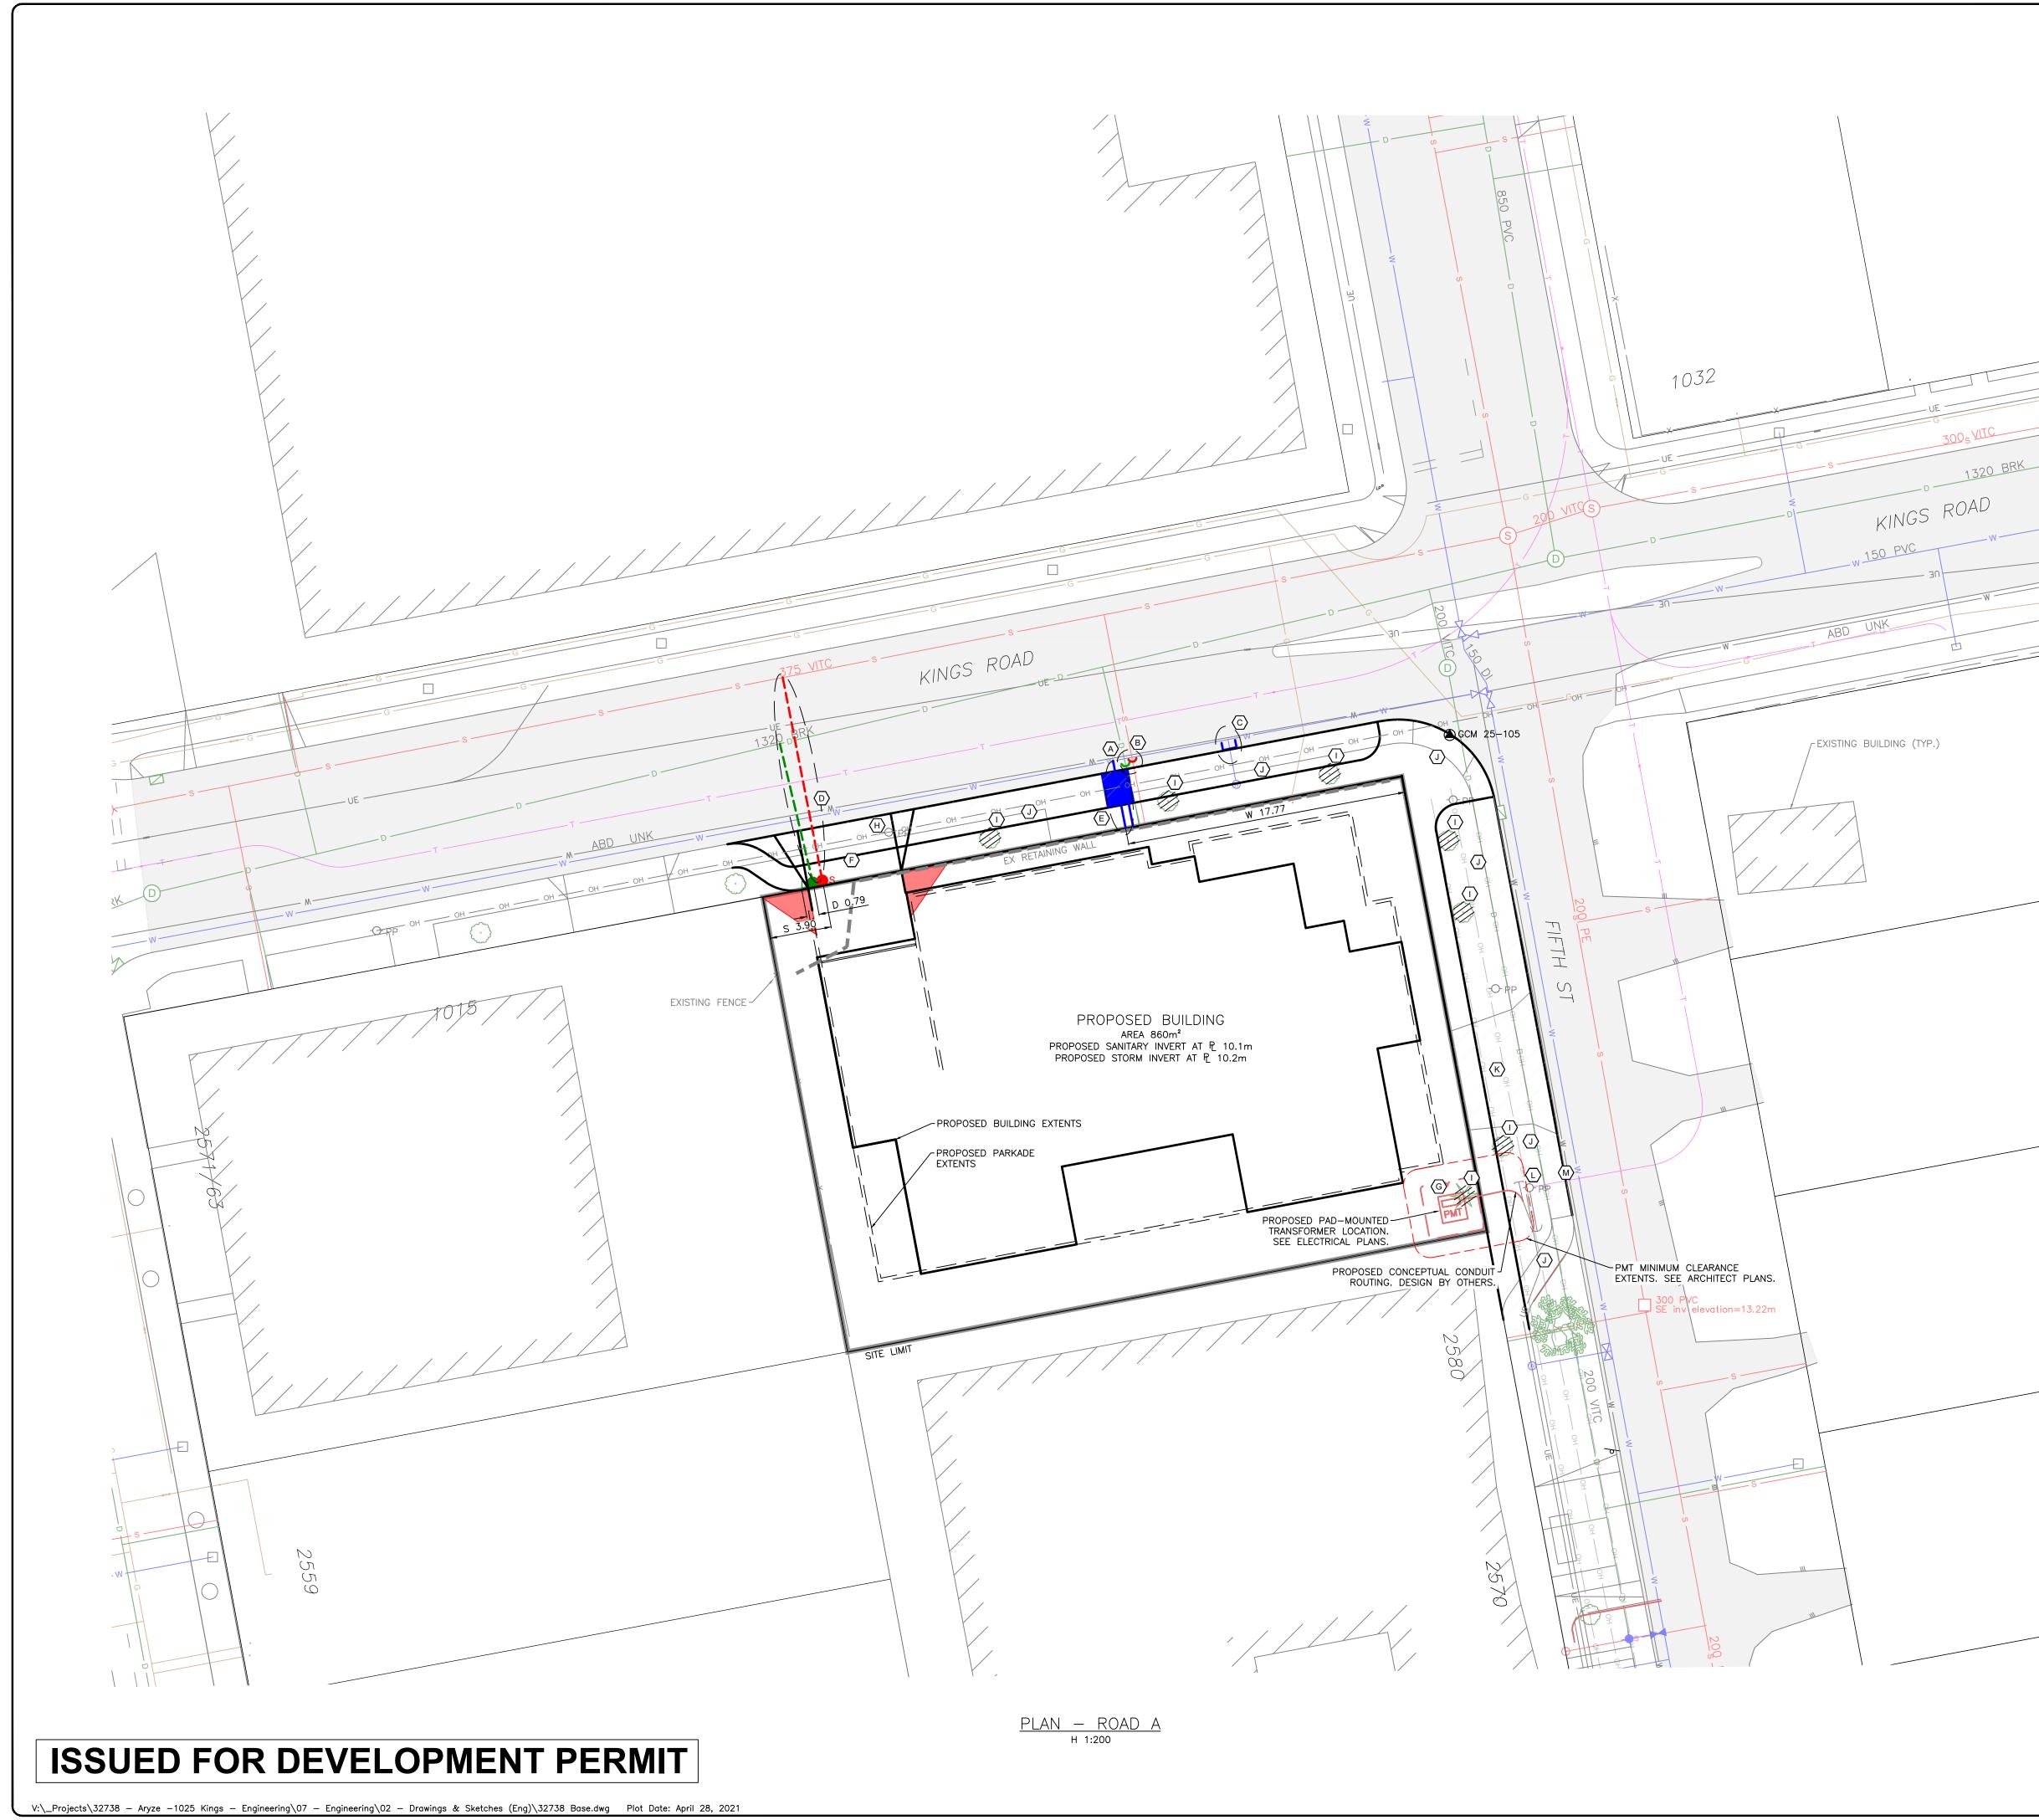
## **1025 KINGS STREET** PRELIMINARY SITE SERVICING PLAN Scale 1:200 Sheet ot Eng. Project No. 32738

- $\langle \overline{A} \rangle$  CITY OF VICTORIA CREWS TO CAP EXISTING DRAIN SERVICE AT DEVELOPERS EXPENSE.
- $\langle B \rangle$  CITY OF VICTORIA CREWS TO CAP EXISTING SANITARY SERVICE AT DEVELOPERS EXPENSE.

- $\langle c \rangle$  CITY OF VICTORIA TO CAP EXISTING WATER SERVICE AT DEVELOPER EXPENSE.
- D CITY OF VICTORIA CREWS TO INSTALL DRAIN AND SANITARY SERVICE TO PROPERTY LINE COMPLETE WITH INSPECTION CHAMBERS AT DEVELOPERS EXPENSE. SIZES TO BE CONFIRMED DURING BUILDING PERMIT.

- $\overleftarrow{\text{E}}$  CITY OF VICTORIA TO INSTALL WATER SERVICE TO PROPERTY LINE COMPLETE WITH METER AT DEVELOPERS EXPENSE. SIZES TO BE CONFIRMED DURING BUILDING PERMIT.

- $\langle F \rangle$  CONTRACTOR TO INSTALL NEW 6.0m WIDE DRIVEWAY TO CITY OF VICTORIA STANDARDS.
- $\langle \overline{\rm G} \rangle$  proposed BC hydro transformer location. BC hydro to confirm servicing design during building permit.

- $(\mathbb{H})$  existing utility pole to be relocated. Design by others during building permit.
- $\langle I \rangle$  existing tree to be removed. Refer to landscape plans.

- $\langle J \rangle$  Contractor to remove existing sidewalk and install separated 1.5m wide sidewalk on property line.
- $\langle \kappa \rangle$  CONTRACTOR TO REMOVE EXISTING DRIVEWAY AND REINSTATE BOULEVARD. L EXISTING UTILITY POLE TO BE RELOCATED AS REQUIRED TO FACILITATE BC HYDRO ACCESS TO PROPOSED PMT. TELUS DUCTS TO BE MODIFIED AS REQUIRED. DESIGN BY OTHERS DURING BUILDING PERMIT.  $\overleftarrow{\mathbb{M}}$  proposed curb to be designed to facilitate BC hydro access to PMT. Detailed design to be during building permit.
