**Construction Impact Assessment &
Tree Management Plan**

PREPARED FOR: Jon Floyd
C/O Jawl Properties Ltd.
200 – 1515 Douglas Street
Victoria, BC V8W 2G4

PREPARED BY: Talbot, Mackenzie & Associates
Robert McRae – Consulting Arborist
ISA Certified # PN-7125A
Tree Risk Assessment Qualified

DATE OF ISSUANCE: July 22, 2021

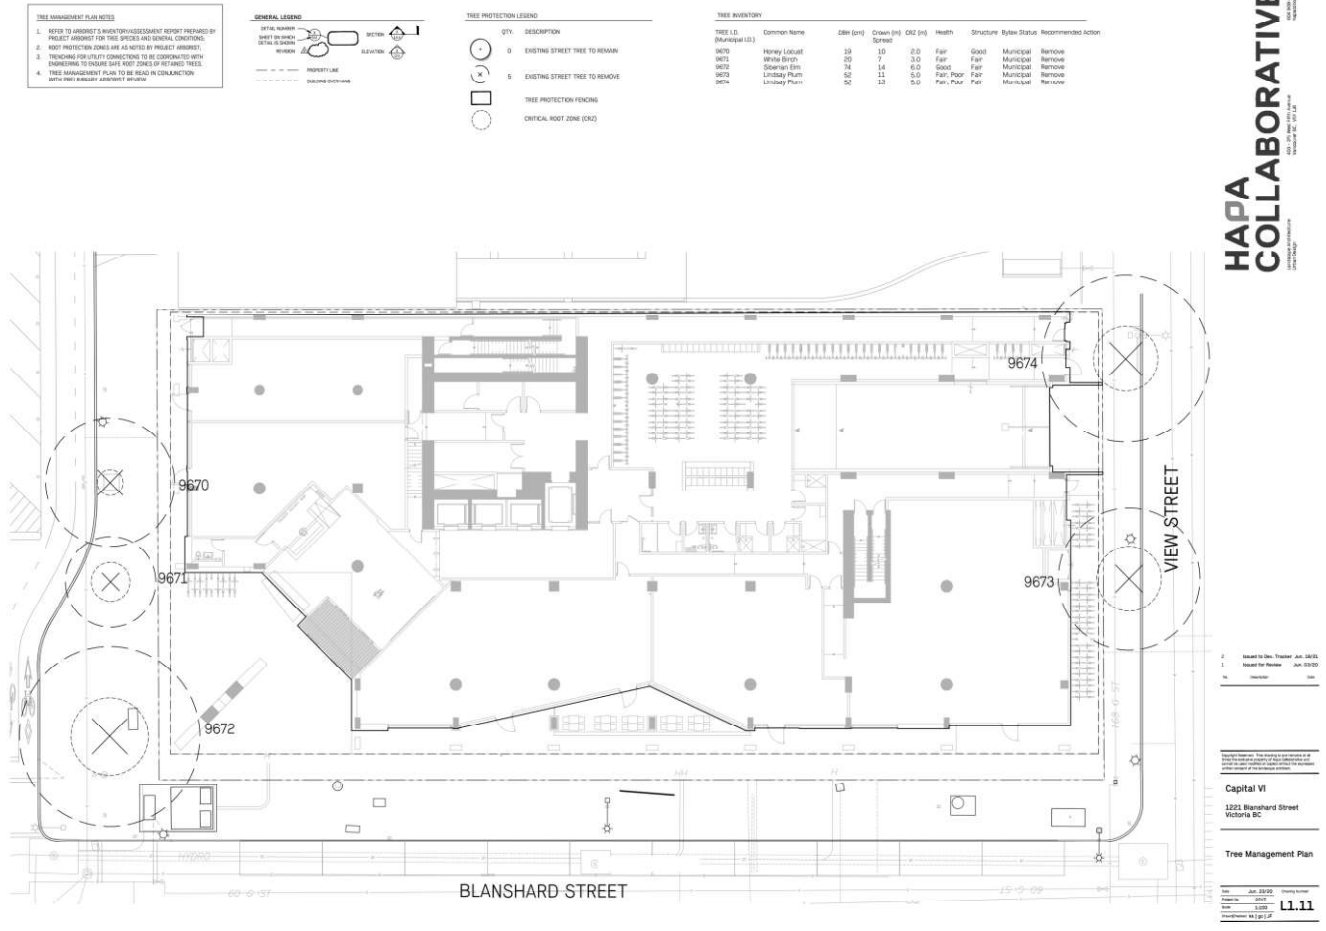
APPENDIX A – TREE MANAGEMENT PLAN

The following municipal trees (indicated by city object ID#) are located where they will be impacted by proposed onsite construction and are proposed for removal (shown on the attached Tree Management Plan):

- 9670-9674

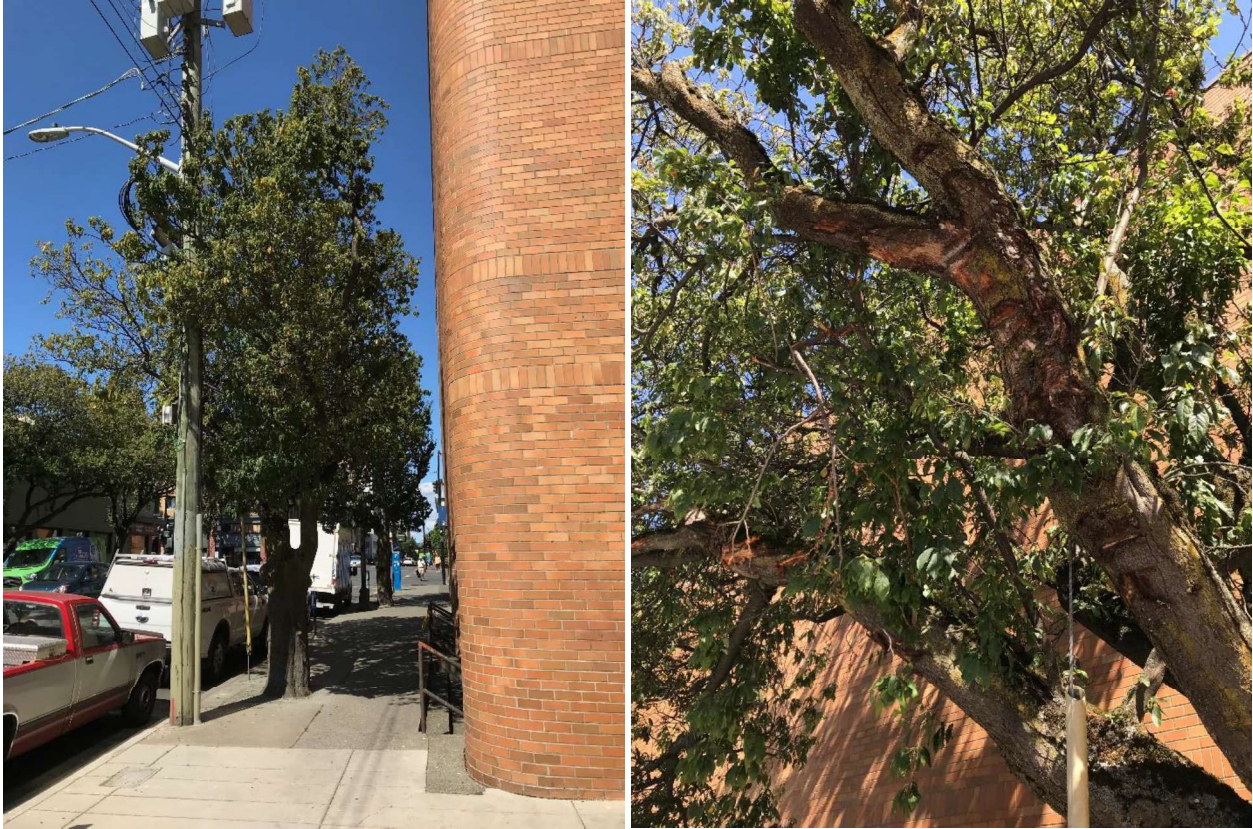
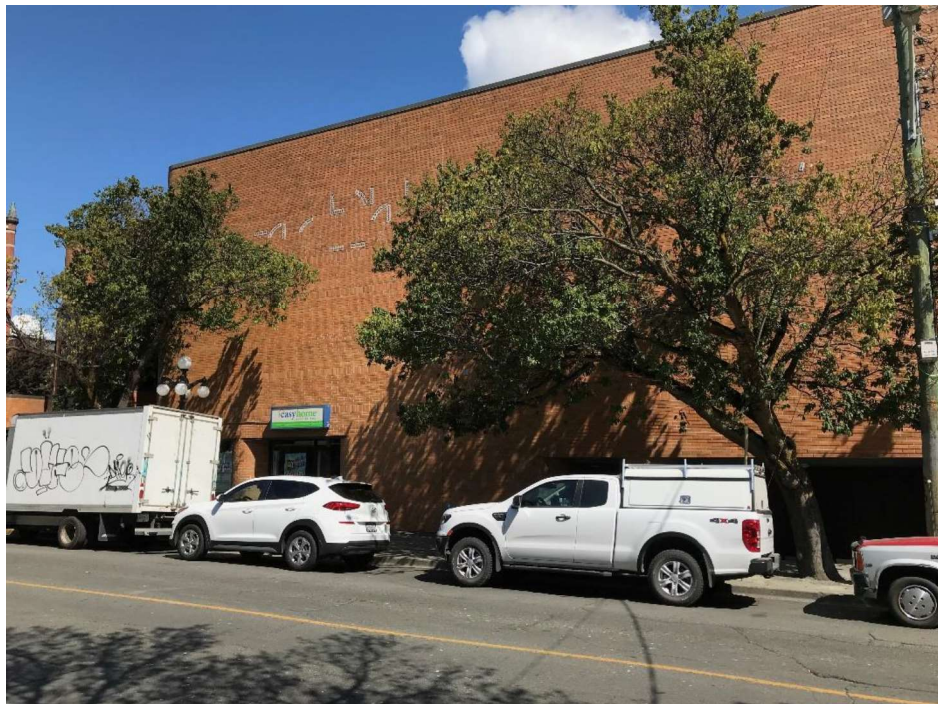
Based on review of the landscape site plan and our understanding of the project scope, 5 municipal trees are located where they required removal to facilitate demolition of the existing building, construction of the new multi-storey complex, with proposed rain gardens and hardscape on the municipal frontages. All the documented trees had structural defects or health concerns that will shorten their anticipated functional lifespan within the urban setting and streetscape, as identified in our July 9, 2020 Tree Resource Review. During our July 22, 2021 site visit, we also observed recent mechanical damage to Lindsay Plum #9674.

Photograph 1-3. Lindsay Plum 9674 (looking west, upper left) with recent mechanical damage (upper right), context with existing building and Lindsay Plum 9673 (below).

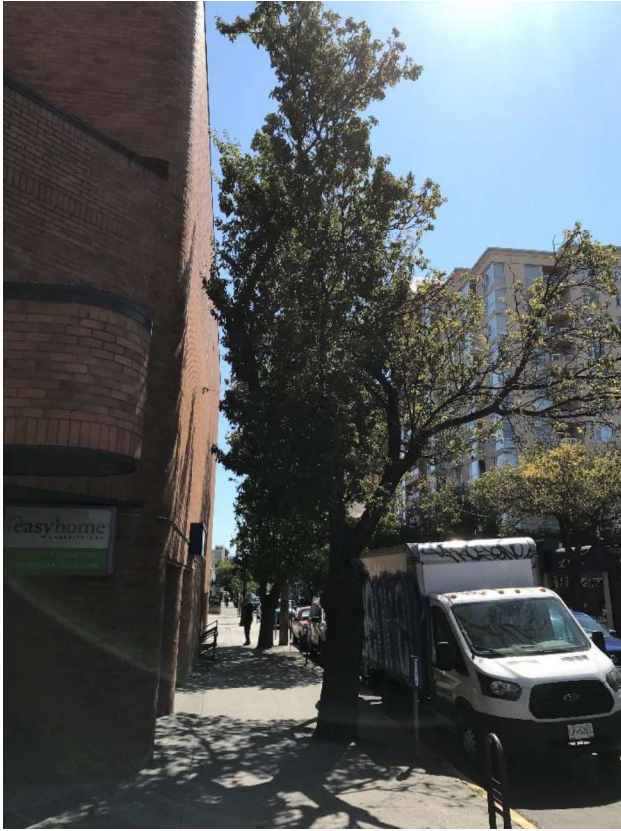
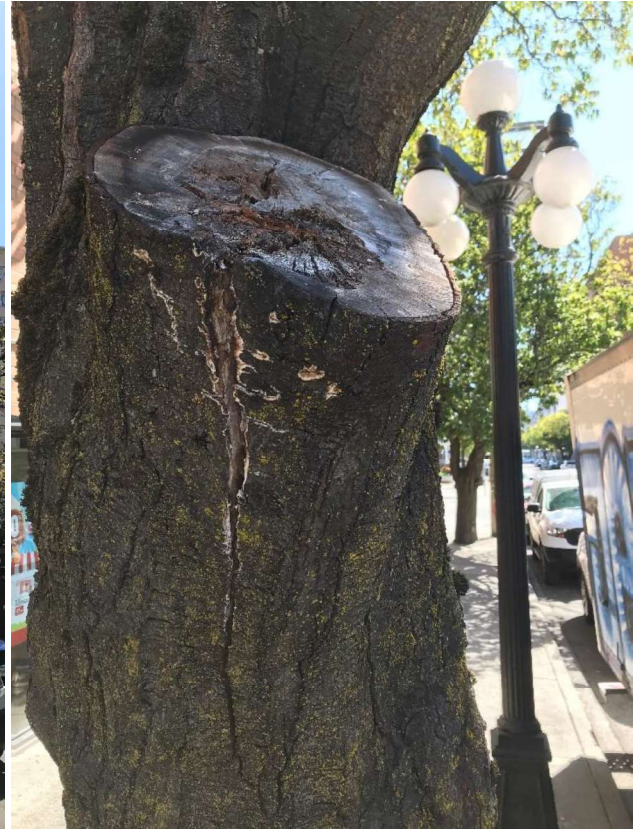
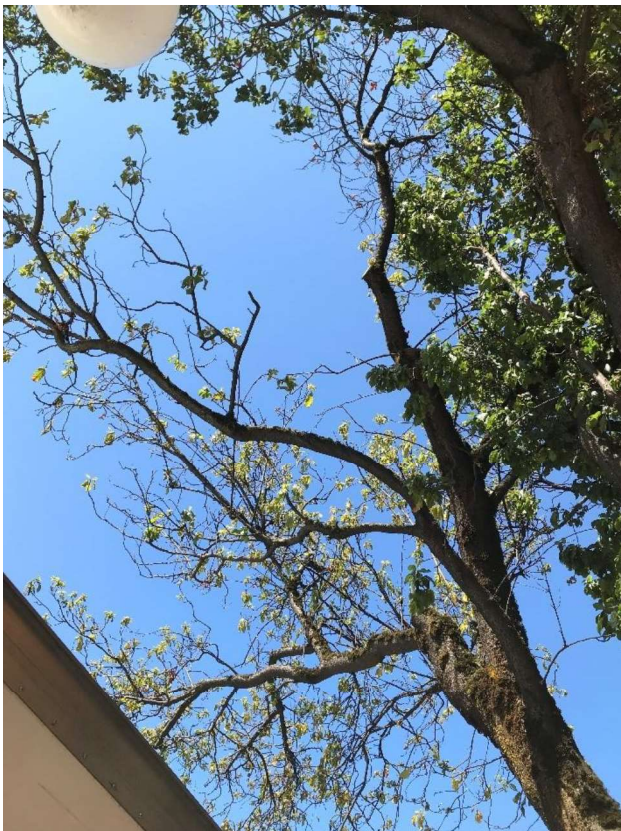
Principal	Lindsay plum	<i>Prunus cerasifera</i> 'Lindsayiae'	52	6.2	11	Fair-poor	Fair		Moderate	Stem removed at weak union, decay in wound. Stem over street in decline. Active reaction wood on trunk. 2 metres from existing wall. Dead limbs recently removed.	Conflict with proposed rain gardens, hardscape, building construction
Principal	Lindsay plum	<i>Prunus cerasifera</i> 'Lindsayiae'	52	6.2	13	Fair-poor	Fair		Moderate	Limb breakage and stem scarring on street side. Declining health. 2 metres from existing wall. Heavy stem weight toward Blanshard.	Conflict with proposed rain gardens, hardscape, building construction

Photograph 4-6 – Lindsay Plum 4673 with structural defects as outlined in inventory.

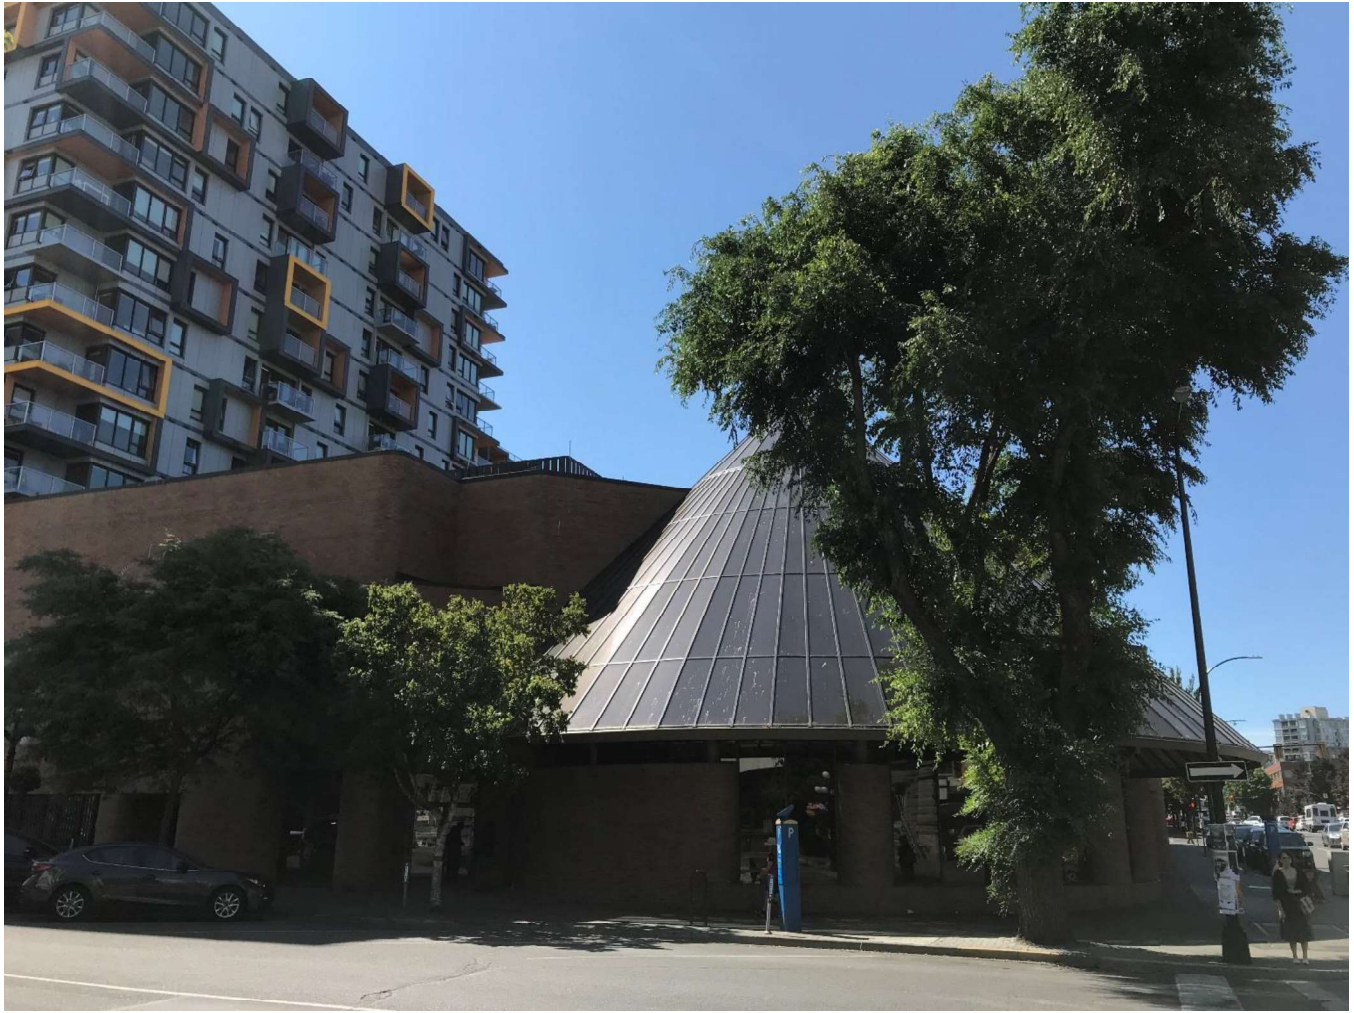
Photograph 7 – Trees 4670-4072 in context with existing building, looking south from Yates St.

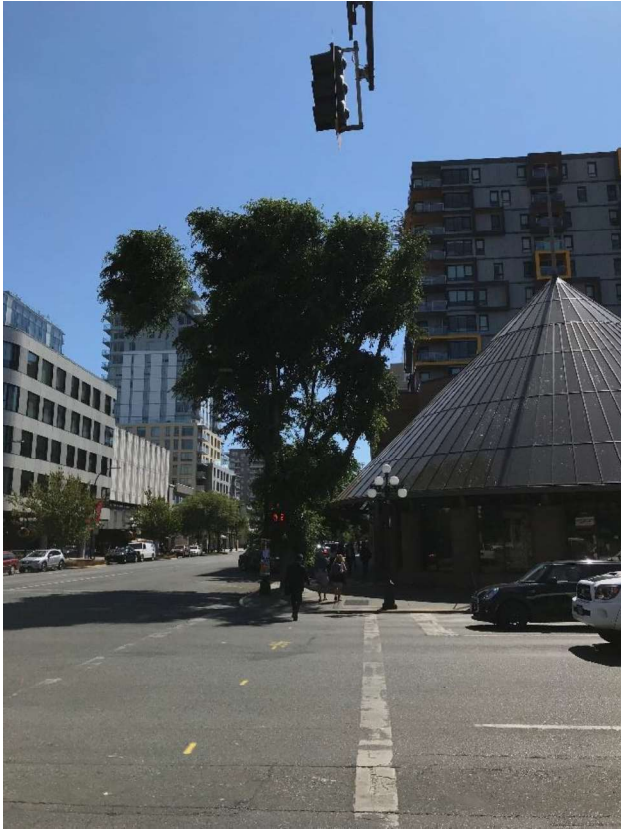
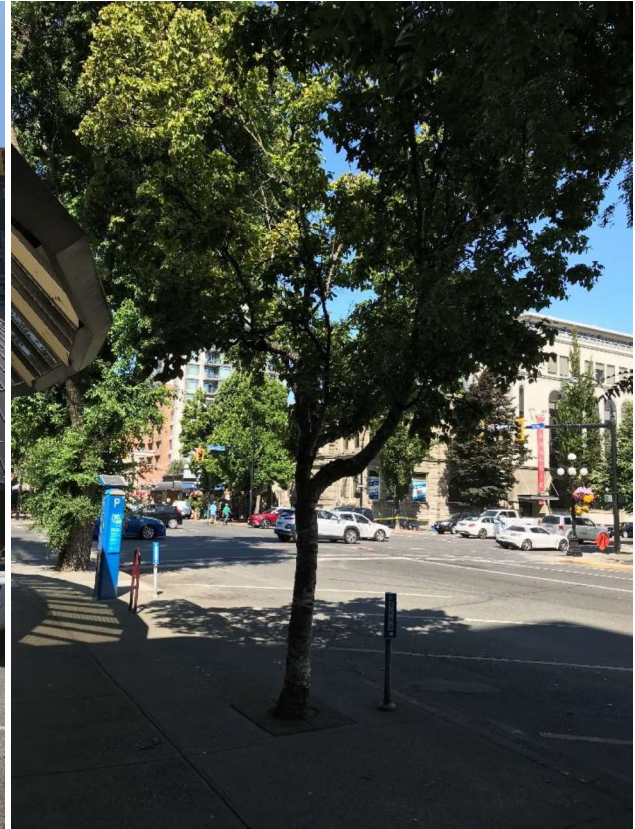
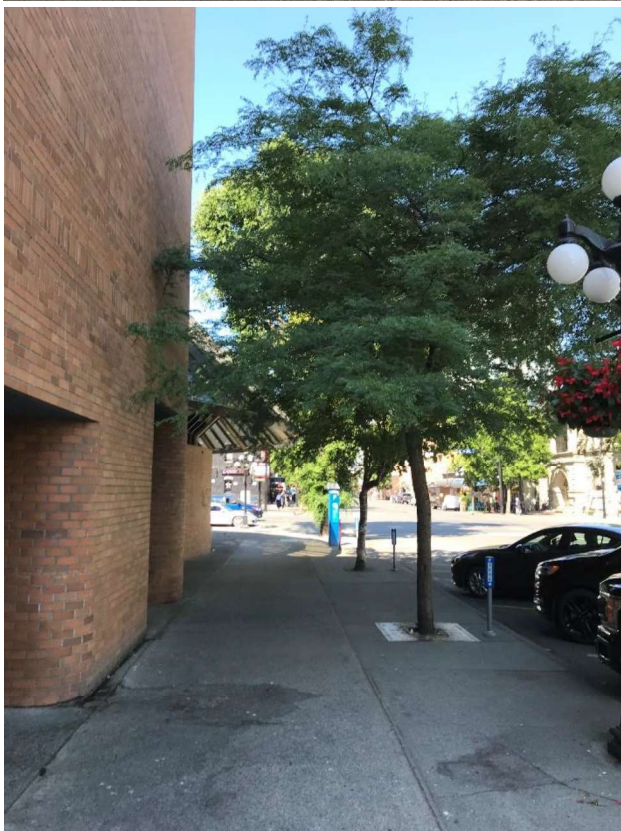
Photograph 8-10 – Siberian Elm 4672 (upper left, note unorthodox pruning) looking east from Blanshard St., White Birch 4671 (upper right, note dieback in canopy) looking west from Yates St., Honey Locust 4670 (lower left) in relation to existing building, looking west from Yates St.
