## **480 & 492 Esquimalt Road—Victoria, BC**

### **Construction Impact Assessment & Tree Management Plan**

Date of Issuance: May 27, 2022

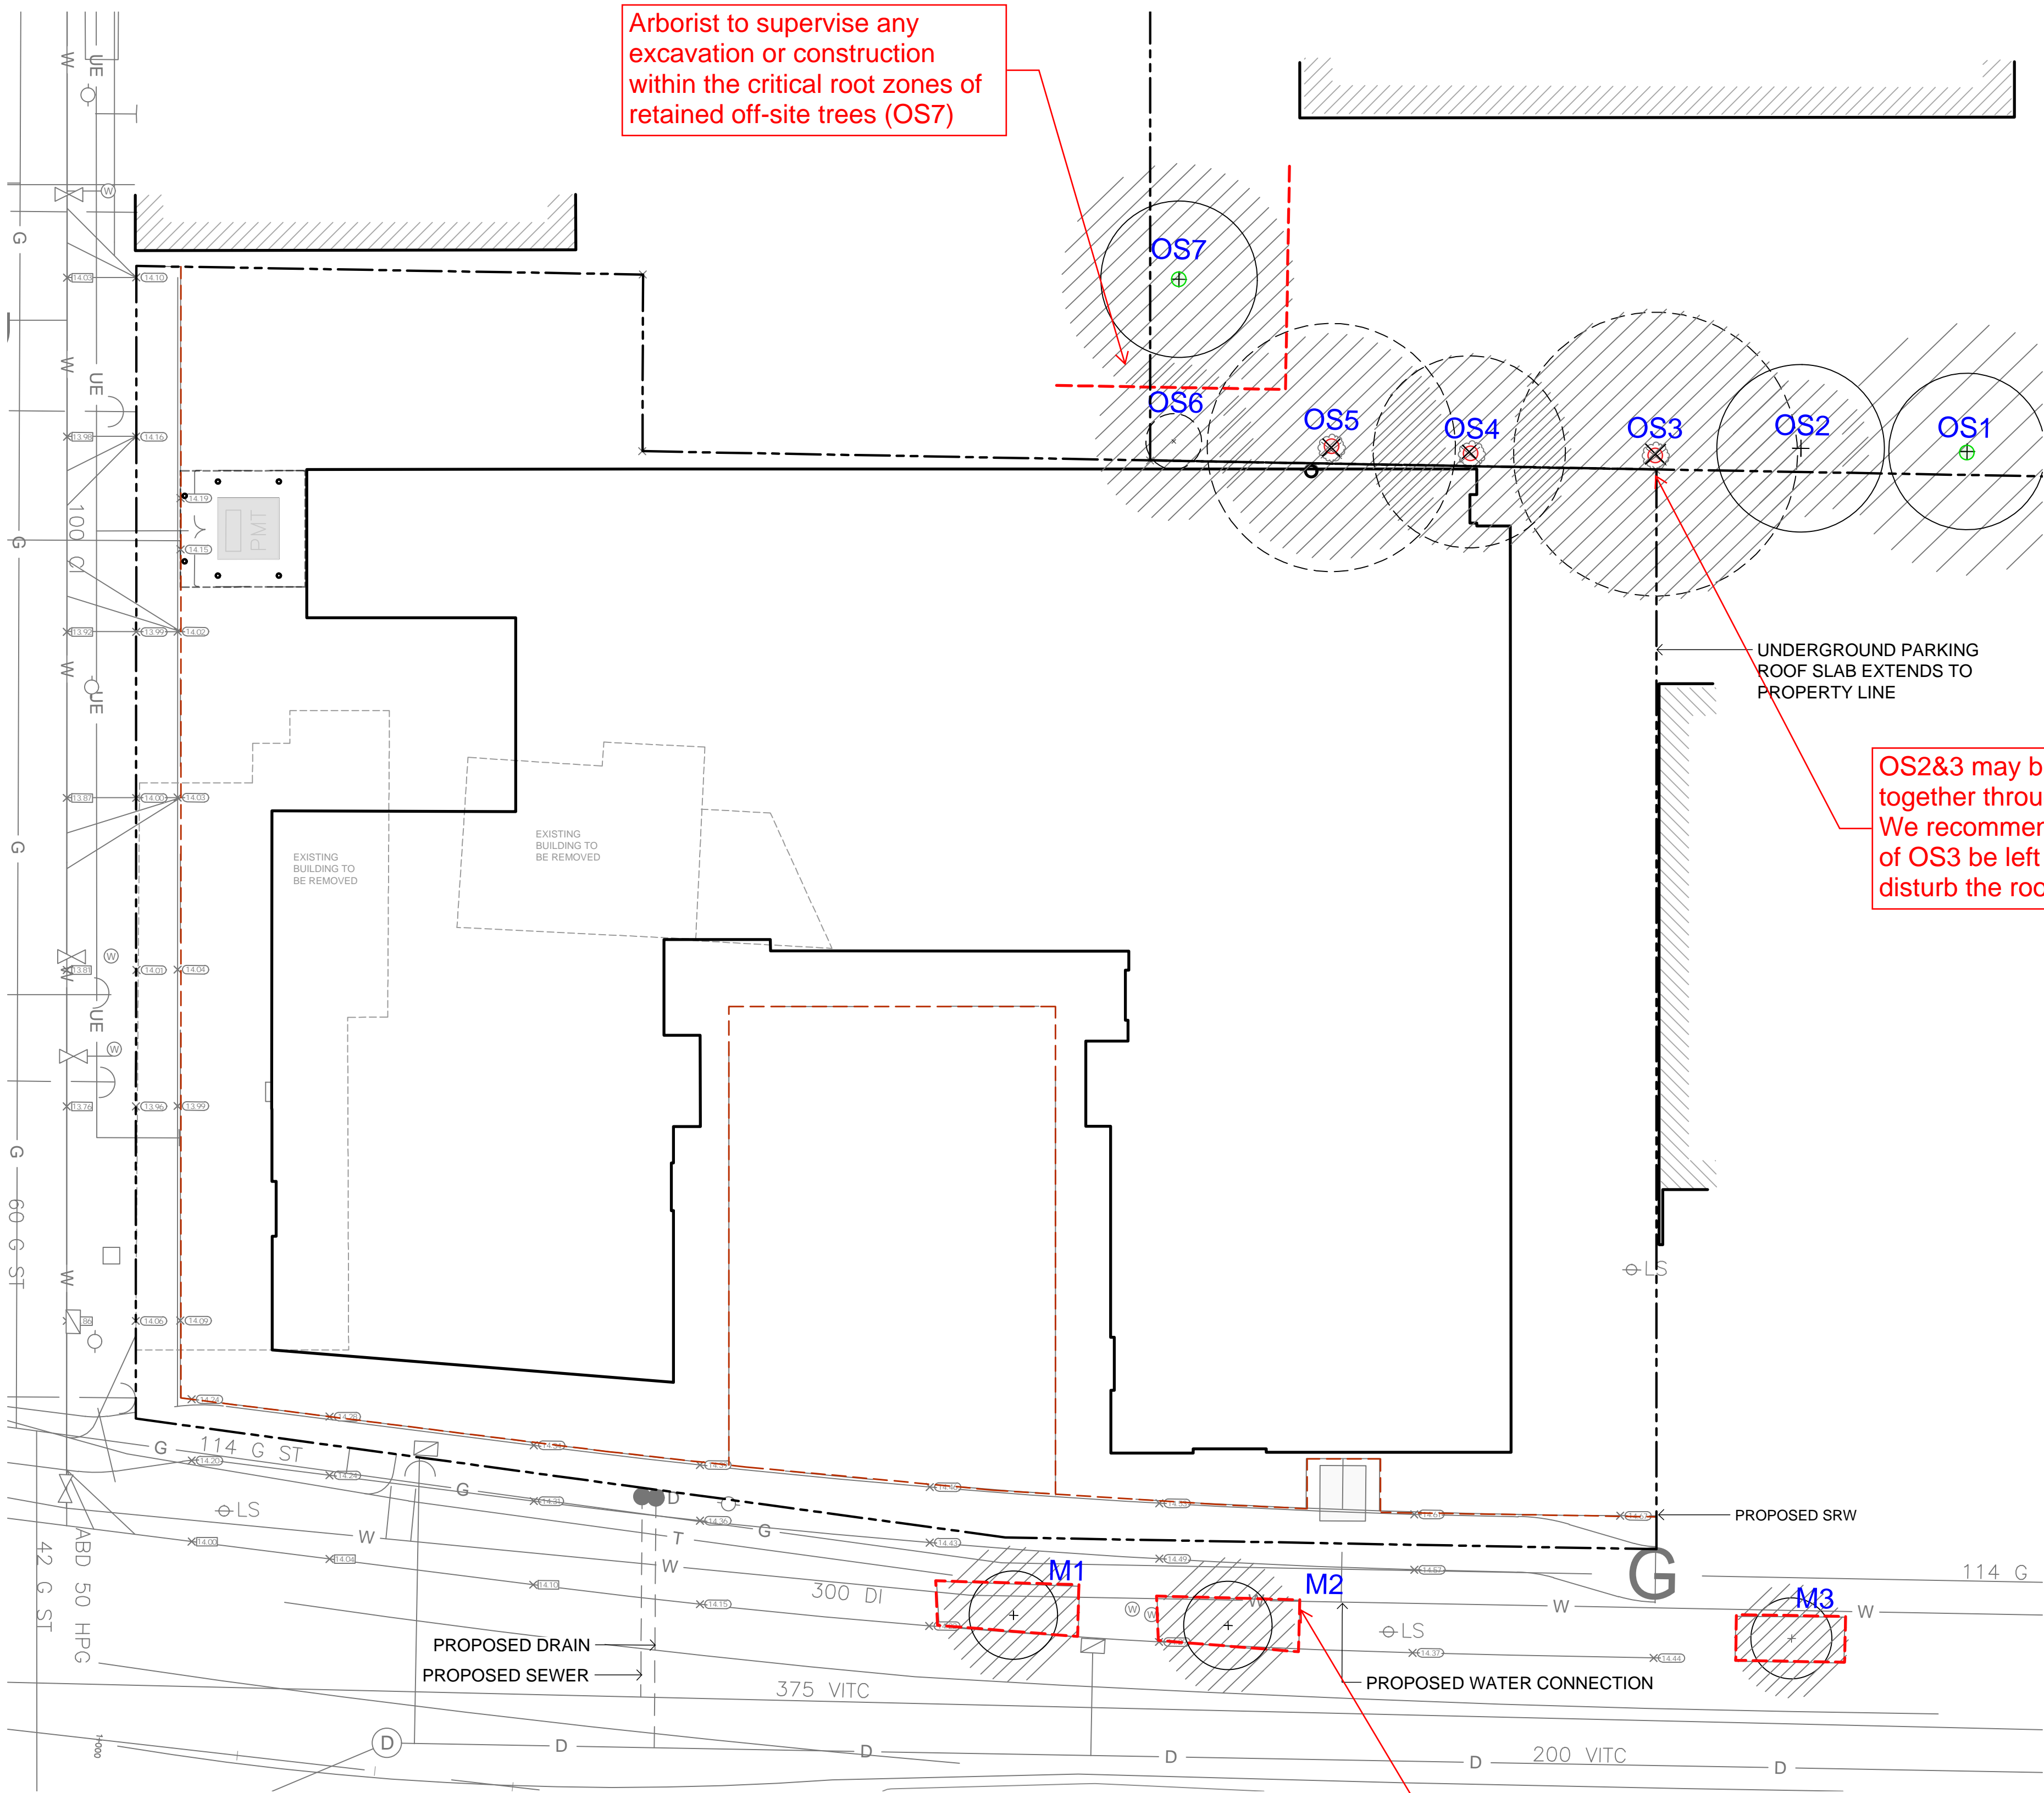
1  
L0  
TREE REMOVAL & PROTECTION PLAN  
1:150

- Excavation for the underground levels of the new building is proposed along the northern property line (shared with 404 Dundas St.). This excavation is within the CRZs of **Three (3) Norway Maples (*Acer platanoides*) OS#3-5 (44, 30, and 34cm DBHs, respectively) and One (1) Pyramidal Cedar (*Thuja occidentalis*) OS#6 (11/9/9/cm DBH):**

These trees are located approximately 0.5m from the property line. Excavation for level P2 (8.75m finished grade) is proposed as much as 9m below existing grades where the above trees grow (between 17-17.68m). Excavation in this location at the proposed depth is likely to destabilize these trees. Therefore, we recommend the removal of OS#3-6, of which OS#3-5 are bylaw protected (Appendix A).

- P1/P2 foundation excavations are proposed within the CRZ of **Norway Maple OS#7 (36cm DBH)**. The project arborist should be contacted if over-excavation is required beyond the north property line (shared with 404 Dundas St.)—in this event we may recommend alternative construction techniques (i.e., shoring) to minimize disturbance within the CRZ.
- To mitigate impacts to **Norway Maple OS#2 (21cm DBH)**, we recommend the stump of OS#3 be left in place or ground to just below grade, as the roots of these two trees may be grafted together. OS#2 is not bylaw protected.

- **Three (3) Red Maples (*Acer rubrum*) M#1-3, municipal ID#s 29668, 29669 & 29670 (20cm, 19cm, and 18cm DBHs, respectively):** We recommend the project arborist be on-site to supervise any excavations within the CRZs, including sidewalk upgrades and water service installation (as required). Protective barrier fencing should be erected and maintained to the edges of the CRZs to the east and west, and to the sidewalk/curb edges north and south to prevent machinery access and material storage in these areas (Appendix B & C).

- The areas surrounding the trees to be retained should be isolated from the construction activity by erecting protective barrier fencing (Appendix B & C). Where possible, the fencing should be erected at the perimeter of the critical root zones.
