# **458 Cecelia Rd, Victoria, BC**

## **Construction Impact Assessment & Tree Management Plan**

**DATE OF ISSUANCE:** March 4<sup>th</sup>, 2022  
**UPDATED:** July 8<sup>th</sup>, 2022

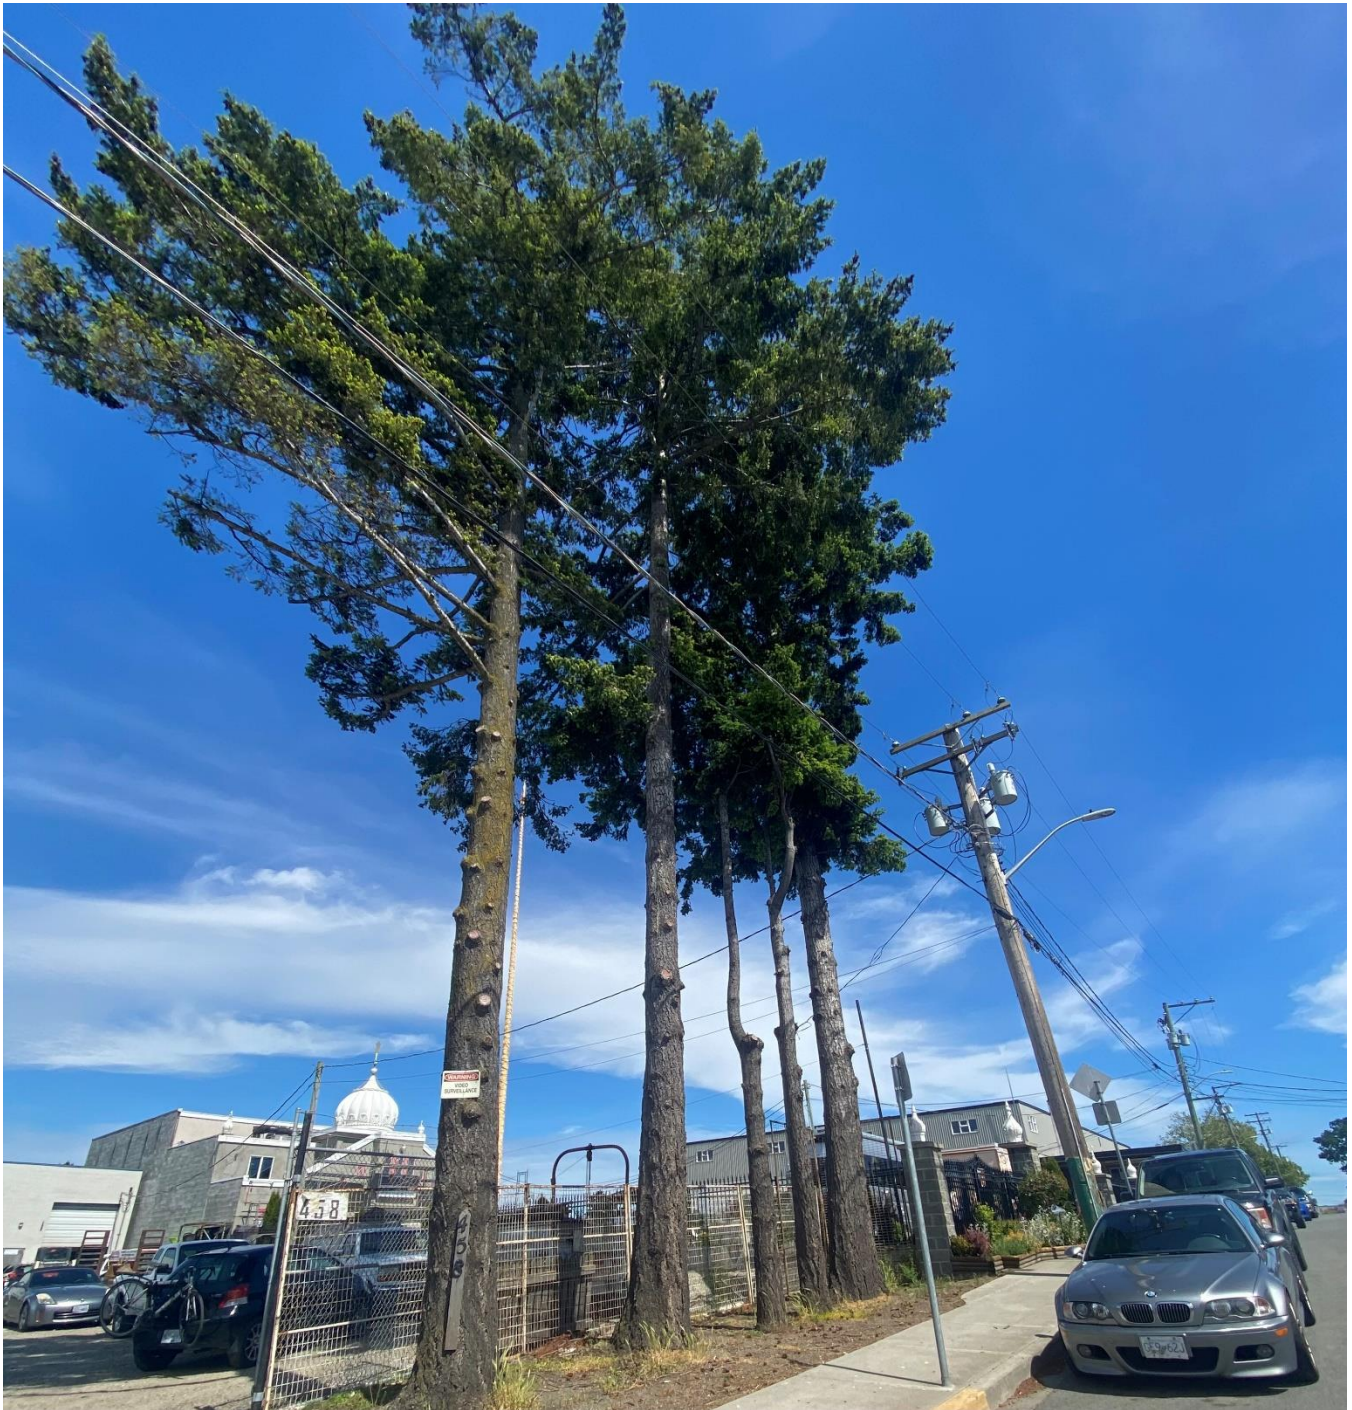
*Image 1- 5 Douglas firs I front of the subject site, all intended for retention. #2505 in the foreground to 2501 in the back.*

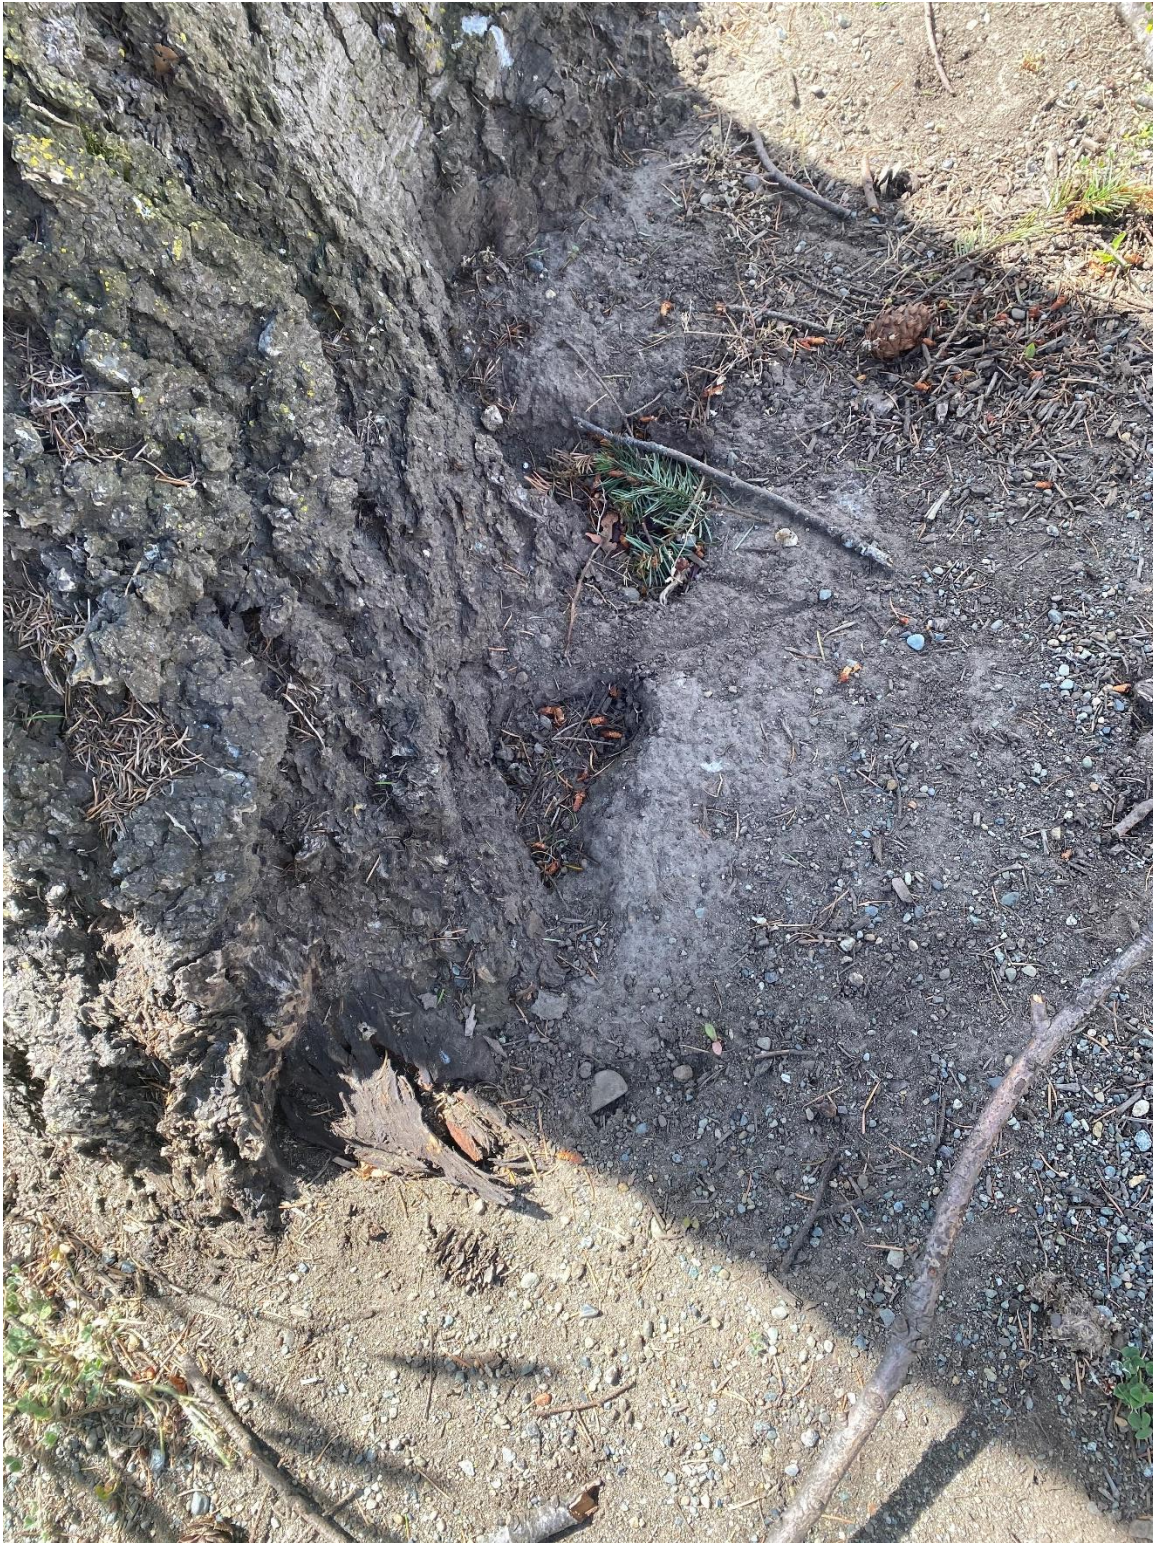
*Image 2 –Base of tree #2502, showing damage at base of root flare an level of soil compaction consistent with soil at base of other 4 firs.*
