Talmack Urban Forestry Ltd was asked to complete a tree inventory, construction impact assessment and management plan for the trees at the following proposed project:

Site:	27 South Turner St
Municipality	City of Victoria
Client Name:	Bryan and Keira Higgins
Dates of Site Visit:	May 14 th 2021, June 4, 2021, November 14, 2022, November 24, 2022
Site Conditions:	1 urban lot.
Weather During Site Visit:	Sunny/Clear (2021 dates) and Overcast (2022 dates)

Construction Impact Assessment and Tree Management Plan for
27 South Turner St.
Prepared for Bryan and Keira Higgins

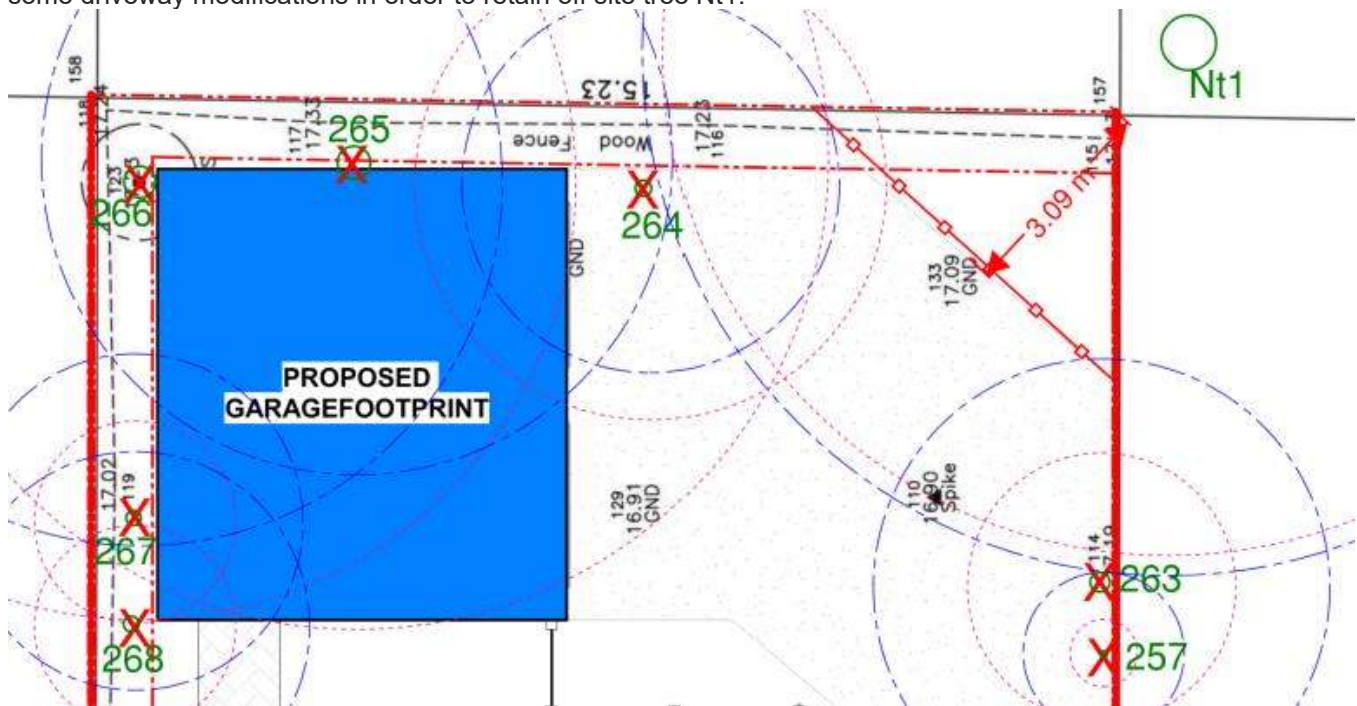
Figure 1: TMP derived from plans provided by Hoyt Designs in April 2022. Shows original proposed driveway with an approximately 3m setback from the Southeast property corner where Nt1 is located.

The intention on the latest set of plans provided by Hoyt Designs (Nov 17, 2022) is to extend the driveway to the Southeast corner of the property where Nt1 is located. The grade of the slab for the proposed garage has been raised to an elevation 17.00m at both the Southeast and Southwest corners of the proposed garage to limit the slope of the driveway while allowing for a section of the driveway to be floated over roots of Nt1. The intention of our driveway proposal is to start floating the driveway within 4m of the Southeast property corner, where roots were encountered during the exploratory excavation (Appendix E). The natural grade within 4m of the property corner increases from 17.09m to 17.4m, at the corner. The finished grades of the driveway within the CRZ of Nt1 is subject to slight variation, however Talmack has provided a sketch below that roughly outlines a profile of the proposed floated driveway within the CRZ of Nt1.

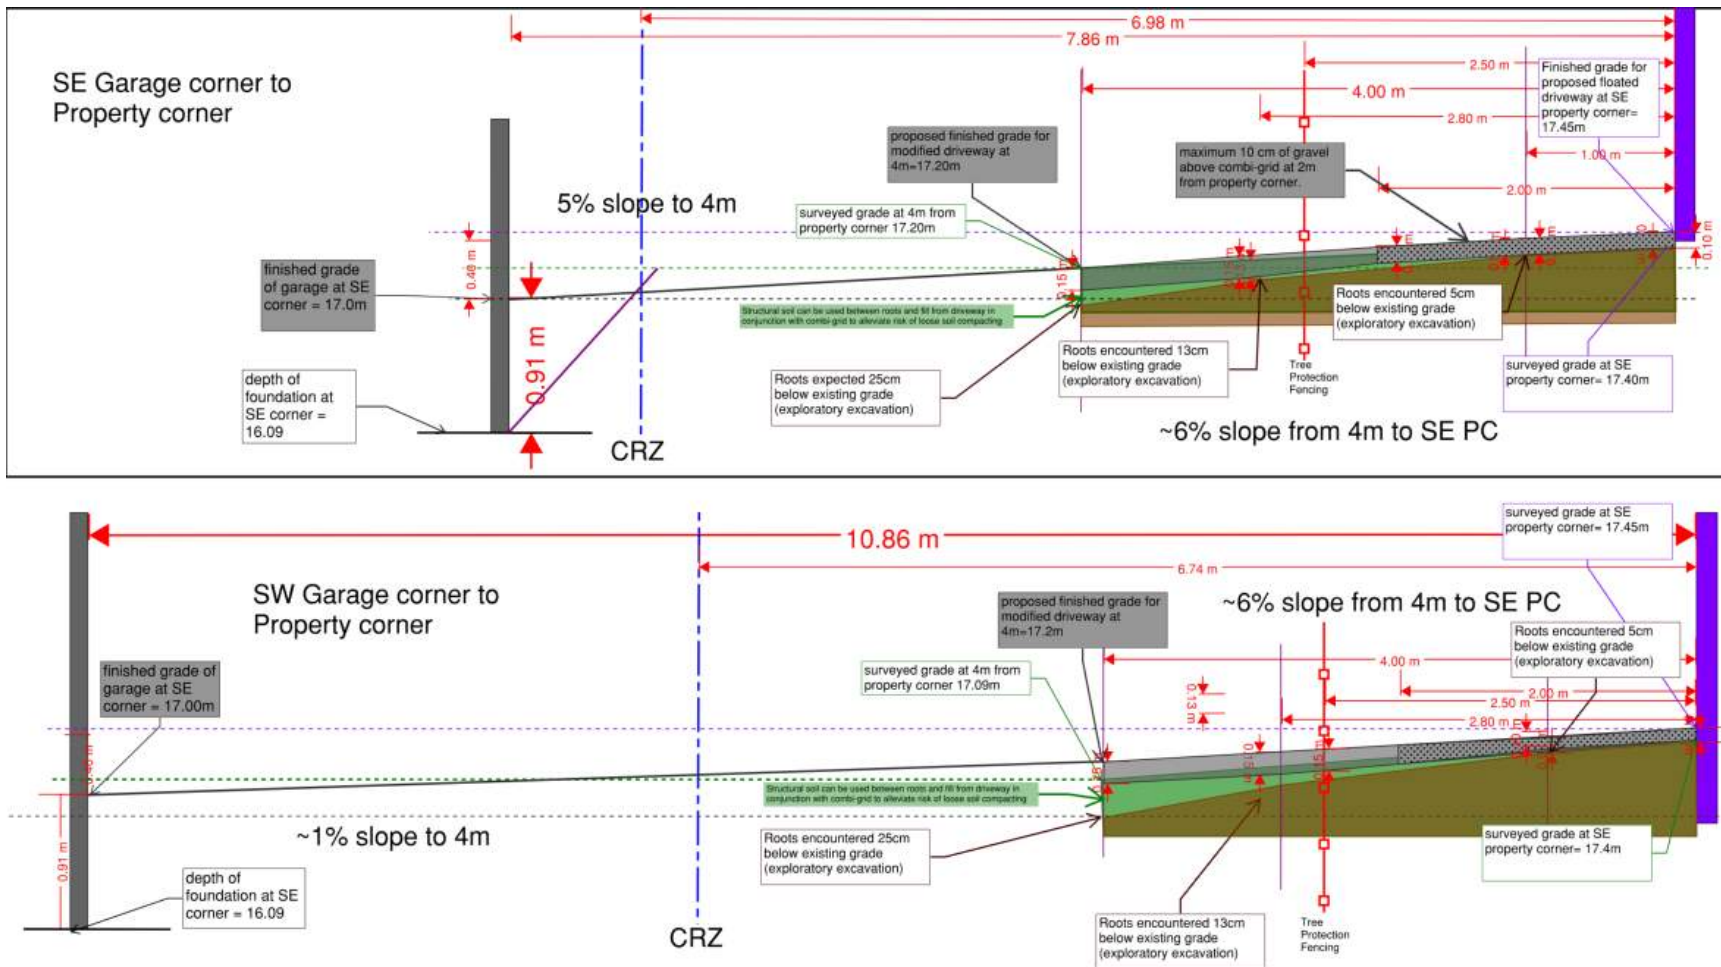
Figure 2: Profile drawing of arborist-suggested proposed floated driveway within CRZ of Nt1. This diagram is informed by the surveyed existing grade values and the results of the exploratory excavation within 4m, 2.7m and 1m of the Southeast corner of the subject property.

4m was established as a reasonable limit of approach from the offsite tree to limit excavation required for proposed driveway within the CRZ of Nt1. As outlined in figure 2, at 4m from the Southeast property corner the driveway will be altered to the 15cm thickness floated driveway spec provided in Appendix C., to mitigate impacts to roots encountered. The proposal is to follow this floated driveway spec along the existing grade until roughly 2.5m from the SE property corner, where the fill layer will start to taper off in order to match the 5-10cm of gravel above combi-grid within 2m of the property corner. Figure 2 shows 10cm for the gravel depth, pending geotechnical engineer consultation. Ideally the gravel layer can be closer to 5m to not exceed a 5% slope on the driveway.

This method ensures no excavation occurs below the depths at which structural roots were encountered during the exploratory excavation. Any alternative minimal-excavation driveway proposals should be reviewed by the project arborist prior to a definitive retention status being determined for Nt1. Any excavation or fill installation relating to the driveway, within the CRZ of Nt1, shall be supervised by the project arborist.

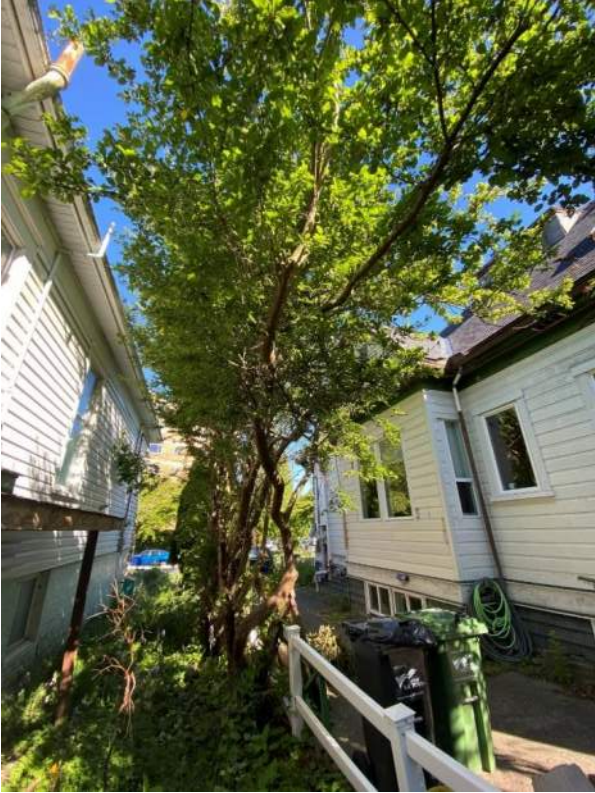
Photograph 1-Cherry plums (tag#: 255, 256) and Pyramidal cedar (tag#: 254) (rear) along Northern fence line captured while facing South Turner Street

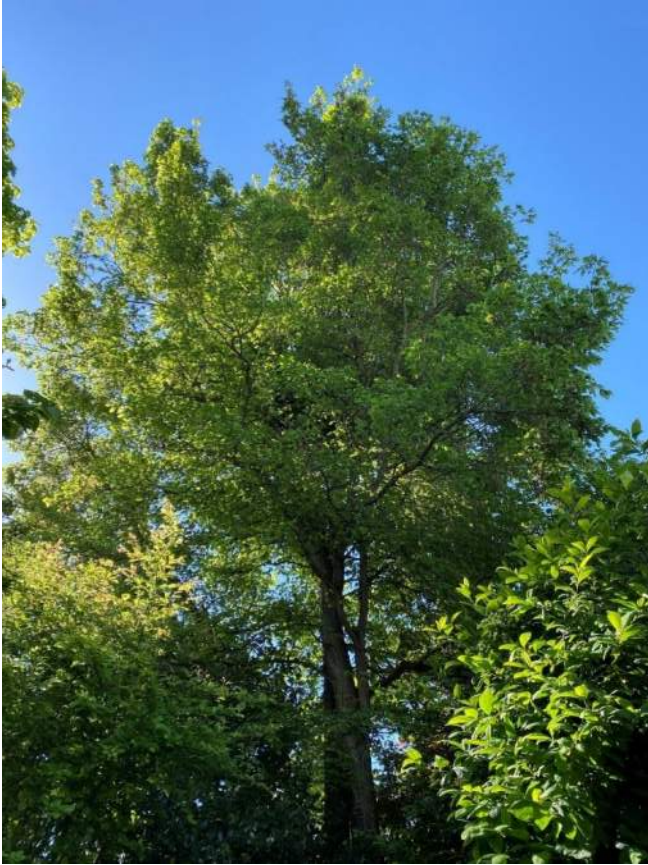
Nt1	No	Off	Yes	American Elm	<i>Ulmus american</i>	82	7.8	7.5	Fair	Fair	Limited visibility of trunk due to lack of access to neighbouring property, multiple stems from union at approximately 1m height, canopy extending into subject Lot by approximately 4m from Southeast corner	Good	CRZ overlap with proposed driveway, Driveway grades altered based on exploratory excavation carried out by Talmack (Appendix E). Retention status is conditional on specifications for proposed driveway within CRZ, to be reviewed by project arborist. Outline for arborist-suggested driveway proposed in section 8 of this report.	*Retain
Nt2	No	On	Yes	Plum	<i>Prunus sp.</i>	18,15,12	3.2	3	Fair-Poor	Fair-Poor	Limited visibility of trunk tissue due to ivy, growing on subject side of existing fence, canopy lean to East.	Good	CRZ overlap with proposed garage, not suitable for retention.	Remove

Photograph 3 – Off-site Elm (#Nt1) located beyond Southeast corner of property.

The retention of the private off-site elm tree (Nt1) is conditional on the proposed driveway being designed and built so it requires minimal excavation within 4m of the Southeast corner of the subject property, where Nt1 is located. Within the 4m setback from the corner, driveway paving should follow the specifications

outlined in Appendix C, not exceeding the depths at which structural roots were found in the exploratory excavation (Appendix E). A profile diagram of the arborist-proposed modified floated driveway is provided in section 8 of this report. The project arborist should be consulted for review once a definitive plan has been derived for a minimum excavation driveway that satisfies the depth and compaction mitigation parameters outlined in this report. The project arborist is to supervise any excavation for the driveway within the CRZ of Nt1.

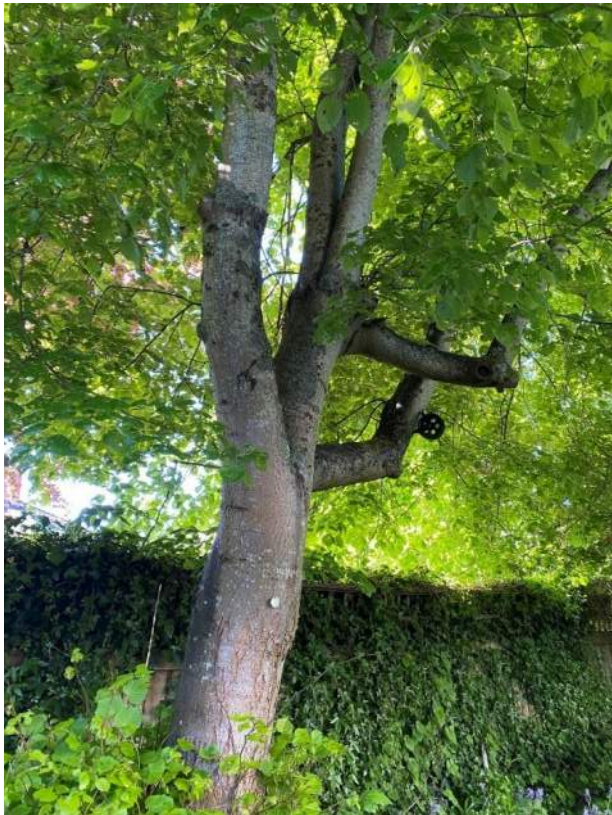
Photograph 4 Linden (tag #265) in back yard along Eastern fence line

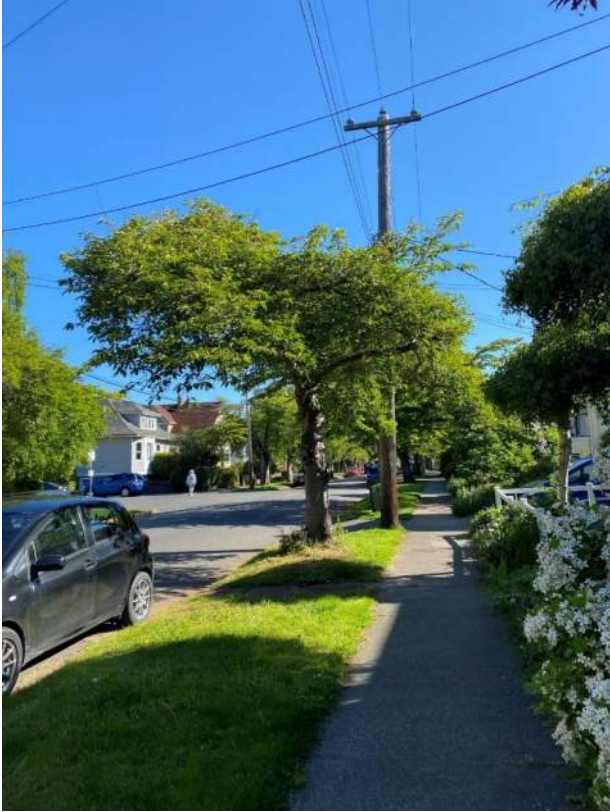
Photograph 5- Municipal tree (tag # 24122)- along South Turner frontage

The municipal Cherry tree (Site ID#: 24122) may be possible for retention provided the project arborist supervises any excavation for the sidewalk widening and old services being capped within the tree's critical root zone (CRZ). Tree protection fencing is to be installed according to Appendix A.

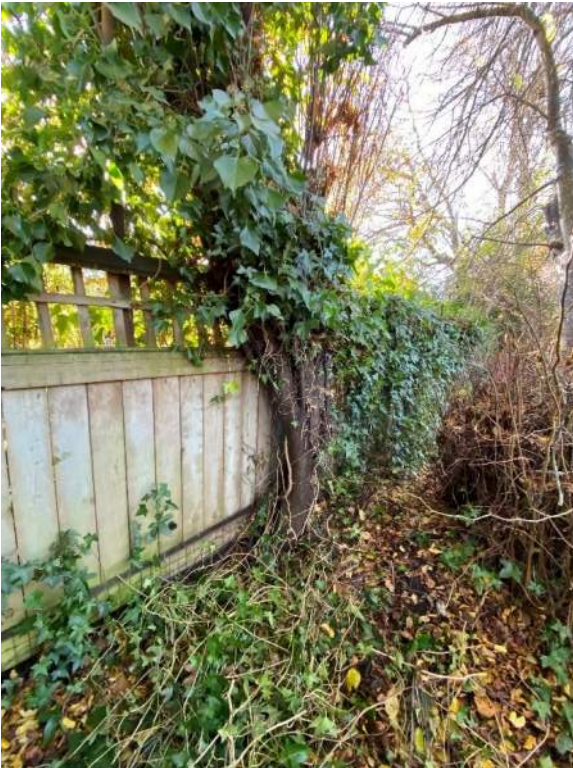
Photograph 6- Protected plum tree Nt2 located along rear fence.

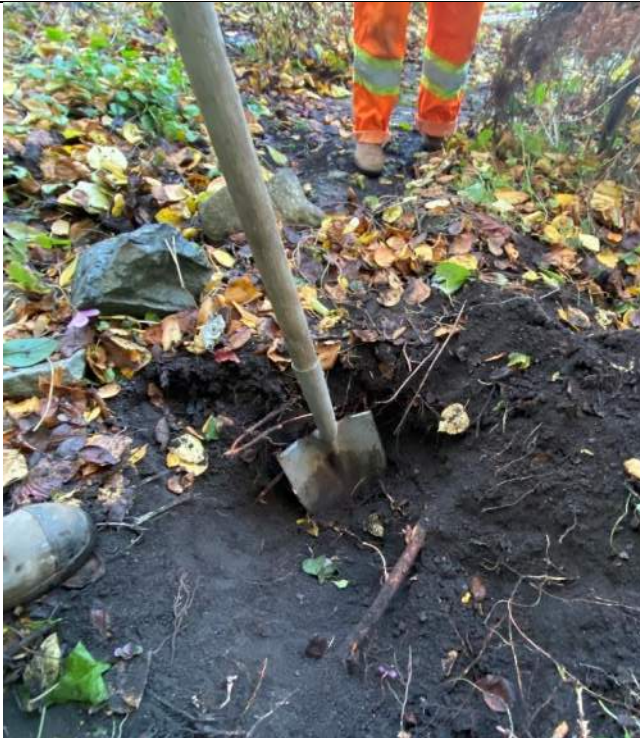
Photograph 1:
4cm root encountered at 4m from Southeast property corner (top of root approximately 25cm below existing grade)

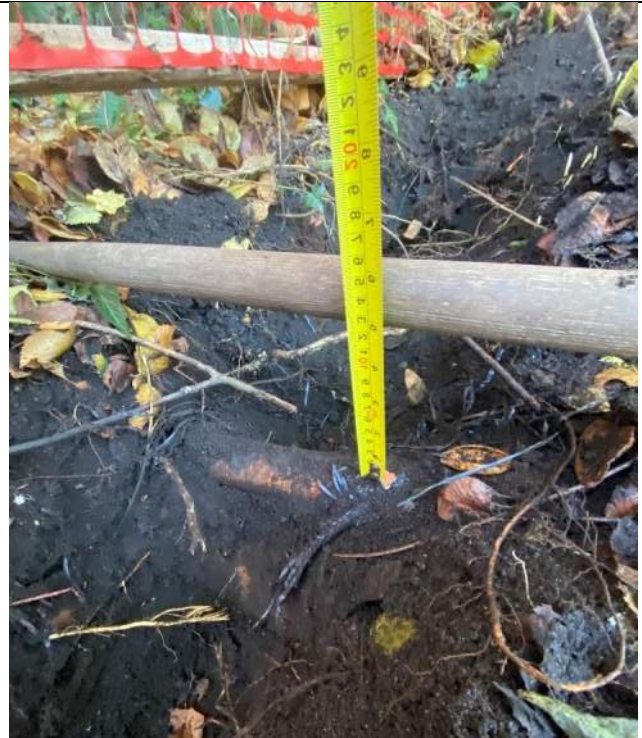
Photograph 2:
7cm root encountered at 2.8m from Southeast property corner (top of root approximately 13cm below existing grade).

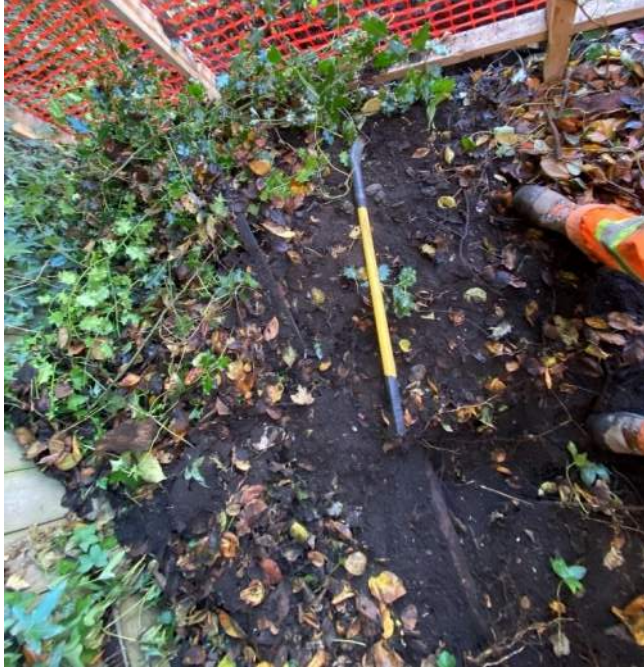
Photograph 3:
10cm root encountered at 1m from Southeast property corner (approximately 5cm below surveyed grade).

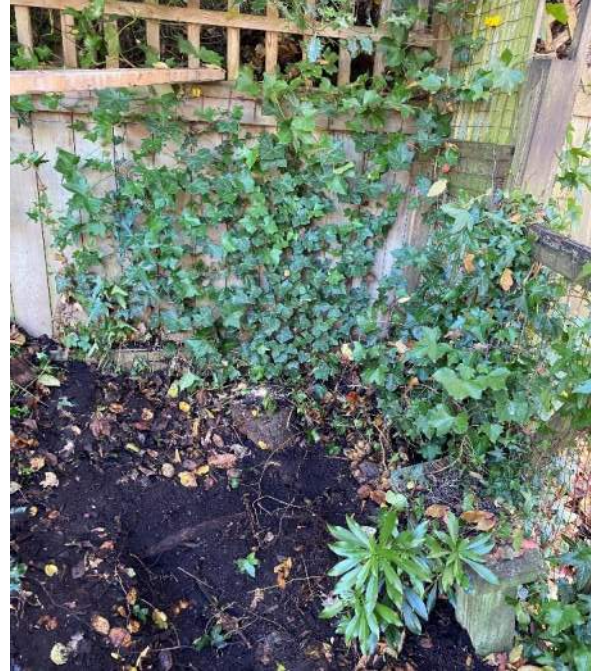
Photograph 4:
Old tree stump uncovered in Southeast corner of subject property beside Nt1.
