Arborist Report

3145 Balfour Avenue
Victoria BC

Nov 4, 2020 – Revised June 12, 2021

RE: 3145 Balfour Ave. Arborist Assessment & Tree Protection Plan (TPP)

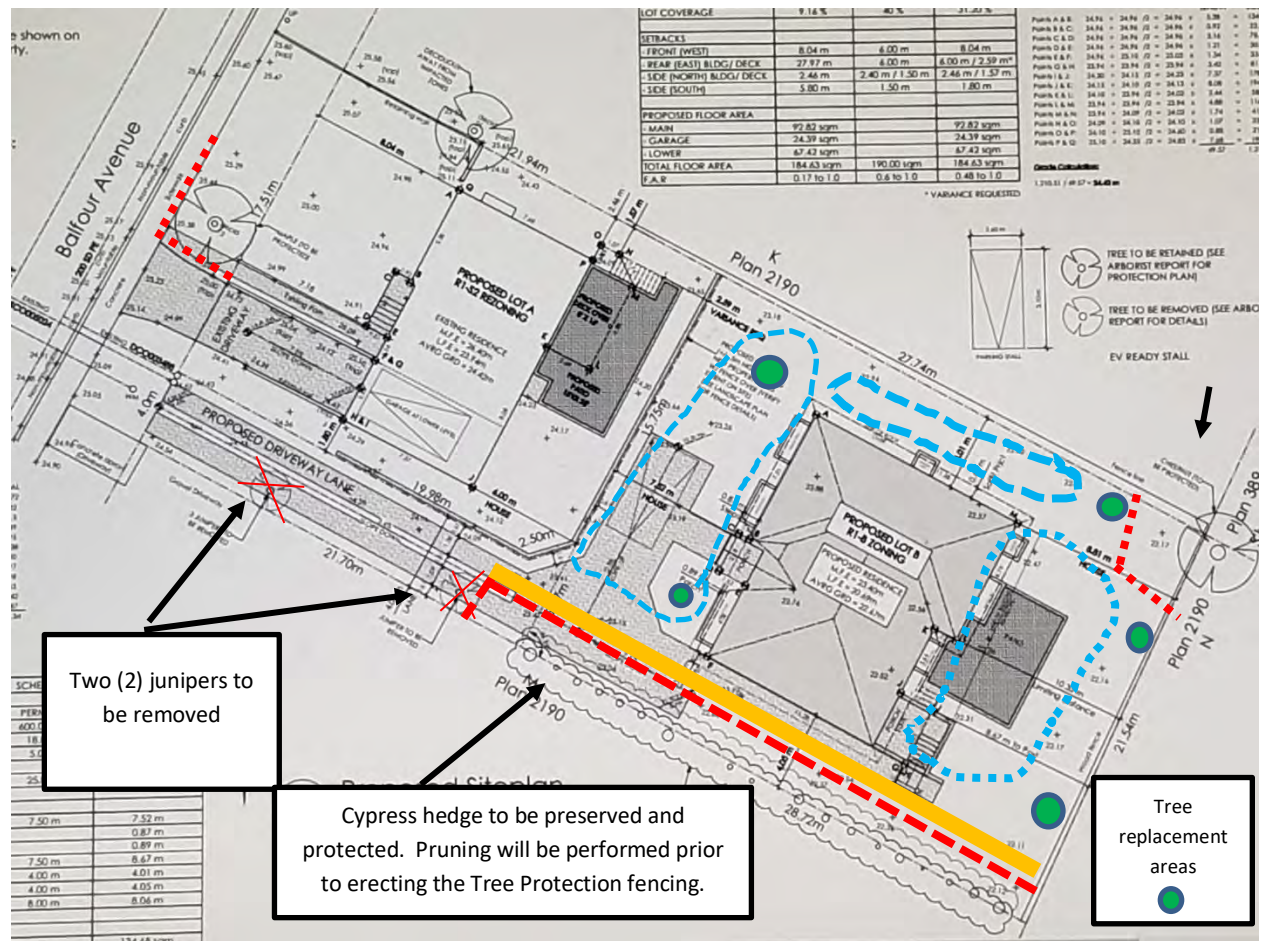
Photo #1 – Site Map – Tree Protection Fencing Plan

Tree Protection Fencing (TPF) is indicated with the red hatched lines. TPF must be erected and inspected by Project Arborist to ensure conditions are met.

In this photo the staging and materials storage area is identified by the solid blue line. Three (3) areas can be utilized during the development event. The solid orange line indicates an area along the edge of the protection zone which will require the addition of hog-fuel and/or wood chips. Placement of wood chips will reduce root and soil compaction.

- Provide tree protection fencing as illustrated in Figure #1 Site Map. All tree protection fencing will meet or exceed the requirements established by the City of Victoria. Provide signage on each section of TPF. Signs shall state "Tree Protection Zone – Do Not Enter". Signs shall be placed on fencing in a visible location. **(Step 2)**

- Provide hog-fuel and/or wood chips to reduce mechanical and material compaction during the event. Place materials at a depth of 20cm over grade in the area identified in Figure #1 Site Map. Place along the outside of the TPF which aligns the cypress hedge. Project Arborist will verify and approve the positioning and depth of materials. **(Step 3)**

- Materials storage will be confined to three (3) areas of the site. Please refer to Figure #1 – Site Map
- This will help confine compaction issues which could be expected within the site.
- At no time will materials be staged and/or stored in the Municipal Right-of-Way to the front of the site.

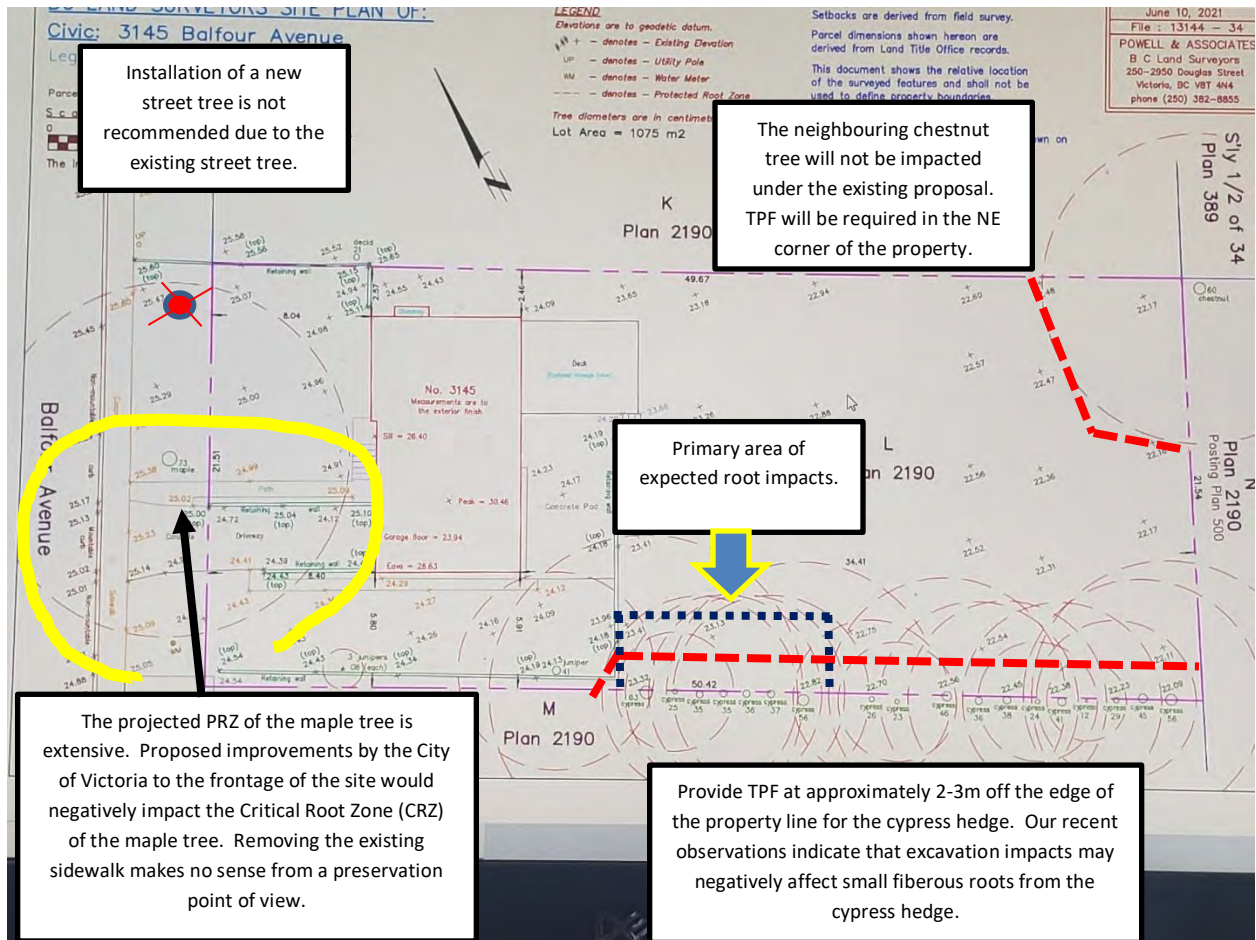
Photo #2 – Tree Positioning & Protected Root Zones (PRZ)

Our observations of the proposed driveway approach and utility corridor indicate that there will be minor to moderate impacts to the western side of the cypress hedge. The trees are elevated (raised) above the existing grade which may reduce root formations into the client's side of the property. The Project Arborist will be responsible for the assessment and preparation of root pruning and preservation. Hand digging or alternative root exposure methodology may be required.

- Provide pruning to reduce side foliage on the cypress hedge. Reduce foliage by 25 to 35 cm along the client's side of the property. Pruning must be performed prior to the demolition phase of the project. **(Step 1)**

- Provide Project Arborist to be on site during the driveway excavation and grading along the cypress hedge. Provide excavation with the use of a small rubber tracked machine. In this case we expect tertiary and small secondary root bundles to be impacted.

- Provide hand, air spade or hydrovac excavation if large structural roots are exposed. In this case we expect no structural roots to be exposed.
- Provide Project Arborist to assist with root pruning, root removal and documentation.

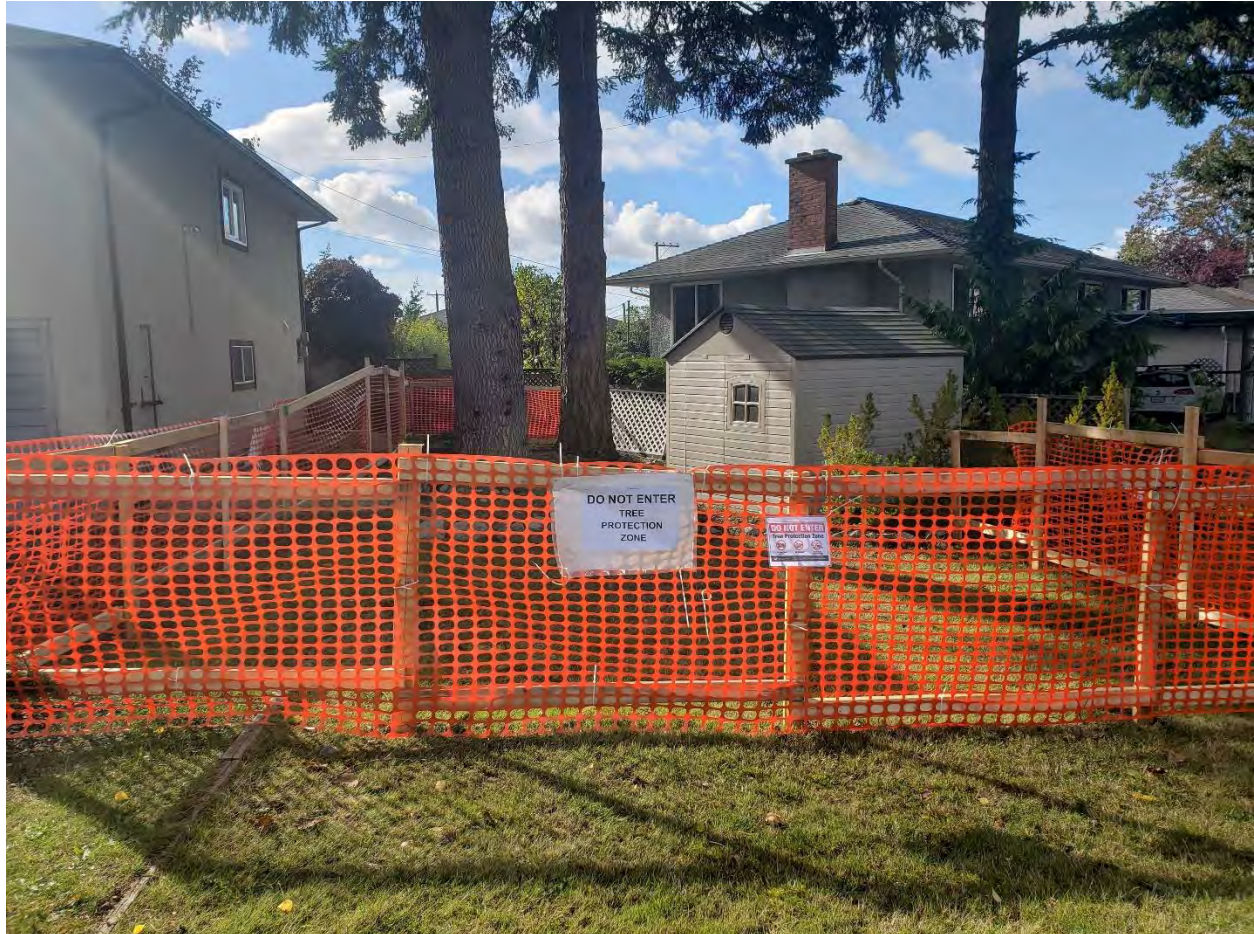
Photo #1 – Tree Protection Fencing & Signage

In this photo you can see an example of an acceptable tree protection fencing barrier. Ensure that the TPF is posted with the proper signage.

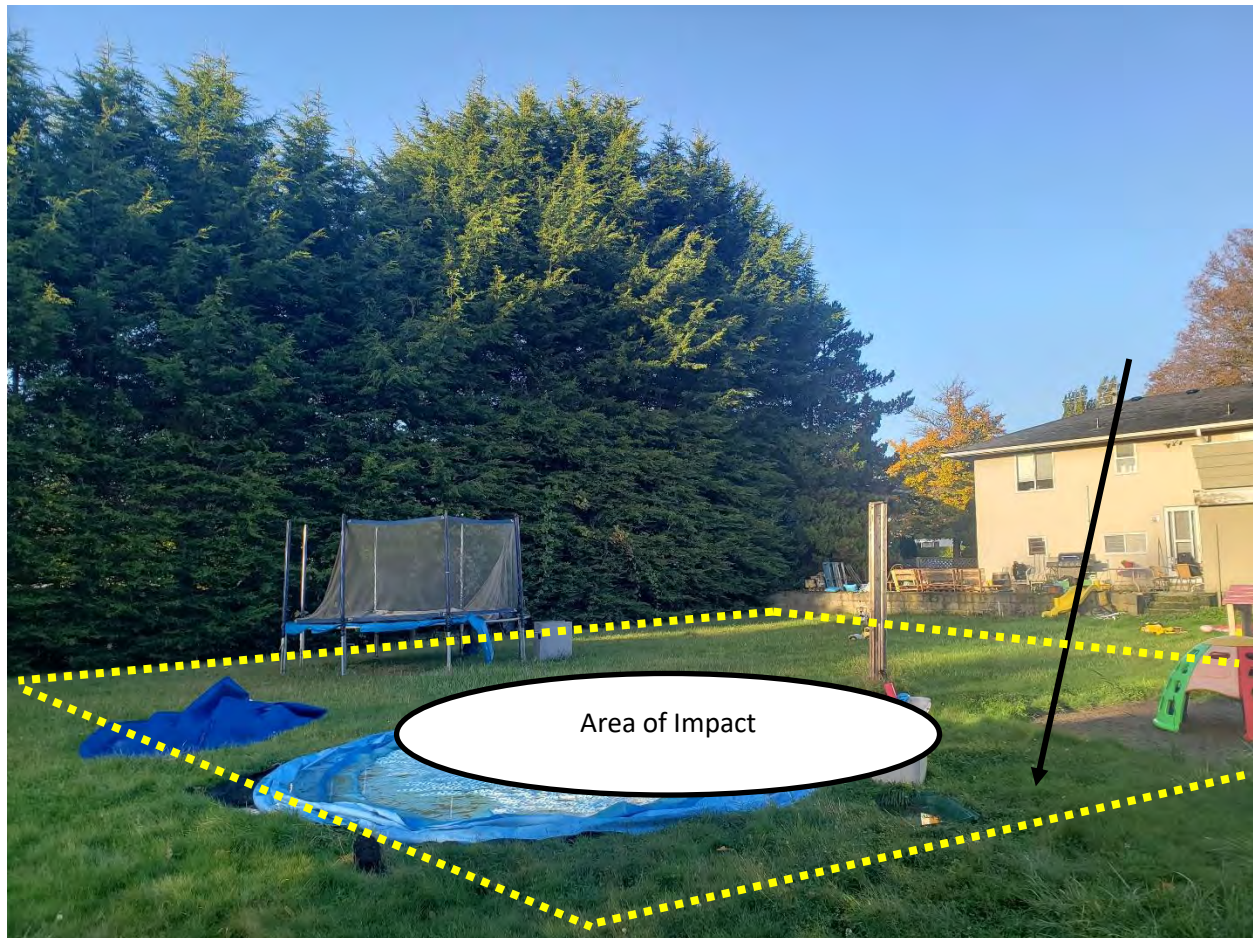
Photo #2 – Rear of Lot – Proposed New Lot & Cypress Hedge on South Property Line

In this photo you can see where the proposed footprint of the new structure will be located. In the background you can see the cypress hedge. The hedge is the only retained tree(s) which will be impacted by the development.

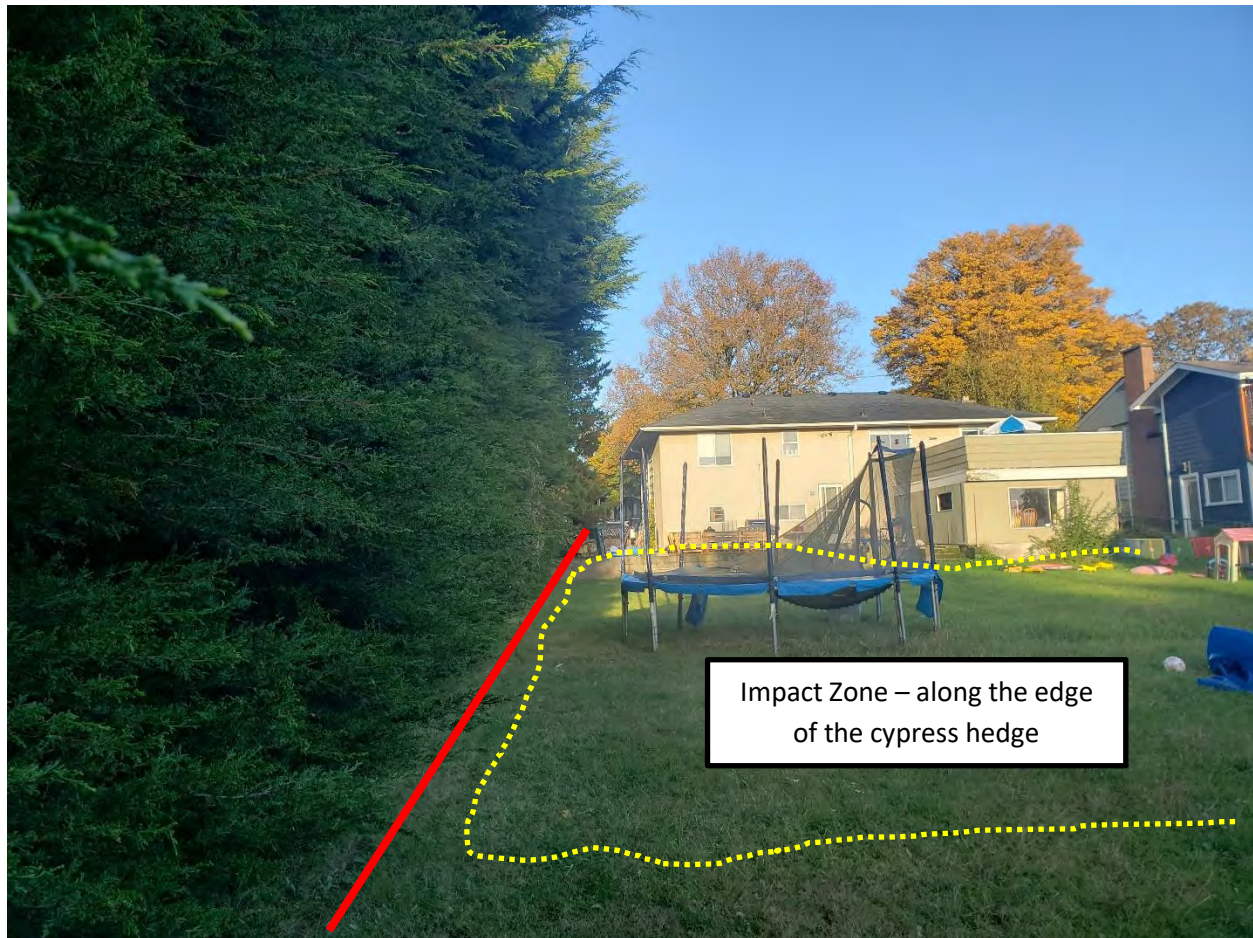
Photo # 3 – Driveway alignment & Cypress Hedge

In this photo you can see the positioning of the cypress hedge to the impact zone. The driveway alignment will be positioned approximately .50m from the edge of the hedge foliage. Pruning the hedge back by 25cm to 35cm will provide greater distance for constructive activity and TPF requirements.

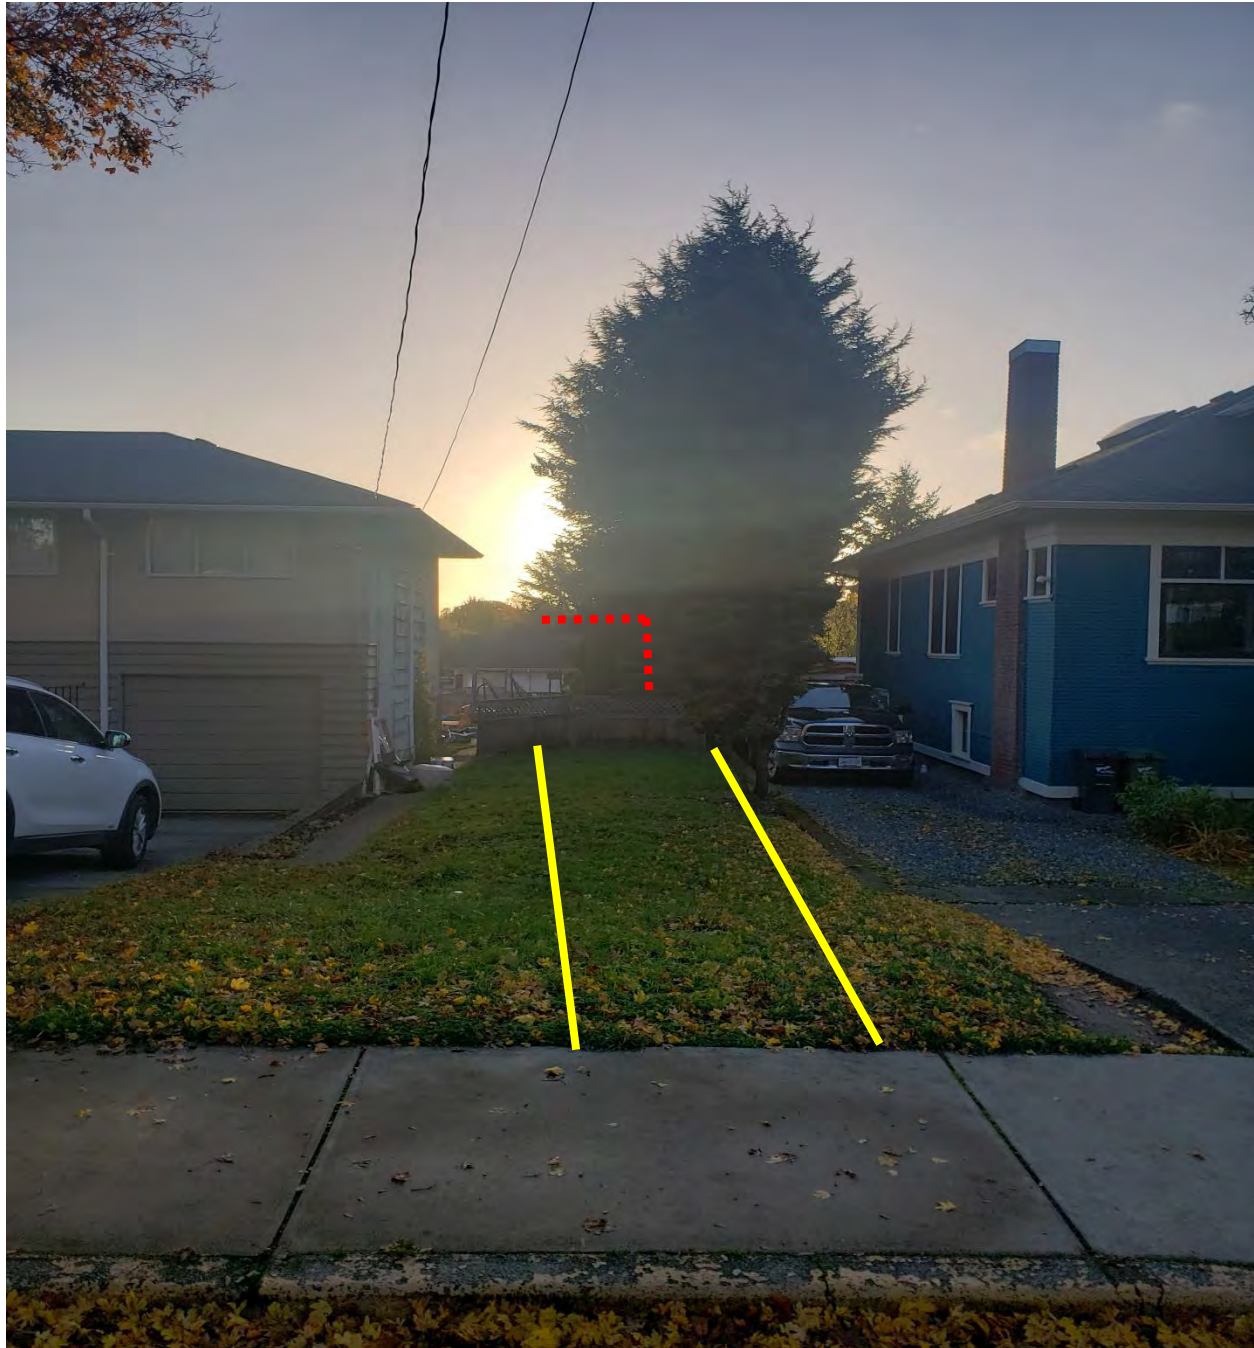
Photo # 4 – Proposed Pan-Handle Driveway

In this photo you can see the yellow lines indicating the driveway alignment into the rear yard. The red hatched lines indicate the edge of the pruning requirements to ensure clearances are sufficient for egress into and out of the site.

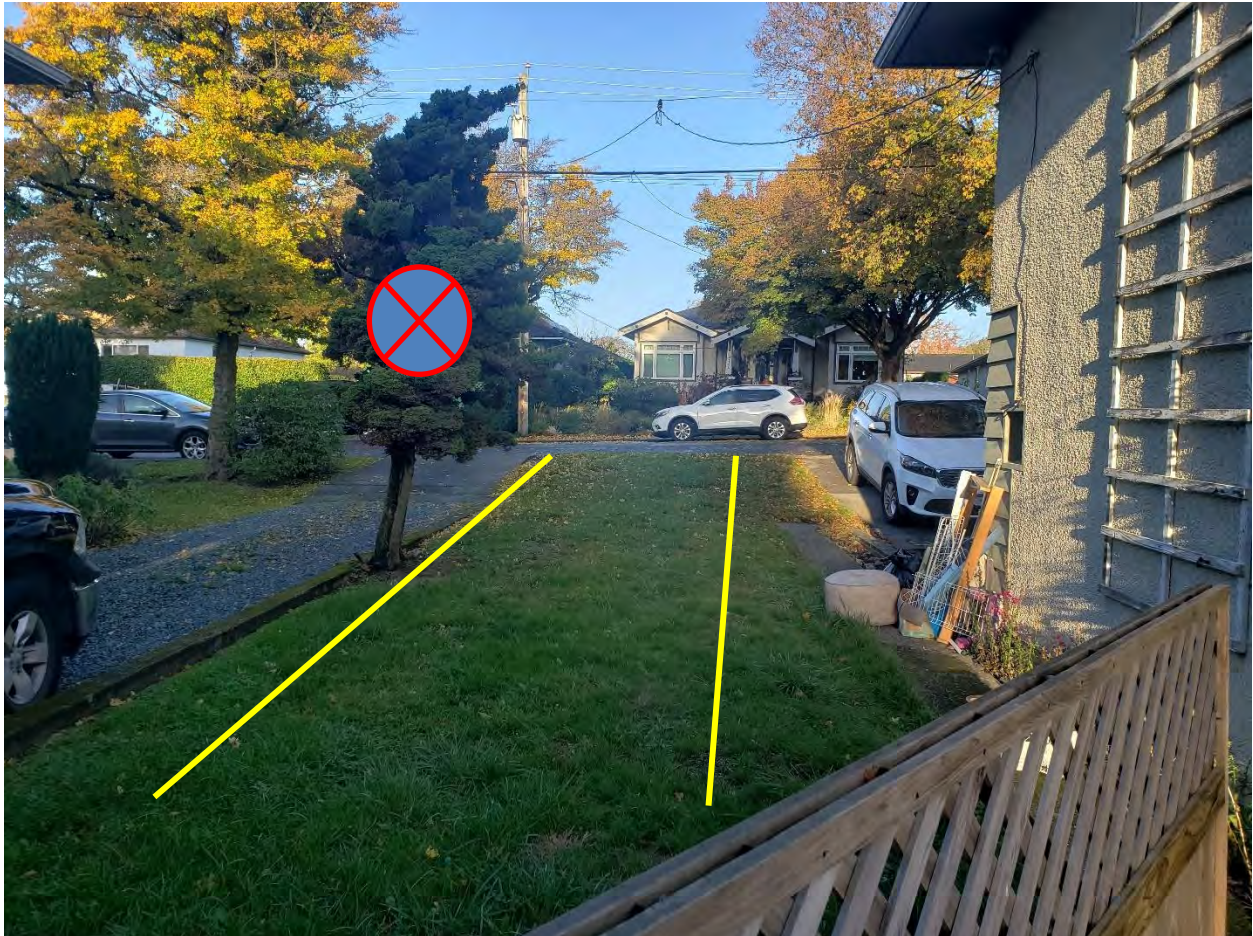
Photo # 5 – Proposed Driveway Alignment

In this photo you can see the juniper tree identified for removal. The yellow lines indicate that approximate edge of the driveway alignment.

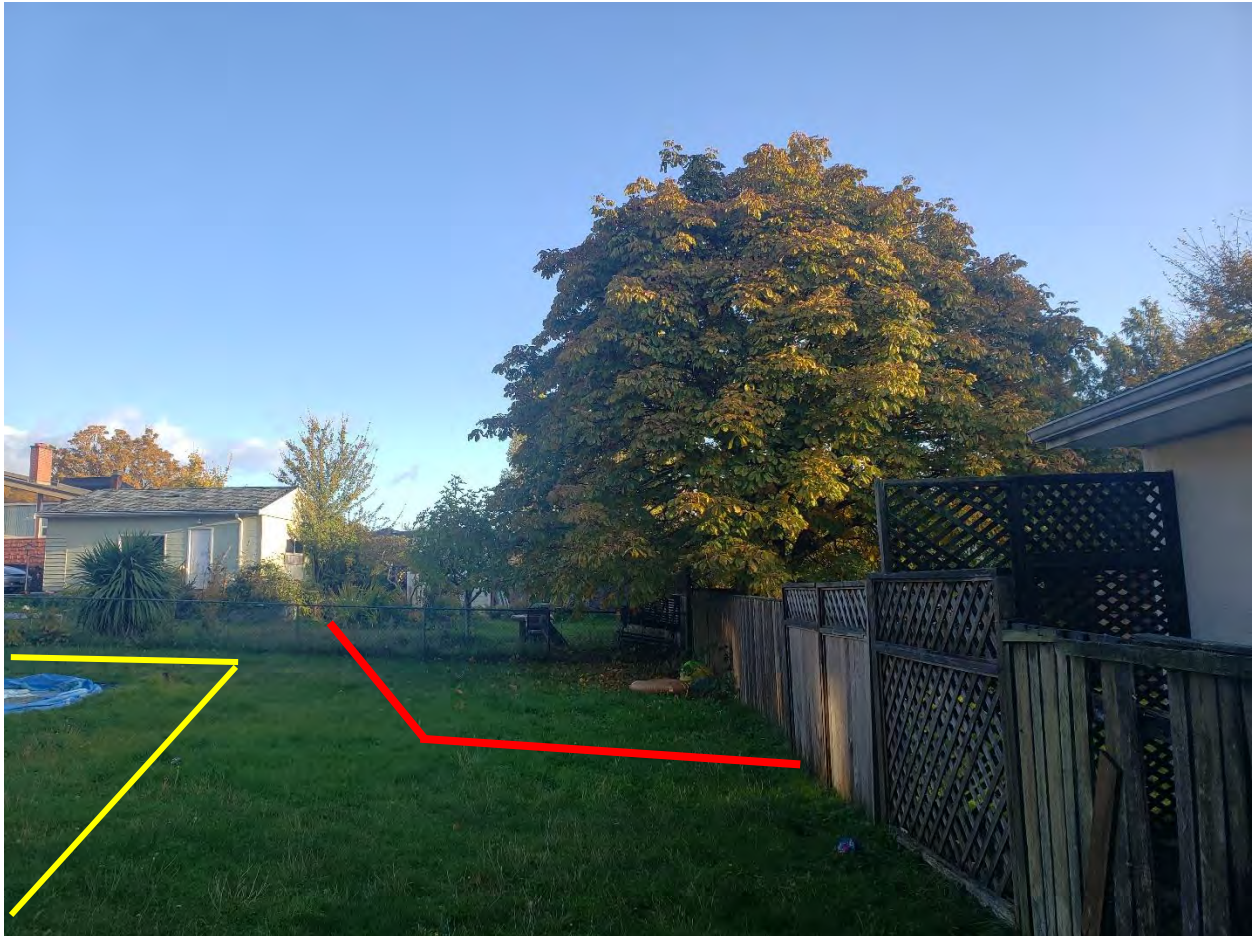
Photo #6 – Rear Yard – N/E Corner of Site – Horse Chestnut

We observed a horse chestnut (*Aesculus hippocastanum*) positioned across from the N/E corner of the site. A private tree, it is positioned outside the impact zone. Our observations indicate that this tree will be protected and preserved. The chestnut tree is a bylaw protected tree positioned on a neighbouring property.

In this photo you can see the positioning of the chestnut tree off site. A portion of the trees PRZ is near the zone of impact. The red solid line indicates the approximate positioning of the TPF. The yellow solid line indicates the zone of impact.
